# Diagnosis and repair of a historic stone masonry arch bridge

**ABSTRACT:** The D. Zameiro Bridge is a multi-span stone masonry arch bridge built between the 12th and 13th centuries that crosses the Ave River in a rural area 40 km North of Porto, Portugal. The bridge is composed of eight arches of different span, with a total length of 130 m. The bridge has been subject to several conservation and repair works along its existence. In 2001, a flood caused the partial collapse of a pier and of the adjacent arches close to left bank. The bridge was repaired in 2003, but a new accident in 2004 caused the collapse of two piers and adjacent arches near the right bank. This paper presents a brief historical note, discusses the inspection works carried out after the collapses and provides the possible reasons for such extreme events. Afterwards, the paper reports the repair works carried out, taking into account the architectural significance of the construction.

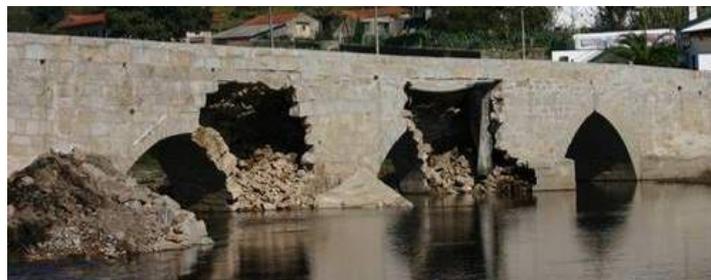
- (1) Partial collapse of piers P5 and P6, involving also the upstream cutwaters;
- (2) Partial collapse of arches A5 and A6;
- (3) Loss of backfill material;
- (4) Partial collapse of the pavement and of the upstream parapet;
- (5) Several cracks in the spandrel walls, at both sides of the bridge;
- (6) Presence of vegetation, moisture and efflorescences;
- (7) Absence of mortar in some joints and presence of cement mortar in others;
- (8) Lack of a suitable drainage system.

Figure 3 : Upstream view of the collapsed arches and piers before the construction of the temporary embankment

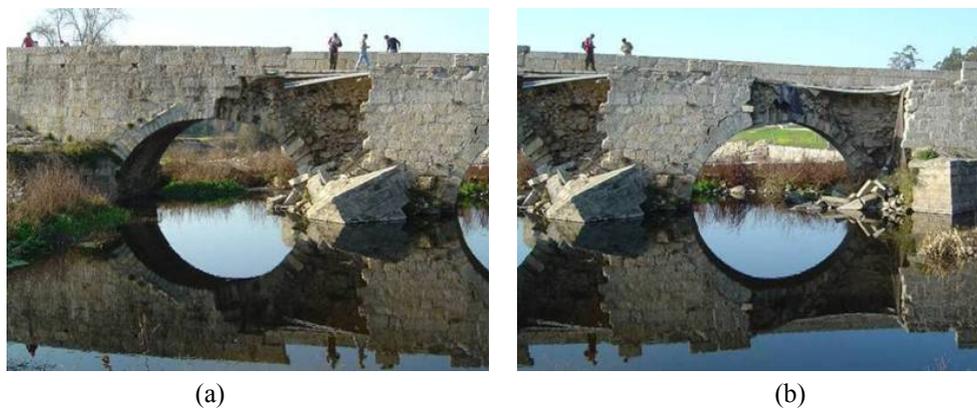
Figure 4 : Main structural damage: (a) arch A5; (b) arch A6 (upstream view).

The collapse mode observed is consistent with the hypothesis of scouring of the foundations associated to the high water velocity. This conclusion was also reached numerically by

The rehabilitation works included the strengthening of arches A5 e A6 with the purpose of prevent any additional increase of cracking at the intrados as well as to assure its future stability. The adopted strengthening measure comprises the use of six horizontal stainless steel anchors across the full bridge width, endowed with cylindrical steel anchorage plates at each side and covered by a stone slip, as illustrated in Fig.7 (a), (b).

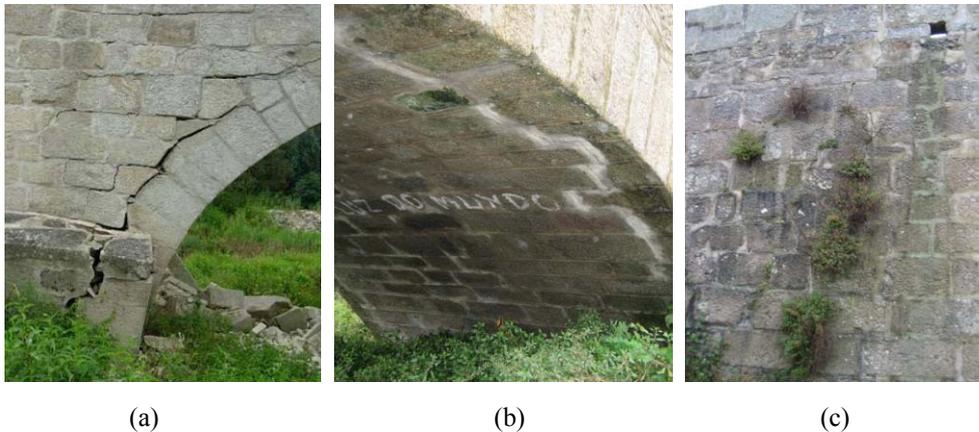
Figure 5 : Main structural damage: (a) arch-spandrel separation, (b) moisture and efflorescences, (c) vegetation and deficient drainage system

After the rebuilding of the damaged areas, the infesting vegetation was to be removed in order to allow cleaning properly the bridge. Additionally, all masonry joints that show degradation should be carefully cleaned and repointed using a suitable lime-based mortar. The same applied to joints filled with cement mortars, which had to be removed. In order to minimize the appearance of humidity and efflorescences at the intrados of arches, to reduce the lateral pressure on the walls and to prevent the fines from being washed out of the fill material, it was proposed the waterproofing of the pavement and the complete reconstruction of the drainage system.

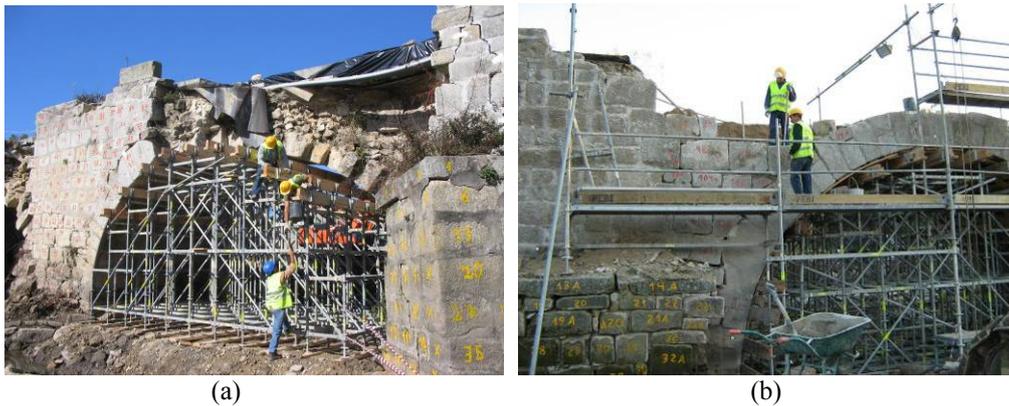
Figure 6 : Repair works: (a)numbering of the stones; (b)rebuilding of the spandrel wall.

The intervention started with the propping of the damaged arches and the rebuilding of the structural elements, namely the missing parts of the foundation, piers P5 and P6 and respective

cutwaters, arches A5 and A6, spandrel walls and parapets. This operation was carried out using the same stones, previously numbered, or when not able to be used, with similar stones from the region, see Fig.6 (a), (b).

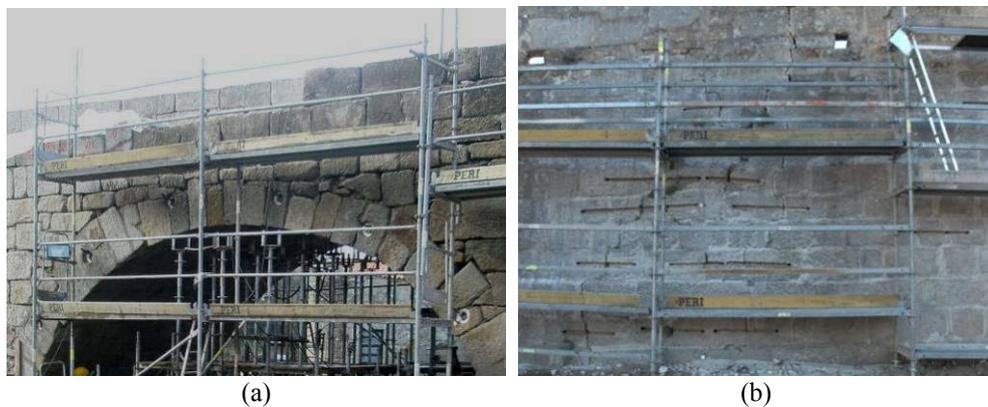
Figure 7 : Repair works: (a) strengthening of the arch with transversal anchors; (b) strengthening of the spandrel wall with steel cramps.

No tension was applied to the rods other than a tightening force resulting from their adjustment. Also, additional stainless steel cramps were used in the spandrel walls, see Fig.7 (a), (b).

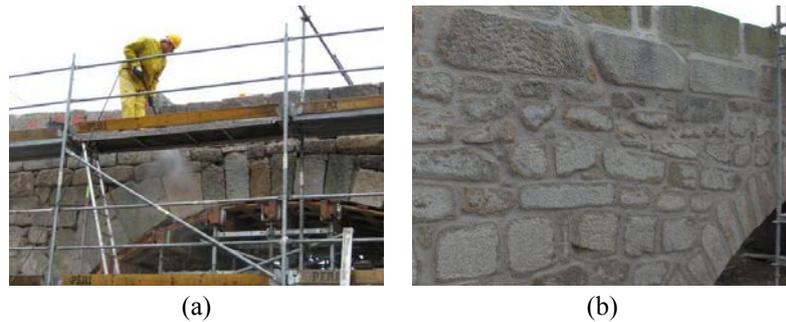
Figure 8 : Repair works (a) cleaning of the bridge; (b) joint repointing using lime-based mortar.

Given the historical importance of the bridge, cleaning of the masonry was performed avoiding any aggressive cleaning product that could cause degradation of the stone. Thus, cleaning of the bridge was done resorting to water jet cleaning, see Fig.8 (a), (b).

The removal of vegetation, roots and biological colonies was carried out through the application of biocide, as to cause the least possible damage to masonry. Joint repointing was performed with a lime-based mortar designed to match the stone colour as close as possible, see also Fig.8 (a), (b).

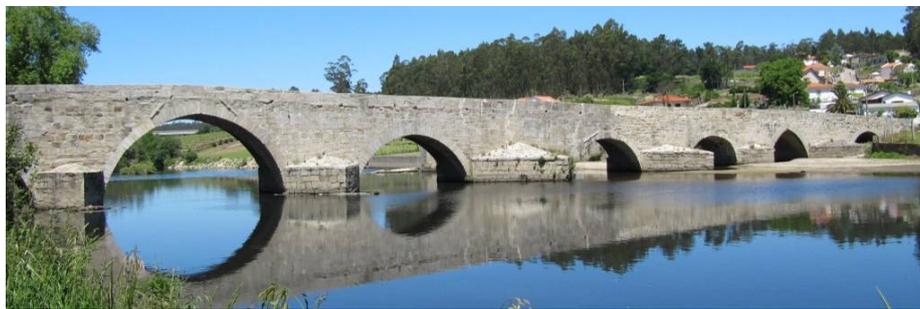
Figure 9 : Bridge after the rehabilitation (upstream view).

Waterproofing membranes were applied below the pavement, with replacement of the existing infrastructures. Also a new pavement was constructed, including a suitable drainage system. Figure shows an overview of the bridge after the conclusion of the repair works.
