# An overview of Krk Bridge repairs

Jovo Beslac, Jelena Bleiziffer and Jure Radic

*Institute IGH, Faculty of Civil Engineering, Croatia University of Zagreb, Zagreb, Croatia*

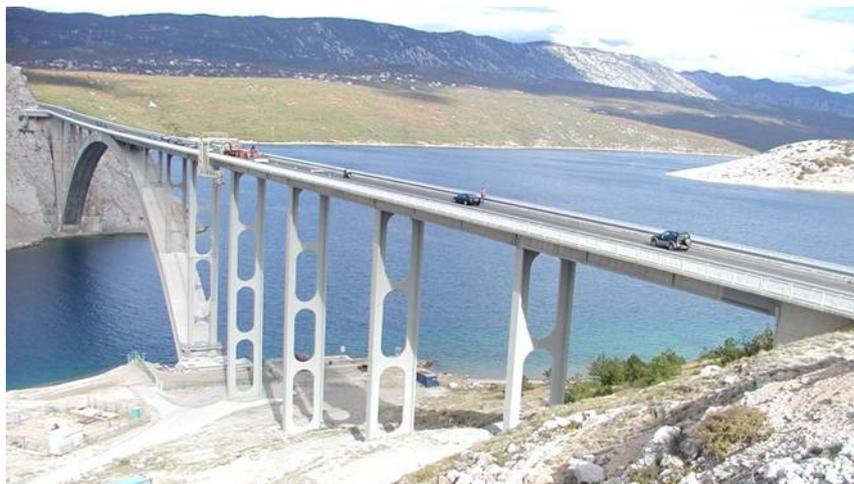
This decision was especially important for the thin and relatively high columns (Fig. 2) which were unfortunately executed by slipforming, the technology which is because of known deficiencies absolutely inconvenient for such elements in such aggressive environment.

Figure 2 : View on thin and relatively high columns executed by slipforming.

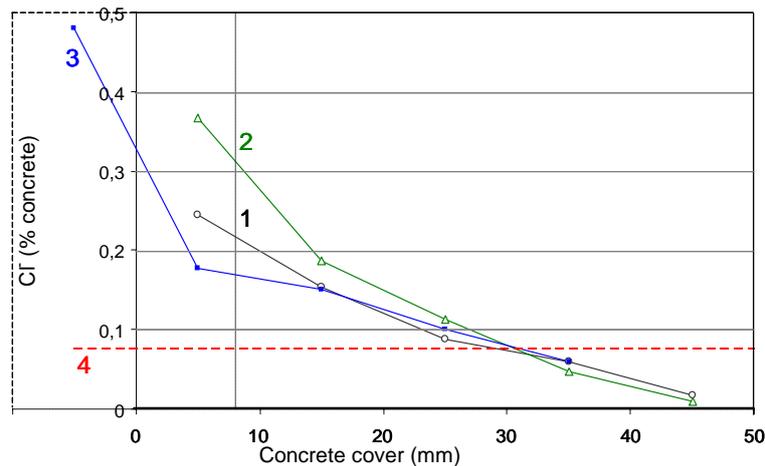
What concerns to the thin designed concrete cover the designers and the executers where explaining lately that it was designed so because it had been planned to protect the whole concrete structure. Some parts had been even protected, some one with epoxy and some one with brittle polymer cement mortar (Thoroseal). Epoxy as it is known is not physically compatible with concrete and Thoroseal as porous brittle coat even increased surface chloride concentration and penetration in concrete (Fig.3).

Figure 3 : Diagrams of chloride ingress in concrete and firstly applied protective systems tested in 2008: 1 – in non protected concrete executed 1978, 2 – in concrete protected with Thoroseal 1980, 3 – in repair mortar + polymer cement coat applied 1989, 4 – threshold value (Beslac et al., 2008).

Some parts of the bridge near the sea level were protected with best of those systems but they did not solve the problem. They helped only by the absorption of chlorides in the added mortar and prolongation of their penetration in the concrete (Fig.3).

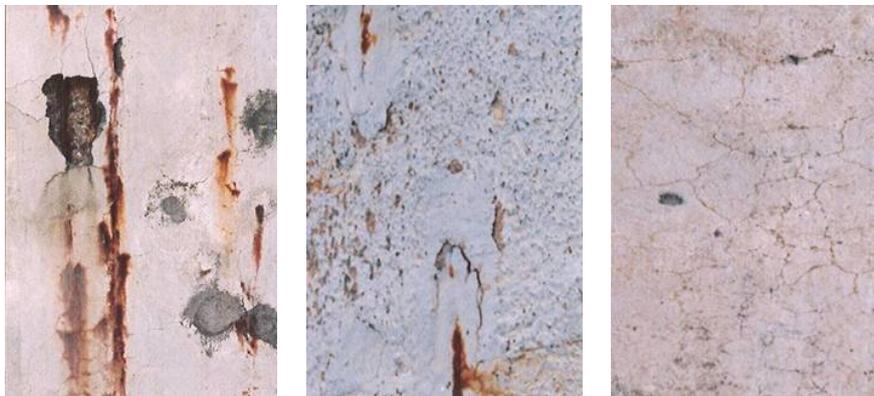
The first general monitoring and restricted testing were performed in the years 1985 and 1986. Testing was restricted because the main part of the structure was not accessible. The conclusion was that the whole reinforced concrete structure must be protected. The first very common specifications for its designing and execution were performed and the first bidding announced in 1988. All protection products, systems and technologies known at that time were possible. There were a number of offers and systems but no one satisfied already mentioned very common specifications. Therefore it was decided and offered to the producers of the systems to make trial surfaces on the foundation strut on Snt. Marko, the mostly exposed position on the bridge. More than 20 systems were tested at that very beginning and more than 10 later on. Only two or three of them were partly satisfactory. Some of them that have been forced for the application made the reinforcement protection even worse (Fig.4). The reinforcement corrosion was accelerated, what is understandable because we removed 1 to 2 cm of very good concrete cover and replaced it with more porous mortar. At that time there were not chloride impermeable coats.

Figure 4 : Some of the poor trial protective systems offered for the protection of Krk Bridge after 20 years of service.

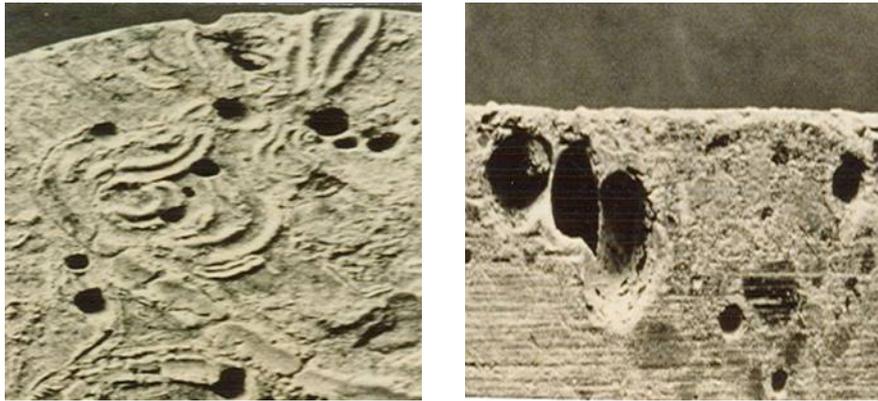
At the same that time the state of the underwater foundation elements of big arch were examined as well. It was estimated that their surface was covered by sea flora and fauna and concrete cover was damaged by the sea shell *Rocellaria Dubia* dwellings about 10 mm in diameter and 25 mm deep (Fig.5). Their greatest density was 4000 unites per m<sup>2</sup> at the depth 5 m below sea level. Then years later it was increased for 10 percents. The reparation of this concrete cover is not solved yet. The cathodic protection of the elements was designed but not executed yet.

Figure 5 : The dwellings of the sea shell *Rocellaria Dubia* in the concrete cover of the underwater foundation elements.

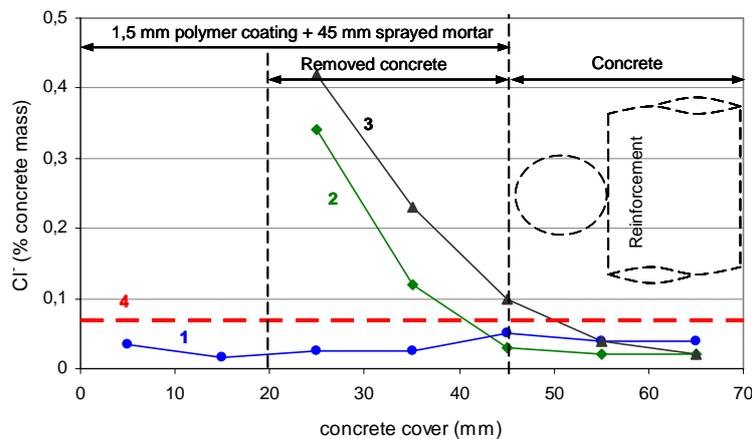
Nearly all columns and lower parts of the arches have being already protected. The efficiency of the system has being tested after 7 years of use and found satisfactory (Fig.7). There are even some redistribution of chlorides rested in concrete.

Figure 7 : Chloride ingress in the present protective system after 7 years (1) and in concrete after 10 years (2) and 20 years (3); (4) is threshold value for Krk Bridge.

(1) concrete cover must be partly or totally (dependent on the chloride concentration) hydrodemolished by the water pressure 2500 Bar;

(2) hydro demolished concrete cover must be impregnated with penetration reinforcement corrosion inhibitor;

(3) hydro demolished concrete cover must be renewed by high quality cement mortar, 1 or 2 cm thicker, with 50 MPa compressive strength and 2,0 MPa adhesion to concrete substrate;

(4) repair mortar and concrete must be protected by pure polymer coat 1,2 mm thick with the adhesion to mortar 0,8 MPa and capillary absorption below  $0,01 \text{ kg/m}^2/\text{h}^{0,5}$ .

For upper parts of the structure (with lower chloride ingress): concrete surface must be washed by water pressure of 1500 Bar, impregnated by penetration reinforcement corrosion inhibitor and protected by pure polymer coat like in before case.

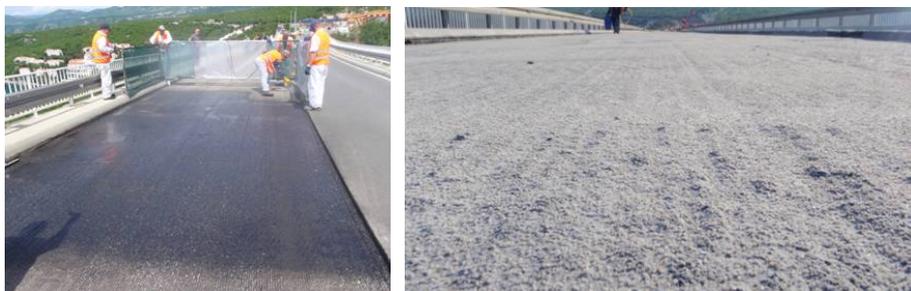
Special problem of the maintenance of Krk Bridge was reconstruction of asphalt layer which has not being repaired from the beginning of its cycle life. The depth of concrete slab of only 11 to 13 cm was not allowed to remove it in the full depth and clean the concrete by surface hydro demolition. It was successfully removed up to the firstly executed hydroisolated layer made of fine sand mastix covered with new liquide hydroisolation pored in situ and 4+3 cm of asphalt concrete (Fig.8).

Figure 8 : Reconstruction of the asphalt layer.
