## REFURBISHMENT OF CONCRETE ARCH BRIDGE IN NE ITALY

P. Franchetti, M. Frizzarin

Studio Franchetti, Arzignano, ITALY.

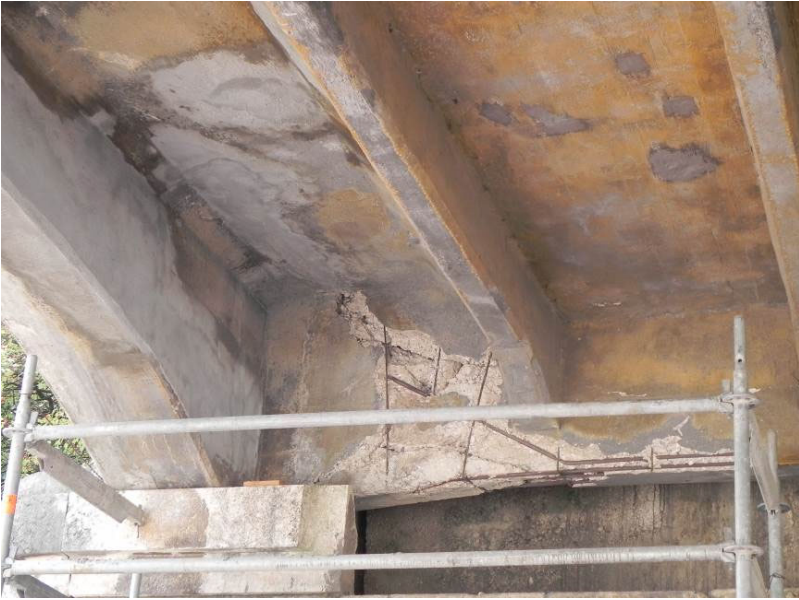
- Extended crack patterns at the ends of the first and last transversal beams of the first West span, with significant loss of the concrete beam section and corrosion of the reinforcement; the degradation is even worsened in the back faces of the beams, in correspondence to the expansion joints;
- Corrosion of the reinforcement, cracking and expulsion of concrete cover in correspondence to the concrete slab;
- Corrosion and loss of functionality of the structural elements of the bearings.

*Fig. 5. First span: lateral view.*

- reinforcing steel structure at the external transversal beams, damaged and deteriorated;
- increase the thickness of the slab with additional reinforcement;
- replacement of supports.

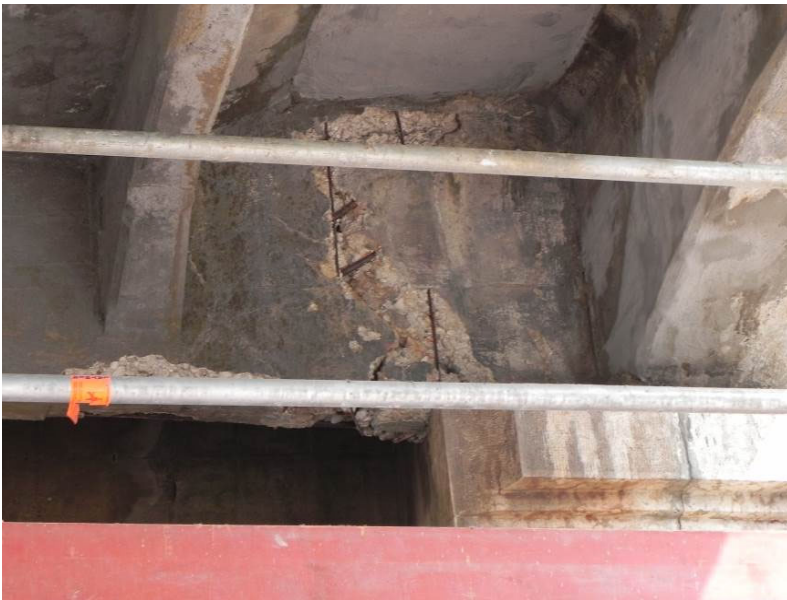
*Fig. 6. First span: lateral view.*

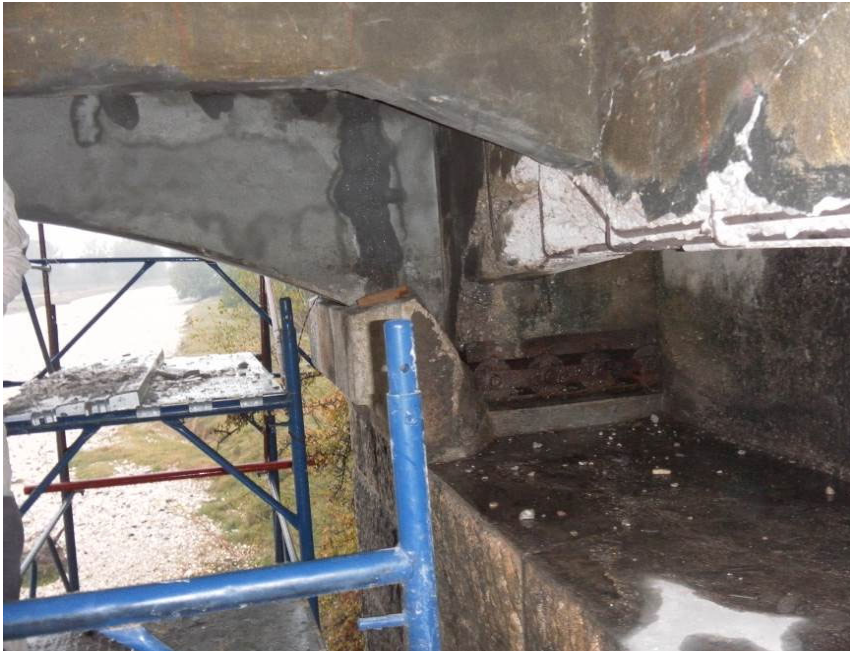
*Fig. 7. Existing bearings.*

The replacement of the supports implied the lifting of the whole first span in order to remove the existing rolling bearings and replace them with new confined elastomeric bearings.

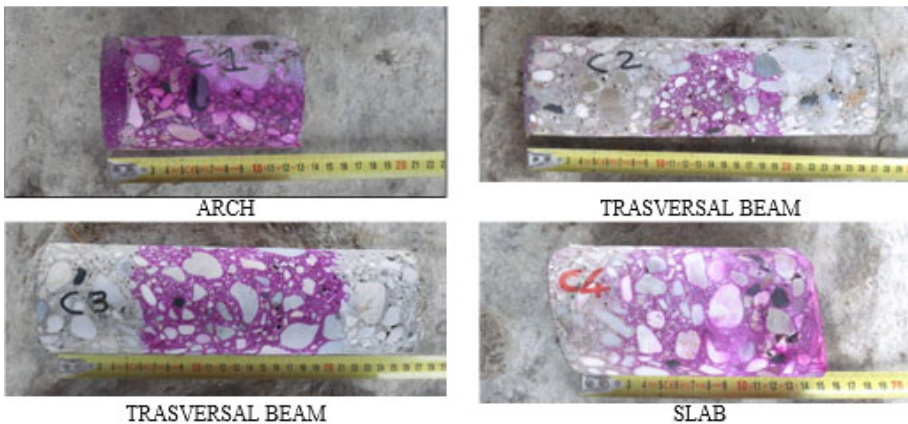
- Lower values of strength were found in the concrete of the transversal beam and of the chain near the columns (East side of first span), while higher values were recorded in the slab and in the chain near the abutment at the West side;
- the chlorides are in high quantities for all the samples acquired, in 2 cases over 3 over the fixed limit. Even sulfates occur in moderately high amount, in 1 case higher than the fixed limit;
- Carbonation: while the cores extracted from the arch does not show particular carbonation, the transversal beams present high level of carbonation, with thickness up to 9 cm for each exposed face. Even on the slab the carbonation is present, up to about 4 cm;
- Corrosion potential tests show that where the steel is still covered by the concrete, the corrosion potential is low;

Fig. 8. Carbonation test.

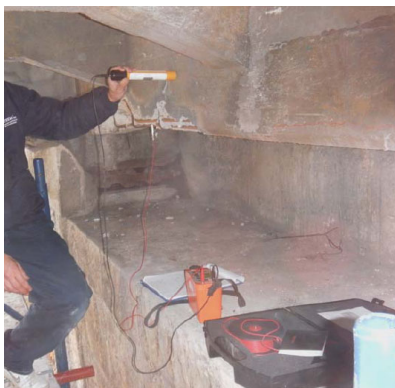
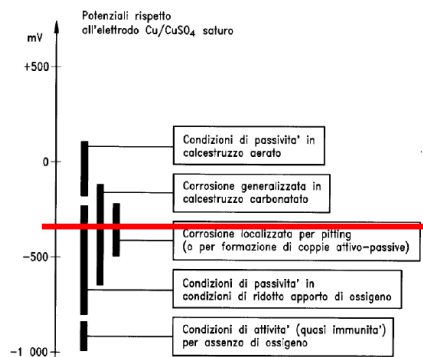
Fig. 9. Corrosion potential.
