EXPERIENCES ON REPAIRING, STRENGTHENING & WIDENING OLD ARCH BRIDGES

J. Pons, Z. Rzeplinska

PEDELTA S.L., SPAIN.

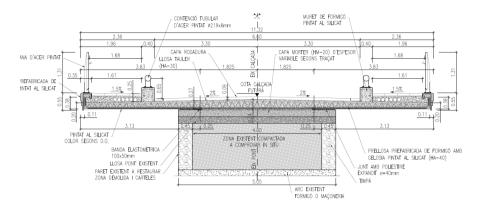
Fig. 4. After-construction cross section.

As a result of a detailed and extend design project, a combined precast and in situ slab deck was built over the original slab deck, due to the extremely good condition of both the earth and the slab deck. It has been a gain of 3.37m in wideness, from 7.95m (Fig. 3) to 11.32m after-construction (Fig. 4).

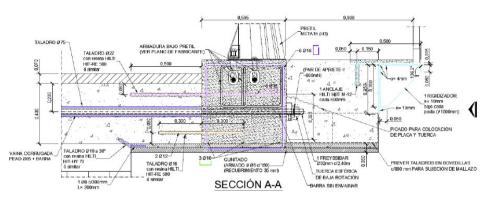
Fig. 15. Detailed drawing for the sidewalk and new safety barrier expansion.

It was necessary to build a longitudinal member under the safety barrier to have it properly anchored and to ensure a proper transmission from the effects of the action to the slab deck (Fig. 15).

Therefore the effects of the forces originated in the barrier in case of an impact go totally to the upper deck and are not significantly transferred to the existing cantilevers (Fig. 15).

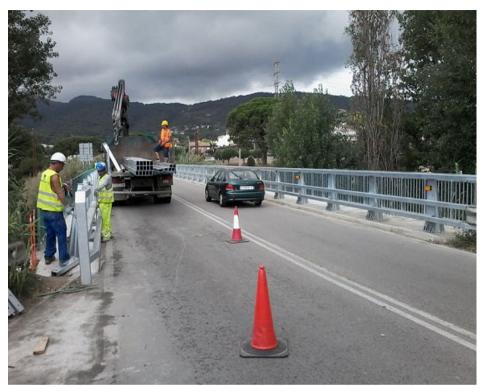
Fig. 17. Safety barrier installation.

The construction works were completed in less than a couple of months and no significant traffic problems were reported (Fig 17).
