TEN YEARS AFTER THE RECONSTRUCTION OF PLEČNIK'S FOOTBRIDGE AT PRAGUE CASTLE

V. Vacek, J. Kolísko, P. Tej, L. Kudrnáčová

An example of a successful reconstruction of the small but important and culturally significant structures Plečnik's footbridge located on the premises of Prague Castle is discussed in this paper. The building was severely disrupted for 10 years after a previous reconstruction. This damage and degradation was caused mainly as a result of faults incorrectly designed new waterproofing and water freezing in the new drainage pipe bridge. Technically properly designed and in 2006, well made reparations, resulting problems removed and for 10 years after completion fulfils its function perfectly and reliably protects valuable object.

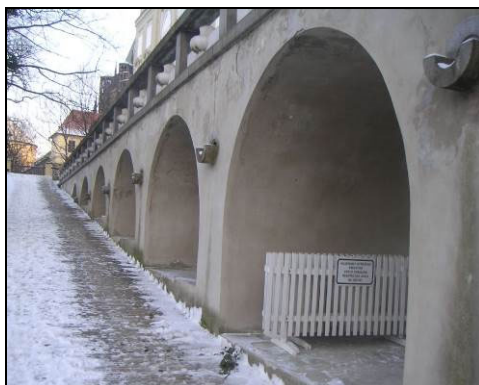
Fig. 2. There are brick arches structure of the Plečník's footbridge - the original state in 2004.

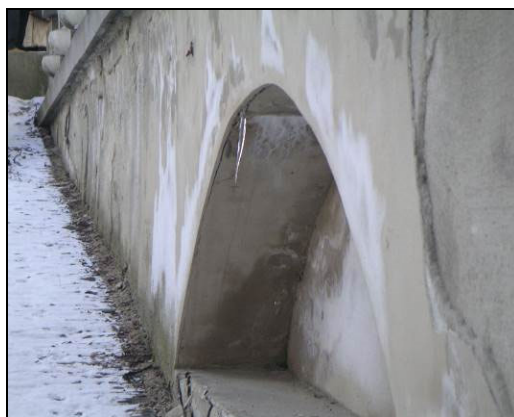
Fig. 3. A closer look at the the state of lower construction - icicle on a significant crack in 2004.

However during the following period the bridge deck tightness was damaged again which led to ingress of water on the bottom face of arches, soaking and plaster degradation. Dismal condition of the structure deteriorated mostly by the leakage and frost action led the bridge caretaker to decision about new repair. Principal problems were leakage of rain water, humidity capillary action and salting. Klokner Institute of CTU in Prague was delegated to perform the structural and technical survey aiming to find causes of degradation as well as the subsequent reconstruction design in order to solve the adverse situation.

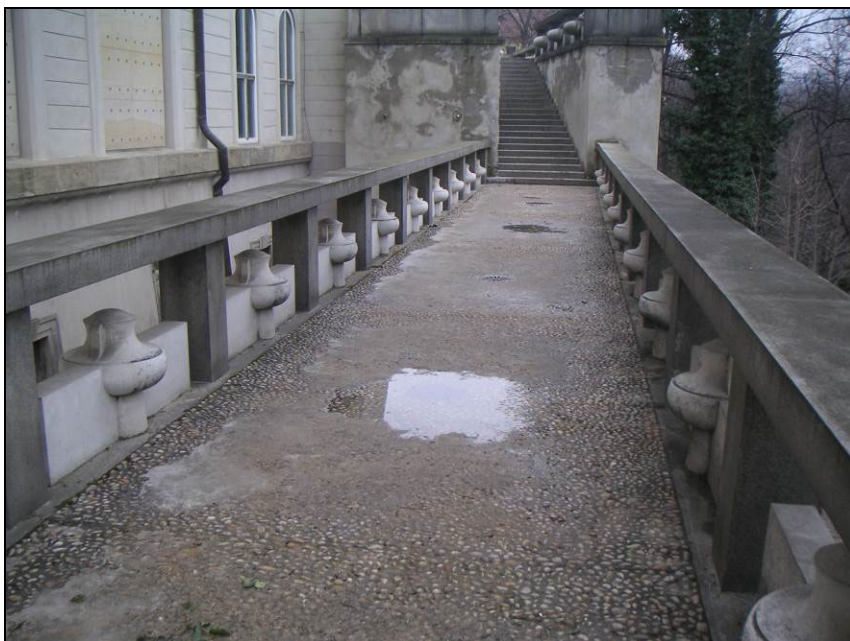
Fig. 4. Water from melting snow and ice on deck in 2004.

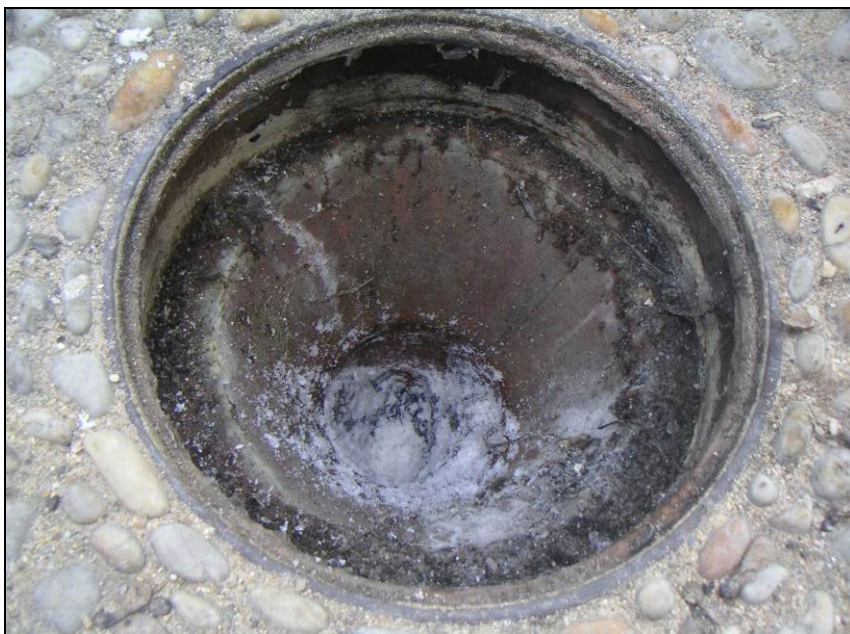
Fig. 5. A detail frozen gullies in 2004.

Specialists from the Klokner Institute of CTU in Prague found out during the diagnostics that gargoyles freeze during the winter season and the mesh and water from melting snow are accumulating in this area of the footbridge. The issue of insufficient drainage of the water is further accentuated also by the deck surface shape where each drainer has its separate watershed. Such a watershed would unavoidably fill with the water and melting slush in case of an impassable drainer. A possible solution emerged to connect all drainers by linear neck gutter thus allowing drainage by any open drainer. However this proposal was unacceptable by the heritage protection authority so heating of outlets leading to gargoyles was designed in order to prevent their future freezing. Two gargoyles were also added as new on the lateral line of the footbridge which had no own drainage previously.

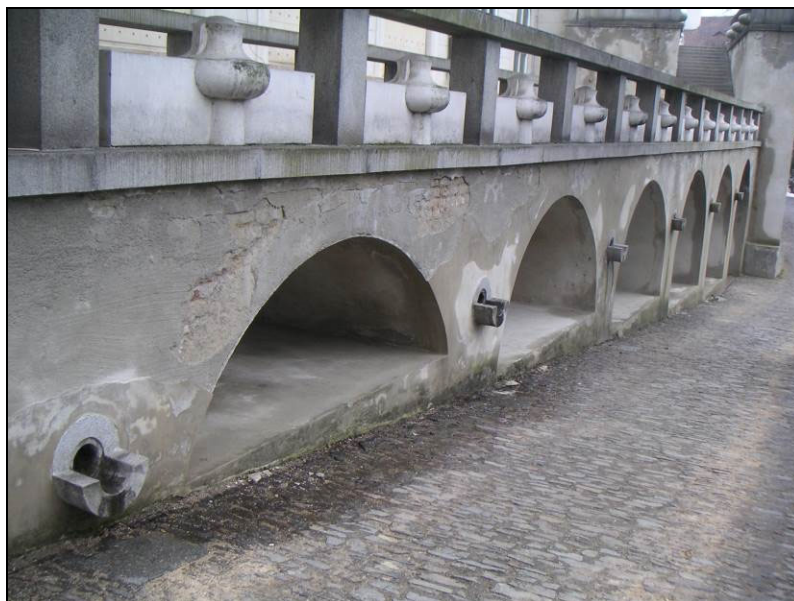
Fig. 6. The soaking wet structures - North Side with gargoyles in 2004.

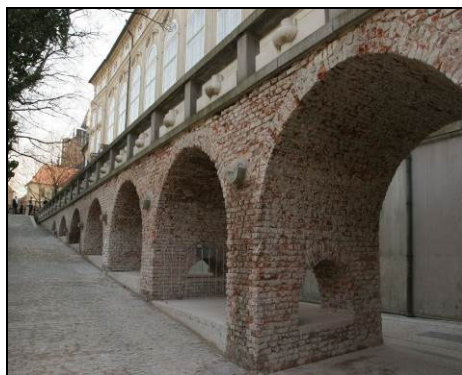
Fig. 7. *The drying brickwork after removing the old plaster.*

During following years was applied a layer of so called lost lime plaster (absorbent) on the substructure brickwork absorbing most of the harmful salts. This layer was knocked down after next few years and the structure was subsequently applied with a new plaster.

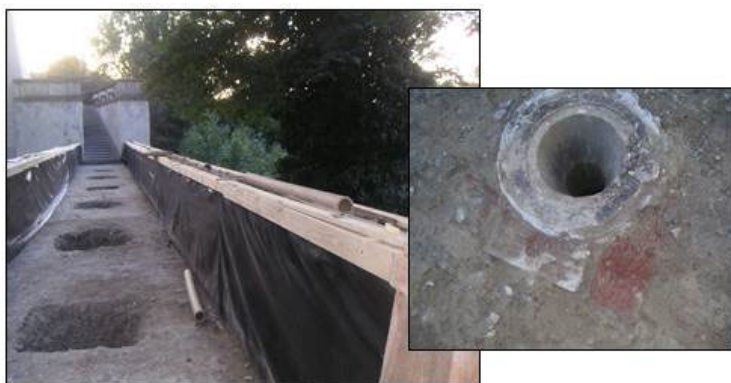
Fig. 8. *The state after the destruction and demolition of the existing bridge deck drainage, original design end of the drain pipe on a right side.*

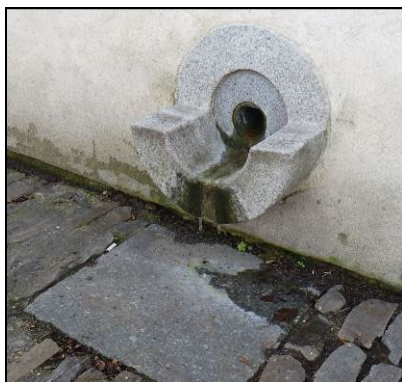
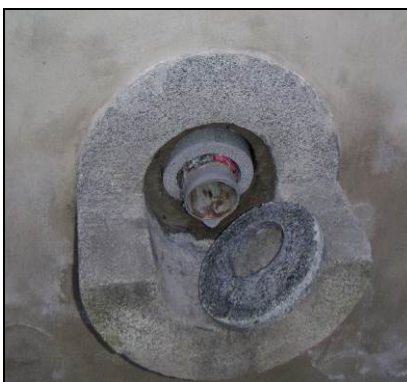
Fig. 12. The pipe end in gargoyles before covering in 2006, a gargoyle to normal operations in February 2016 on the right side.

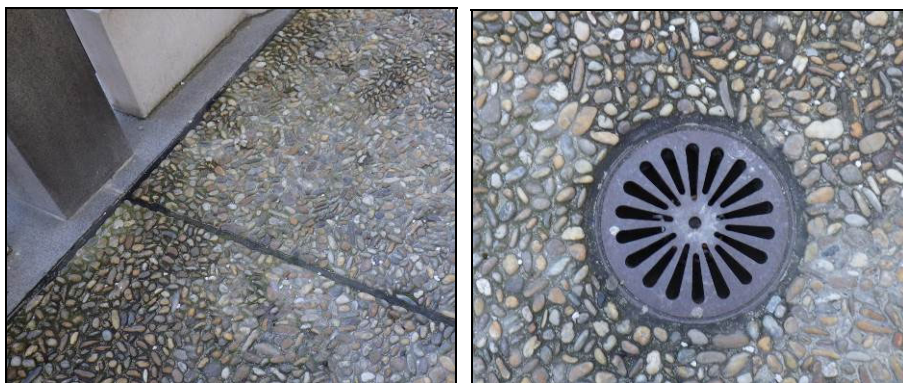
Fig. 16. The condition decisive details after ten years of operation in February 2016.

Functionality of the drainage system, its heating and very high quality double water insulation of the bridge deck had been tested during several frost waves in the winter 2007. Reliability of the new solution was confirmed, the system is fully protecting the footbridge structure against adverse impacts of rainwater which is led from the structure even during winter operation under action of the frost and layers of snow with ice melting on the bridge deck. We are pleased to state that the repair carried out in 2006 is unlike previous attempts reliable and fully functional even after ten years of operation of the reconstructed Plečnik's footbridge and is in compliance with all demands of the national heritage authority related to this unique works.
