Restoration of bridges built with the dry stone technique

ABSTRACT: The mountainous interior of the province of Castellón and Teruel is characterised by omnipresent dry stone structures, for instance, shepherds' or farmers' huts, walls around fields or terraces, ramps, stairs, pavements or wells. The bridge in the Pobleta de San Miguel fits into this category; it is an extraordinary work of medieval vernacular engineering that was built by combining lime-bonded masonry techniques around the single arch with the dry stone methods typical in the area. The original pavement of the bridge is made with pebbles from the river arranged in chain. The restoration project included drawing up a meticulous survey, with an exhaustive study of the constructive system. The work involved the individual selection and precise placement of thousands of stones of different shapes and sizes, from the pebbles in the pavement to the large blocks weighing several tons used to channel the course of the river or form the bank.

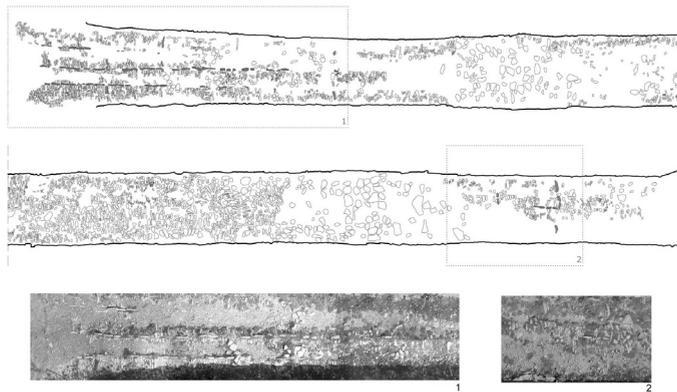
separated by longitudinal rails formed by the pebbles placed and arranged in a row. In this pavement, the chains are also identified, arranged in a cross-sectional position with respect to the road and approximately positioned every 2.5 m. The second, possibly a repair with respect to the first one, consists of an irregular river pebble pavement of larger dimensions and two different colors, white and yellow. In both cases, the pavements are built in the following way: there is a layer of earth with variable thickness on the structure of the bridge; the pebbles or the small rough stones are settled on this earth layer; the joints between pebbles or rough stones are filled with earth where in most of the cases a spontaneous vegetation grows which contributes with its roots to the compaction of the earth and the resistance of the pavement.

The degradation conditions and, mainly, the lack of material in the pavement, has allowed to identify the stones that corresponded to the structural base on which the pavement was placed. Large limestone slates constitute the last stone line of the structure of the bridge.

Figure 3: Bridge pavement with traces of rails and chains

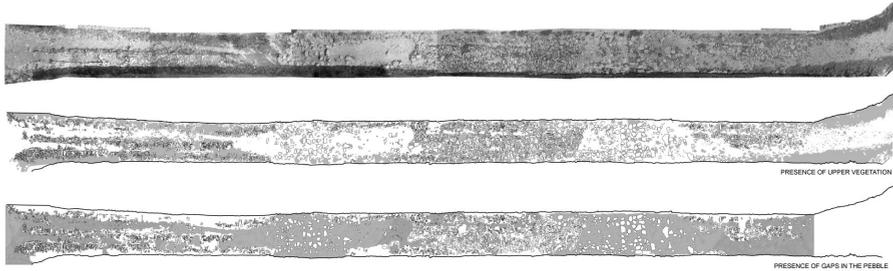
The two most degrading phenomena present in the pavement of the bridge were the major gaps in the pebble layer and the presence of upper vegetation. The pavement of the bridge has suffered considerably with the passage of time and traffic of cattle, since it has been object, even in recent times, of vandalism by some inhabitants of the village who, as said above, used to remove stones and throw them to the river in the days of flood just to see the pebbles skimming the surface of the water. These vandalism acts together with the action of atmospheric agents and the passage of time and people, have caused a very accused phenomenon of loss of pavement material.

Grass grows between the pebbles or small rough stones of both types of pavement, which was not considered as a true affection to its presence and health. On the contrary, the growth of grass was considered as an element that increased the compaction of the earth in the joints between such pebbles consolidating the pavement itself. In addition, it was considered that the vegetation became an important element for the traditional image of the bridge. The upper vegetation is accumulated, mainly, in the joints of the existing pavement (the original pavement as well as the replacement pavement), in this case being spontaneous grass, and mainly little bushes on the sides of the road in an adjacent position to the parapet. However, the gaps in the pavement represented, without a doubt, the true and most important phenomenon of degradation. It can be stated that the gaps reached more that 70% of the total surface of the pavement, calculating also the pavement found after the cleaning of the vegetation.

Figure 4: Pavement photographic survey and pathologies survey (vegetation and gaps)
