From the fabrication to the maintenance – a report of the history of the Mur River Wooden Bridge in Styria/Austria

ABSTRACT: This article describes the history of the Mur River Wooden Bridge, which was built in 1993 in Styria/Austria as a three-hinged arch bridge with supported carriageway. It covers the fabrication and assembly of the wooden bridge and a description of the supporting system, as well as the results of the accomplished bridge inspection in the year 2003, and the consequential ordered measures of rehabilitation. Furthermore, there are given the incurred costs and the determined annual maintenance percentage of the bridge.

1 MUR RIVER WOODEN BRIDGE – PROJECT DESCRIPTION

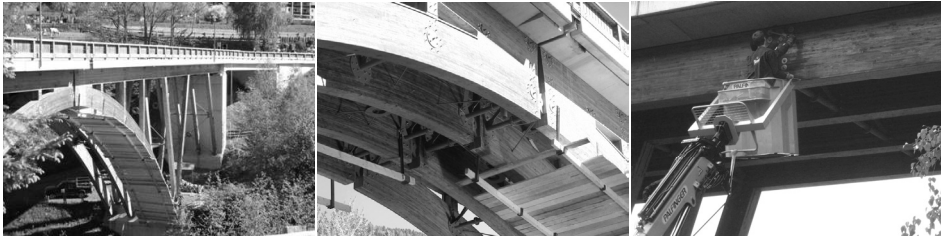
Figure 6 : Platform for the work at the main structure (left, middle); Joints: control of the firm fit (right).

A cost-saving and more practical alternative for the (expensive) auto crane could be found for the extensive work on the main support structure (specially the three-hinged arches). Steel members were fastened to the three-hinged arches by threaded rods, which served as anchorage for a scaffold platform for two of the four arches. The finished platform substantially facilitated the work for the necessary measures.

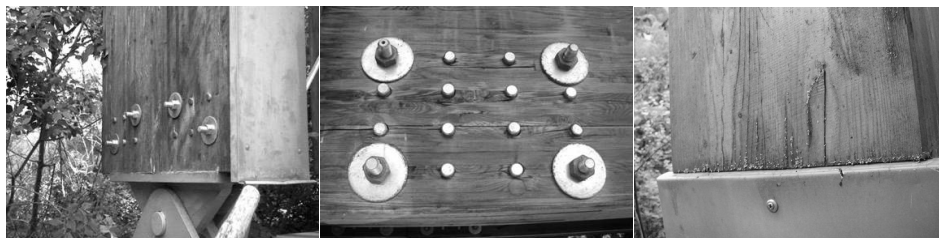
The surfaces and bearing points of the outside arranged three-hinged arches, V-supports and struts in contrast, already showed substantial weathering with partial strong discolorations (washing). More or less deep, mostly locally limited cracks were noticed. Supplementing wood moisture measurements delivered a moisture content of 12 % to 16 % at the bearing points of the three-hinged arches and the V-supports. Only one arch bearing point, arranged on the outside, showed a higher wood moisture content of approximately 20 %.

All flexible seals required repair or were lacking. The surface coating of the steel elements was already partly flaked off, which caused commencing corrosion of the surfaces.

The connection bracing system showed first signs of corrosion; the load bearing capacity was not affected.

Figure 7 : Substantial weathering with discoloration and locally limited cracks; Lacking flexible seals.

The supporting structure was cleaned using compressed air prior to the first steps of reconstruction. The cracks caused by the influence of weathering were force-locked filled with epoxy resin. The entire wooden structure was impregnated, primed and coated with a wood preservation paint. Furthermore a renewal of the flexible seals and of the corrosion protecting coat of all steel sheets and elements took place. All joints (screws, bolts) were examined for their firm fit and retightened if necessary. As an additional measure, three sides of an arch bearing point (the wood moisture content was approximately at 20 % at the time of bridge inspection) were completely encased with larch three-layer boards. A measuring device might be arranged for a continuous gauging of the moisture content at the bearing point of the arch.

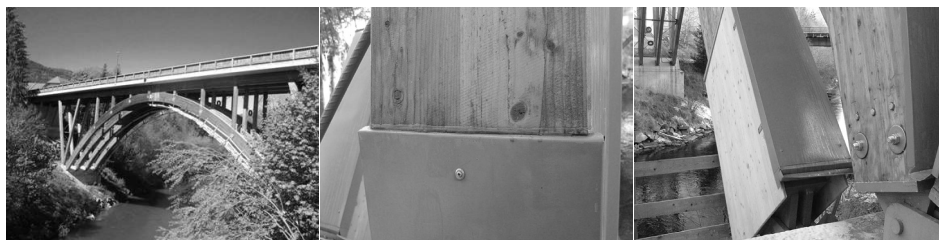
Figure 8 : Finished coating of the left bridge side (left); Renewed flexible seals (middle); Additional measure: encased arch bearing point (right).

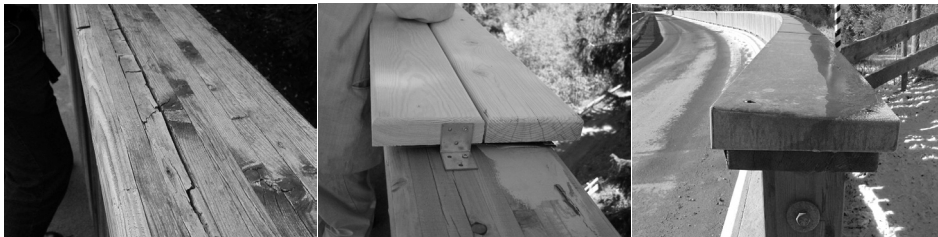
The railing and particularly the hand rail were generally in a bad condition at the time of the bridge inspection. The hand rail, implemented as a flatwise glulam beam, showed very strong indicators of weathering combined with distinct cracking. In some areas wood crumbling already took place. In areas of bordering vegetation, the railing (hand rail, posts) showed moss and lichen infestation.

Figure 9 : Condition of the handrail in 2003 (left); Additional cover measures (middle, right).

The entire railing construction was cleaned in the course of the rehabilitation works. The mostly intact zones of the hand rail were mortised; strongly damaged zones were completely replaced. The wood repair material, which was brought in in the course of an earlier measure of rehabilitation, was removed and new properly matching fillings were bonded. All end grain surfaces were protected with a sealant. After these rehabilitation measures the coating of the surfaces took place with a wood preservation paint.

An additional cover measure was taken to extend the durability of the hand rail, whereas two different systems were used. The coming years will show the success of these two systems regarding a perfect constructional wood preservation. A bituminous coating and a self-adhesive bitumen foil, covered with larch boards, was applied to one hand rail. The other hand rail was protected by a rear ventilated metal sheeting, see Fig. 9 (middle, right).
