## WIDENING AND STRENGTHENING OF A TWO-SPAN ARCH BRIDGE

**Janusz Holowaty**

West Pomeranian University in Szczecin, Poland  
Janusz.Holowaty@zut.edu.pl

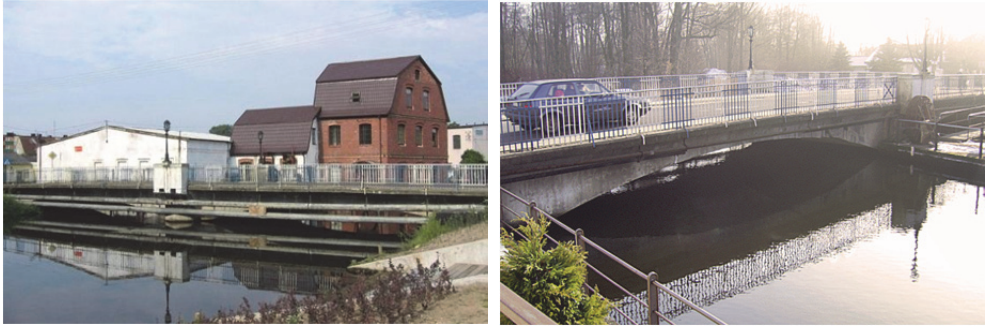
Figure 2: General views of the bridge with the historic hydroelectricity plant

The sidewalks were on reinforced concrete cantilevers and were protected with riveted steel balustrades with concrete wall sections. The support walls are of plain concrete on timber piling. Side views of the bridge before rebuilding are shown in Figure 2. The view of the arches was spoiled by externally-attached utilities (water and sewage).

Originally the carriageway used stone block pavement but when the number of cars increased, a bituminous wearing course was added. The concrete barrel surfaces had been repaired due to the spalling of the concrete. The bridge needed upgrading, as it is also located along an industrial transport route from a timber processing plant on the outskirts of the town. The bridge is the only such structure over the Rega River in this region. The design load class used at its construction was much lower than that presently required for existing bridges (40 t). The fittings and concrete surfaces were in poor condition; however, checks on the concrete quality and strength gave satisfactory results. No traces were noted of insufficient capacity in the structure; however, some war damage had been covered. The bridge drainage systems were insufficient. Waterproofing was nonexistent and there was leakage on the barrel soffits. Over the years, municipal utilities had been added externally to the bridge sidewalk cantilever (Figure 2) and these needed to be removed.

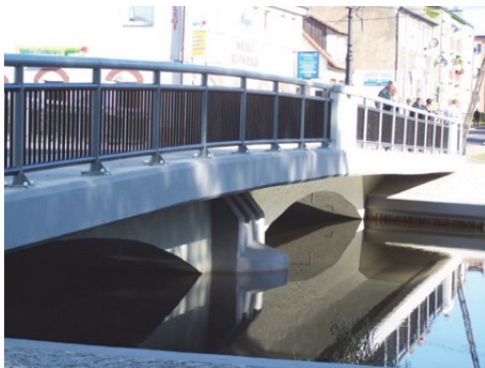
Figure 7: The bridge at opening (2009)

The bridge works followed the design schedule. During the demolition works, some major longitudinal cracks were found on the top of the arch barrels which were repaired. After the overslab construction, waterproofing and a bridge drainage system were installed. The bridge deck was equipped with new wider sidewalks. The arch spans and supports were repaired and strengthened. During the earthworks, near the abutments, rectangular timber piles of deep foundations were discovered, which proved to be in very good condition. The general appearance of the bridge was improved by removing the external utilities and making a road restraint system in the form of old balustrades. The old gas lighting poles on the bridge parapets were renovated and electric lighting was installed. Views of the bridge after upgrading are shown in Figures 7 and 8.

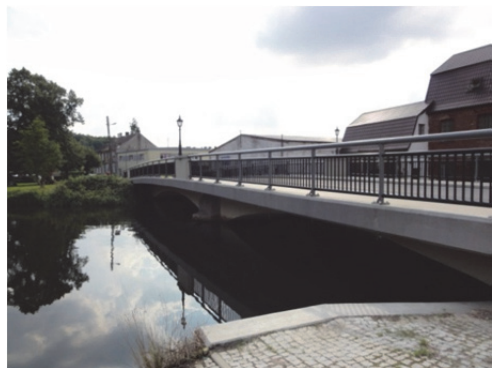
Figure 8: After 3 years in service (2012)

The widening and upgrading of the bridge were carried out in 2009. After 3 years in service, no defects in the upgrading work have been observed and the bridge remains in very good condition. The overslabbing technique was used for the refurbishment of the arch barrel bridge structure. The new overslab replaced damaged RC side cantilevers and stone pavement on the bridge. The overslab allowed the bridge to be kept integral and no expansion joints were installed in the asphalt carriageway. Waterproofing was installed and all other damaged accessories were replaced. The overslab increased the bridge strength to current load demands and widened the deck for a wider carriageway and new sidewalks. Both bridge and user safety were significantly increased. The architectural view of the bridge was improved by removing externally-attached utilities and keeping the original arrangement of balustrades and bridge lighting.
