# Study of the constructing materials, techniques and pathology symptoms of the stone bridge DeBosset in Kefalonia

ABSTRACT: The stone Bridge DeBosset in Argostoli the capital of the island of Kefalonia, Greece, was firstly constructed in 1810, in order to connect the two opposite coasts of the Argostoli gulf (Argostoli – Drapano). It was considered to be one of the biggest above sea stone bridges of the Mediterranean basin at those times, with a total length of 750m. It is still in service, but serious problems have been appeared. The continuous contact with the sea water and waves, the different types of materials used for interventions, as well as the increased car circulation, have resulted in severe pathology symptoms to the materials and structure. Based on the analysis of the existing building materials, new repair materials were proposed so as to be compatible with the old ones, in terms of aesthetic harmonization and functionality in the structural system.

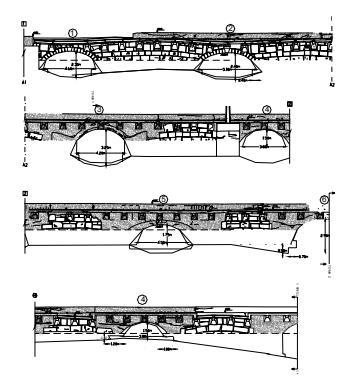
Figure 2 : The first stone arch of DeBosset Bridge.

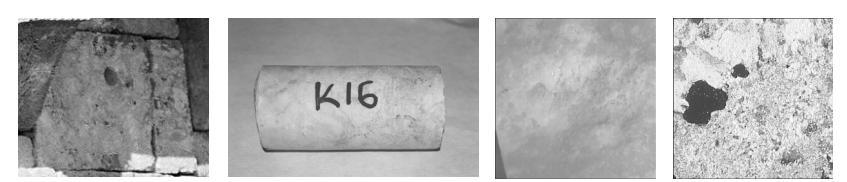
The calcitic stone, see Fig. 10, is of biogenic origin and presents color alterations, while it contains crystals of different size (rough or micro-crystallic), which are mainly calcitic (in a smaller proportion there are silicious as well).

Figure 10 : Sample 16. In situ, macroscopic, microscopic and photo taken by polarized microscope.

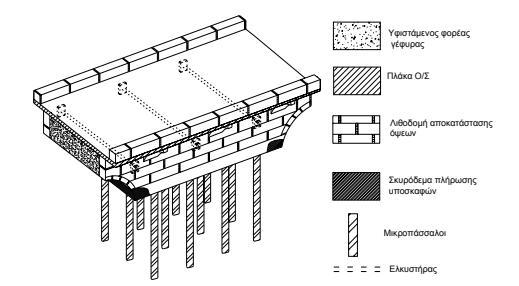
Figure 12 : Design of the bridge's corpus, after the interventions.

The restoration methods that were proposed, regarding the building materials are, see Fig. 12 (Pitilakis, K.D, 2006):

- Cleaning of the bridge's masonry and consolidation of the stone elements with special jointing mortars. These mortars should be resistant as much as possible, to the severe climatic conditions of the area (high humidity, contact with sea waves), while being compatible with the authentic materials.

- Partial or total restoration of the stones in the places where there are detachments or loss of much, with new materials compatible with the old ones (physico-mechanical properties, aesthetic harmonization). Jointing with mortars.

- Restoration of the whole corpus of the bridge (where there is now concrete), with placing a layer of stones jointed with mortars (as described above). The concrete should then be cut in an adequate width. In this way the bridge would retain its authentic form by gaining uniformity.

- Strengthening of the main corpus of the body with lateral tendons that will be placed every 1-1.5m and which would retain the two facades of the bridge, increasing its mechanical capability in seismic loads. In parallel, increase of the bearing capacity of the bridge with the construction of small piles, that will be 30-50cm lower than the concrete slab of the road.

- Replacement of the concrete slab of the road, with a new one, reinforced and of small width. This slab should correlate in the best way with the structure and should be of low weight, so as not to create additional loads.
