Improvement, reinforcement and protection of the foundations of the Sernada do Vouga railway Bridge

F. Martins

REFER - Rede Ferroviária Nacional, EP, Lisbon, Portugal

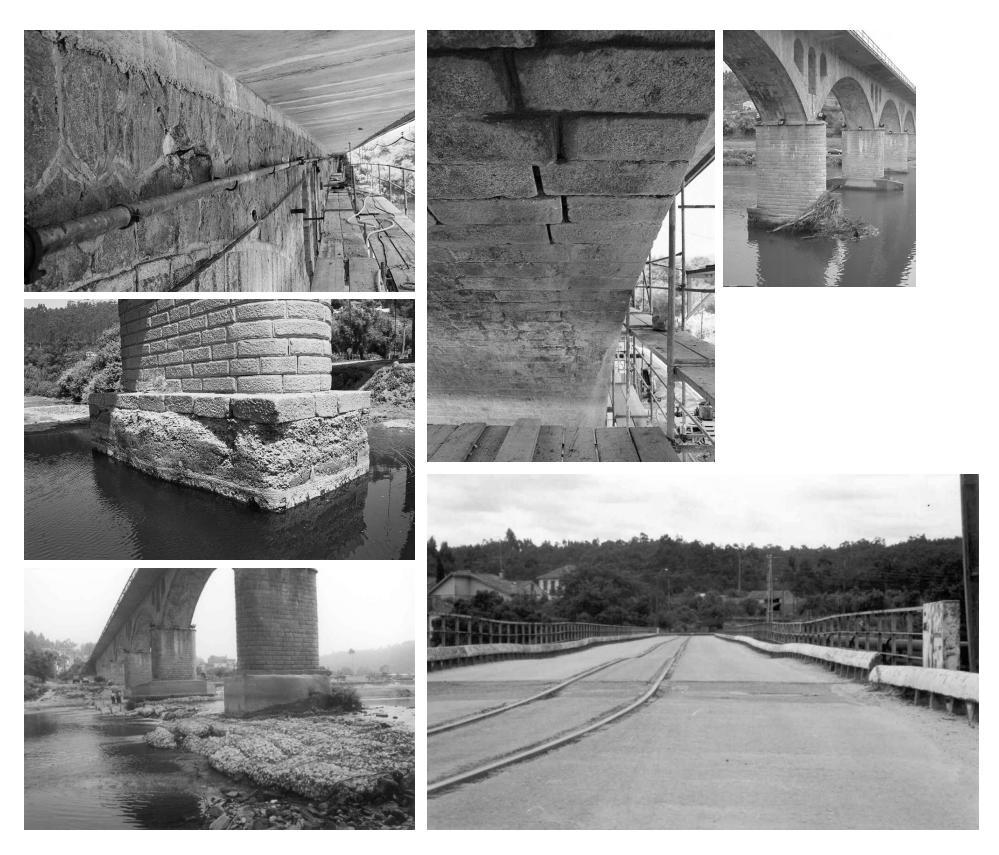
- Various cracks in the inner frame of the vault;
- Significant detachment of the frame's face from the vault's body;
- Cracks on the wing walls of the abutments, namely on the Sernada side, showing the presence of differential settlements in the foundations;

- Unveiling of the deck on the Sernada side;
- Infiltration and cracks in the arches and at the base of the concrete consoles;
- Signs of deshoeing and/or de-confining of the piers and abutments, being pier P5 certain to have been object of a previous intervention;

- Erosion and degradation of the foundation massifs of the piers;
- Degradation and deshoeing of the Reno gabions/mattresses downstream of the Bridge, as a consequence of a recent intervention, after which, it was verified that the existing weir, place downstream of the Bridge (Pic. 8) will not have been strong enough to stop the strength of the waters to degrade and deshoe the gabions. Consequently, the riverbed showed signs of serious erosion that might lead to infra-excavation phenomena in the foundations of the piers and consequent structural instability.

Fig. 2, 3, 4, 5, 6, 7, 8, 9 and 10 - Damages found on the Bridge

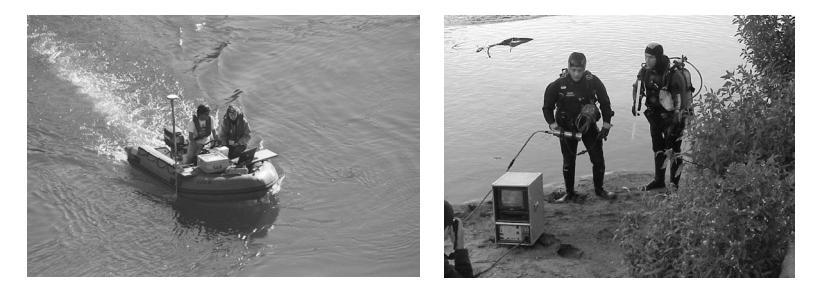
From this inspection was also possible to establish which "holes" under pier P5 only referred to the deshoeing of the breakwater, carried out at a later intervention, which started to work partially as a console. Thus, the reports from the local inhabitants, who said that this pier had some abnormalities, were not founded, namely concerning the possibility to dive from one side to the other of the pier, i.e. revealing the existence of eventual hiding-places. (Pic. 6).

Fig. 11 and 12 - View of the boatimetrical survey and underwater inspection

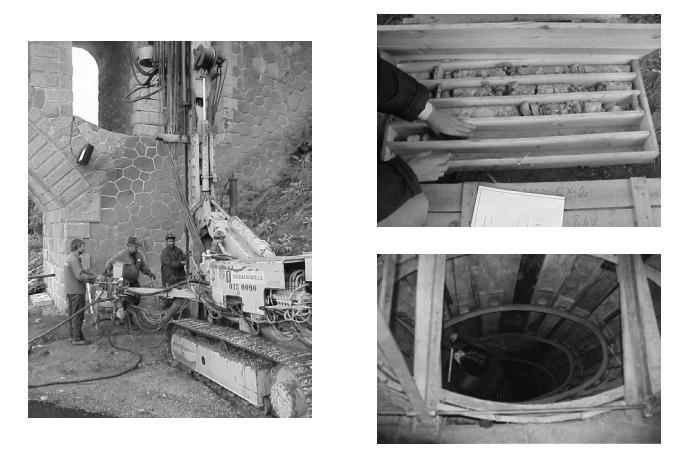
Fig. 13, 14 and 15 – Carrying out a probe, samples of the collected material and view of a reconnaissance well

The bridge's piers are founded on pivots Carried out with metallic and wooden mould and filled up with badly mortared masonry.

The supports observed on the tray are only corresponded by the deficient founding conditions of pier P1, and not pier P1 and P2, as it was initially evaluated, as pier P2 is founded directly on the schist formation.

With the exception of pier P2 and abutment E2, all other supports are founded in alluvium formations of low supporting capability, working essentially by lateral attrition of the foundation pivot itself.

The metallic plates that exist at the top of the pivots were totally or partially corroded, which made the filling material to be uncovered, and exposed to the erosive action of the river's water.

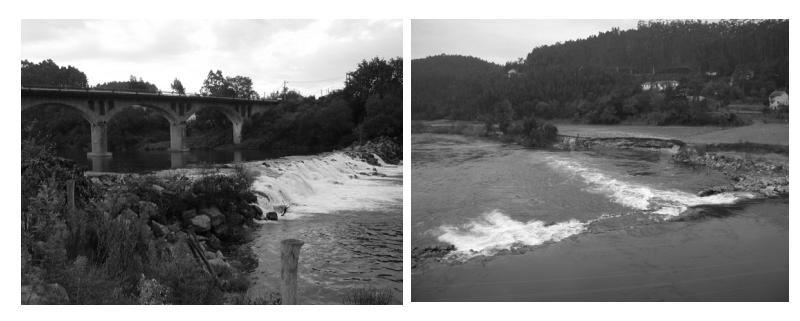
Fig. 21 and 22 - The weir downstream of the Bridge

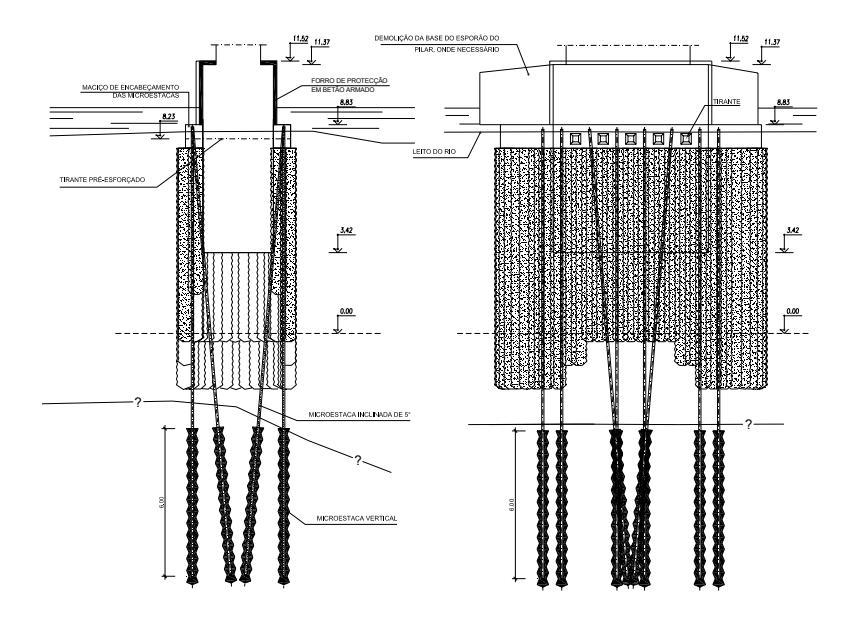
Fig. 23 and 24 - Lateral and Vertical Projection of the reinforcement of the foundations of Pier P5

Bearing in mind the results of the surveys on the three piers, it was verified that in the most unfavourable of the studied cases, the was a potential deshoeing risk of piers P4 and P5, with the foundation of pier P6 remaining in a limit situation, that was very compatible with the safety criteria.

In this way, the adopted solution for these piers was based on micro-stakes, being similar to that applied to piers P1 and P3. However, as piers P4 and P6 had been subjected to the floods and excavation of the riverbed, it was important to guarantee an additional protection for the micro-stakes. In this way, the execution of two lines of jet grouting surrounding the entire pivot was done, at a depth that would not be affected by the riverbed's erosion. The external files are about 10.0m under the heading massif, reducing to 8.0m in the areas under the arches. The inner columns have a similar speed to the external file, but are two metres higher in depth.

In order to reduce the apartment of the jet-grouting columns and the micro-stakes in relation to the axis of pier P5, part of the massif, presently acting as a console, was demolished.
