# Investigation of the historical Osobowicki Bridge in Wroclaw

Tomasz Kamiński, Jan Bień, Mieszko Kużawa and Józef Rabiega Institute of Civil Engineering, Wrocław University of Technology, Wrocław, Poland

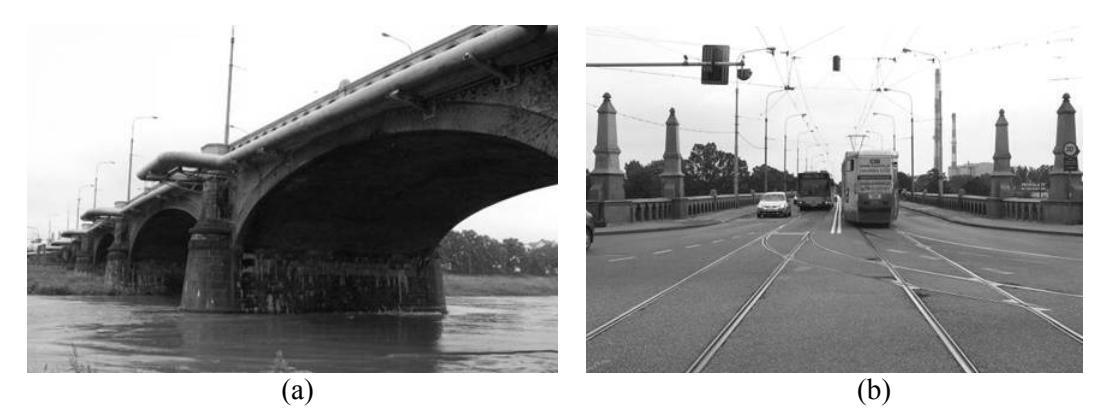
Figure 2 : Osobowicki Bridge: (a) main spans with visible pipeline system, (b) bridge deck with the usual traffic.

The main deficiencies of the structure are related to inefficient waterproofing of spans which causes moistening and in consequence leads to destruction of the masonry material, its cracking and losses (see Fig.4). Along the edges of most of the arches there are present longitudinal fractures separating these parts of arch barrels from their central parts (Fig.5a). This effect is most probably influenced by large pipelines attached to spandrel walls (visible in Fig.2a).

(7) removing of the pipeline system attached to the structure excessively loading the spandrel walls and marring aesthetics of this beautiful historical bridge.

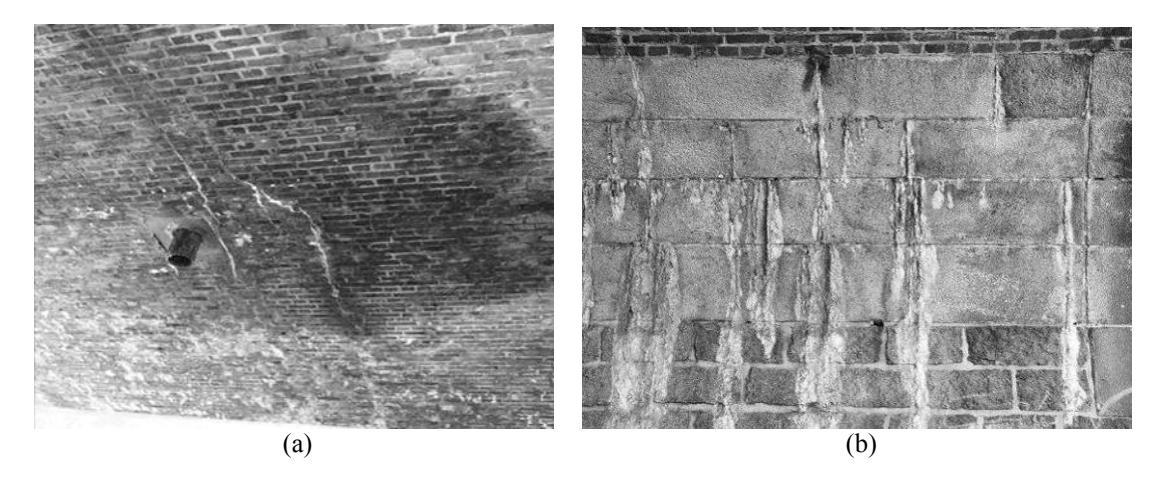
Figure 4 : Typical defects: (a) longitudinal cracking and moistening of arch barrel: (b) leaching at arch barrel springing.

according to Eurocode 6). The maximum tensile stresses equal 0.58 MPa were detected in the transverse direction on the bottom surface of the arch (Fig.11b) and almost reached the corresponding material strength (compare Van der Pluijm 1997). This susceptibility of the arch to its bending in the transverse direction was also confirmed by presence of the longitudinal cracking (shown in Fig.4a) in the middle of a few arches.

(1) renovation of arch barrels including injection of cracks and fractures, refilling material losses and removing superficial sediments,

(5) reconstruction of the waterproofing layer and a new drainage system,

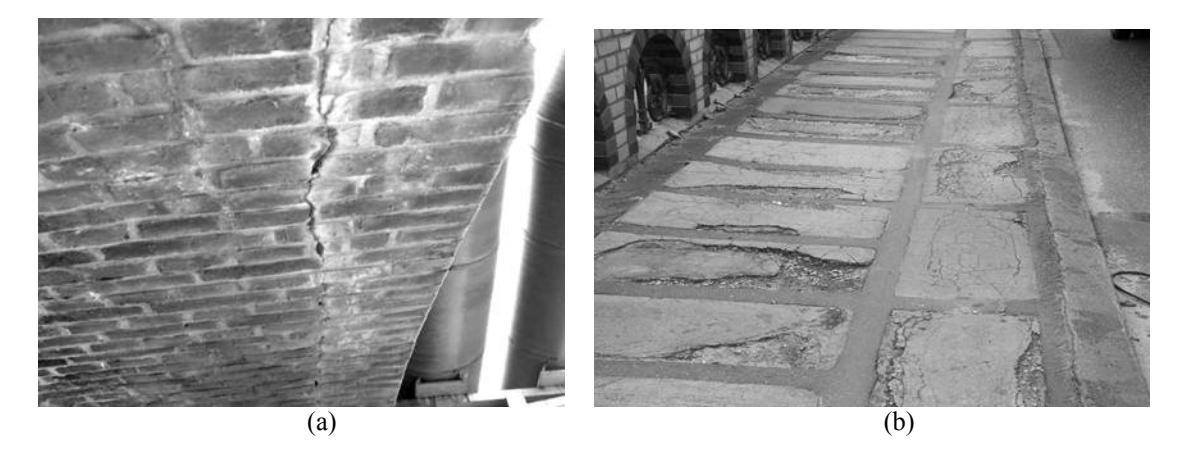
Figure 5 : Typical defects: (a) longitudinal cracking along the edge of arch barrel: (b) losses on the pavement surface.

Generally on the basis of the acquired observations very poor condition of relatively "young" bridge equipment against quite good condition of the "old" structural components was found. Serious damage of the pavement surface on the bridge is also visible (see Fig.5b).

(1)refilling of the losses in road surface and pavement,

(6) replacement of the road and pavement surfaces,

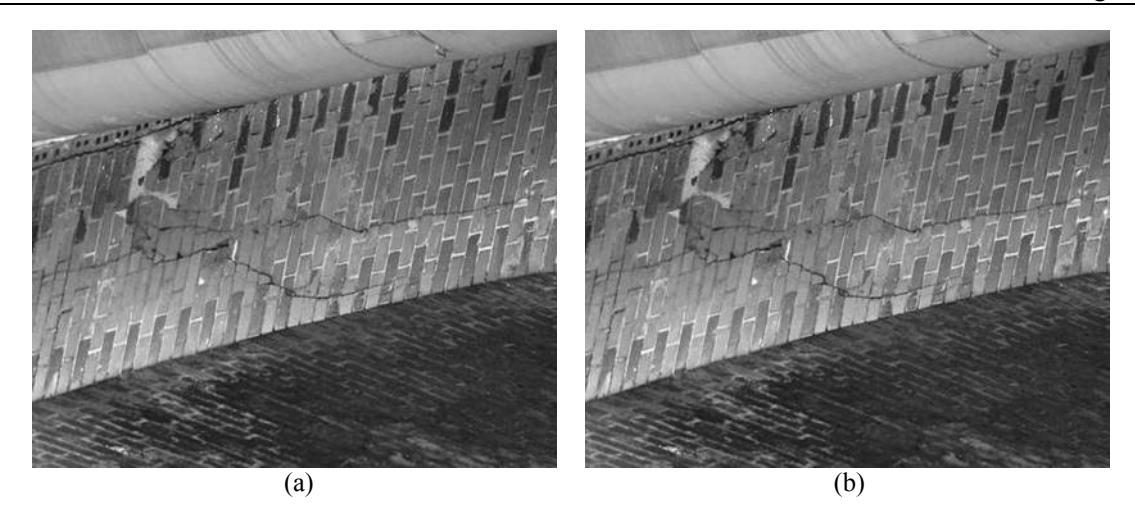
At the fronts of the arches there are also several areas of cracking going through the arch or between the arch barrel and spandrel wall (Fig.6).

Figure 6 : Typical defects: (a) Skew cracking of the arch front, (b) fracture between arch and spandrel wall.

(2) elimination of the transverse displacements of spandrel walls with their renovation and more efficient connection to arch barrels,

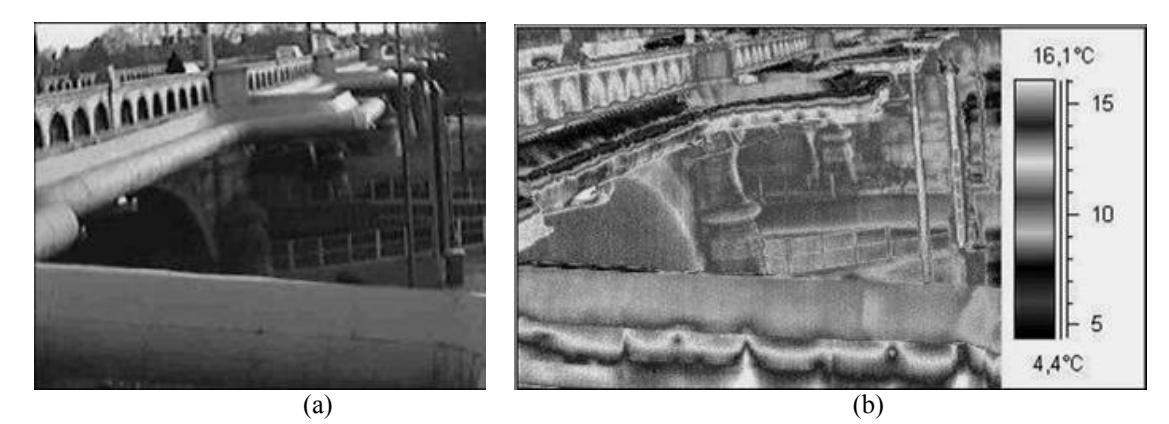
The thermographical inspection was also applied in survey of the pipelines attached to the bridge. During this test an extensive damage of the pipelines' thermal cover and its dysfunction were confirmed (see Fig.7).

# Figure 7 : Inspection of spans 6-7 and 7-8: (a) photographic image, (b) thermographical image.

(3) reconstruction of selected elements of external devices on the bridge including thermal covers of pipelines.

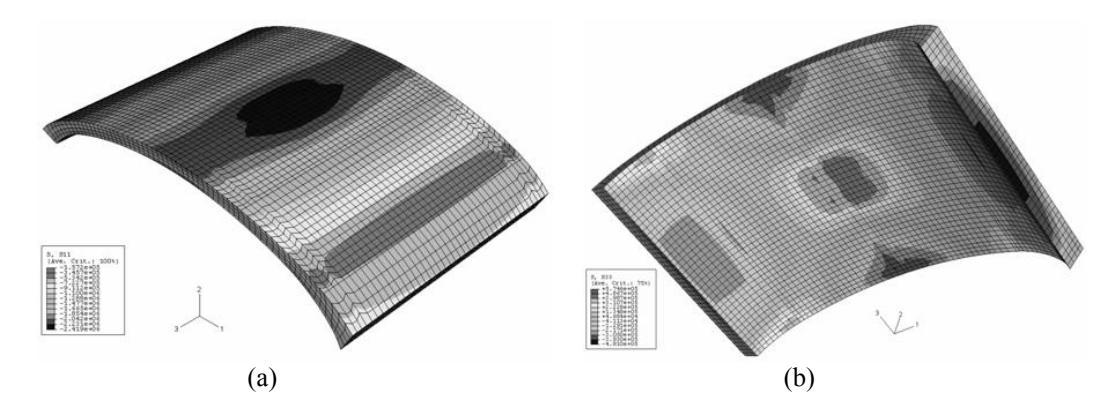
Selected results of calculations presenting stresses in the main (peripheral and transverse) directions in the arch barrel of span no. 2-3 caused by code load corresponding to C class of the Polish standard are shown in Fig.10. Presented stresses are triggered by the most unfavourable location of loads including code vehicle placed centrally in the middle of the span. The maximum compressive stresses equal to 2.4 MPa appeared in the peripheral direction on the top surface of the arch (Fig.11a) and did not exceed assumed material strength of 5 MPa (calculated

Figure 11 : Analysis results for the arch barrel of span no. 2-3 with the code load applied: (a) peripheral stresses  $\sigma_{11}$ , (b) transverse stresses  $\sigma_{33}$ .

(3) constructing of a concrete deck uniformly transversally distributing loads to arches,
