# Monitoring performance of large Croatian bridges

Jelena Bleiziffer and Jure Radic

*Institute IGH, Faculty of Civil Engineering, Croatia University of Zagreb, Zagreb, Croatia*

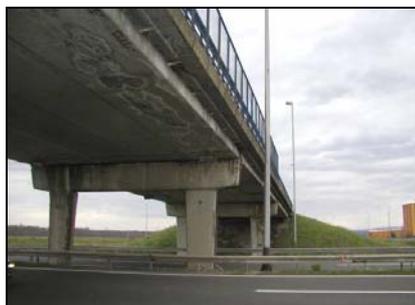
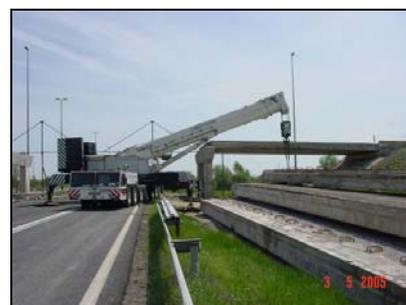
Figure 4 : Reconstruction of a severely deteriorated motorway overpass

out maintenance in 1990's due to war activities in the region. Major rehabilitation works started in 2003 comprising pavement repair (replacement of the wearing course, and bonding layer as necessary), equipment replacement, drainage rehabilitation as well as technically demanding and costly repairs or even replacement of severely deteriorated motorway structures (Fig.4).

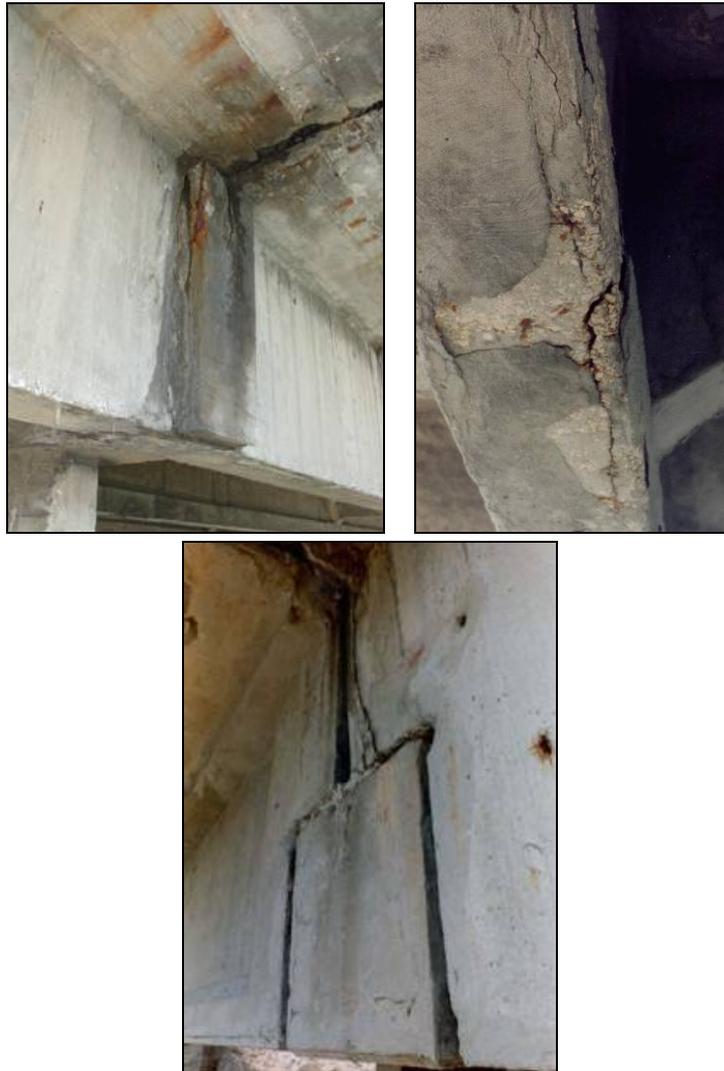
Figure 5 : Sibenik (left), Pag (center) and Krk (right) Bridges: deterioration of bridge superstructure

Repair works on the Pag Bridge started already after a decade of its service, but did not prove efficient in terms of stopping the corrosion process. Major reconstruction started in 1991 with the repair of the arch and was finally finished in 1999 when the original concrete superstructure was dismantled and replaced by a completely new structure in steel. Columns were repaired by encasing in steel and concrete. Bridge inspection was carried out in 2009 and the condition of the steel portion of the structure was assessed as satisfactory, although minor local defects were detected. However, the inspection and limited testing revealed that more detailed investigation is required to draw final conclusions on the condition of the arch as disturbing delamination and chloride content levels were found.

The repair works on the Krk Bridge started several years after its completion focusing on superstructure supports. In the 1990s the works were broadened to include the repair of columns at the smaller arch. Different repair techniques had to be devised for spandrel and approach columns. The smaller arch has been recently repaired by removal of the contaminated concrete, its subsequent replacement with shotcrete and adding protective coating. The repair of the larger arch presents major challenge to engineers. The arch is actually supported on submerged inclined struts. After many years of research and testing of various corrosion protection systems, cathodic protection method was selected for this part of the structure (Beslac et al., 2007). All of

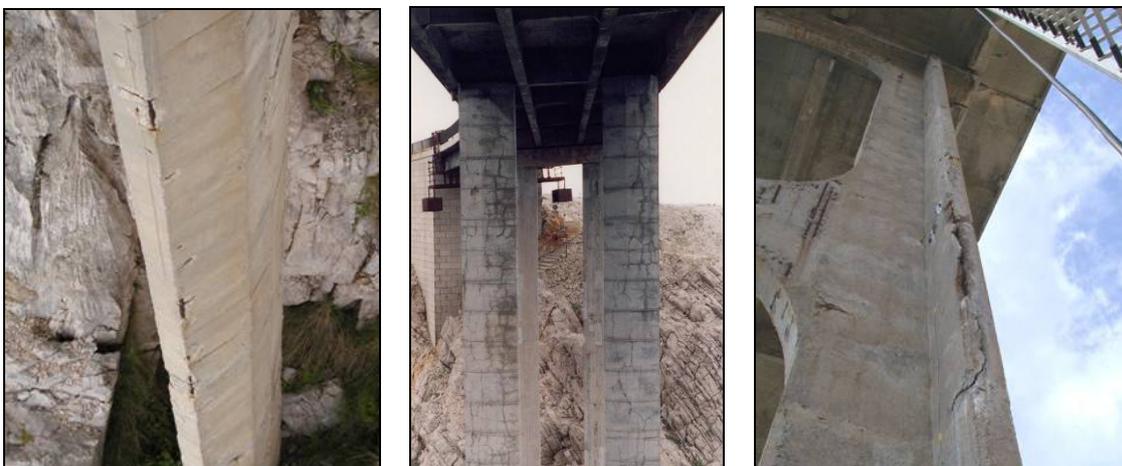
Figure 6 : Sibenik (left), Pag (center) and Krk (right) Bridges: deterioration of columns

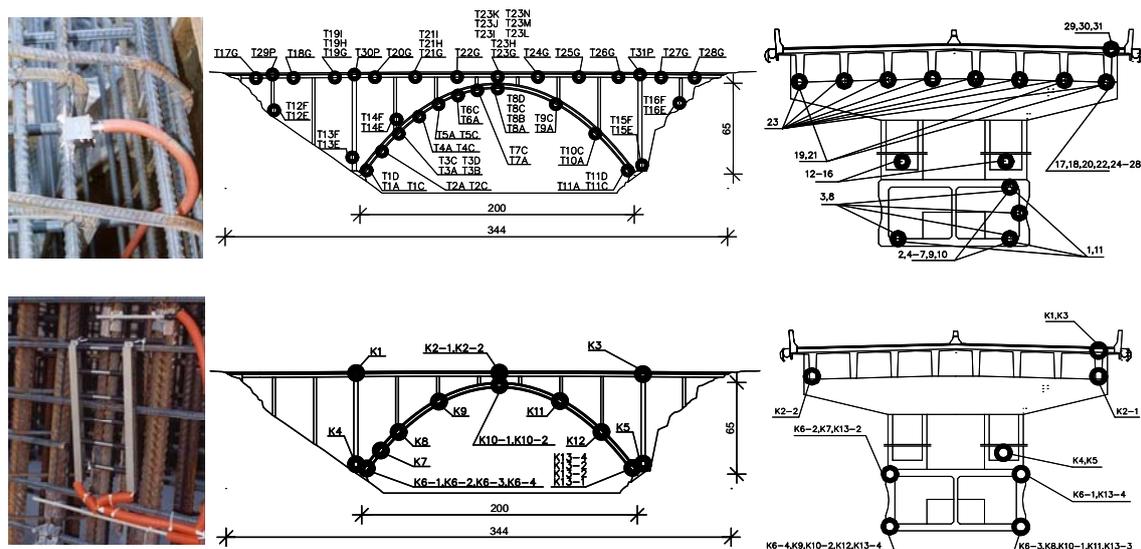
Figure 7 : Location of strain-gauges (top) and corrosion sensors (bottom) installed on the Maslenica Bridge

The monitoring system (Simunic et al., 1999) was used to record the stresses and strains at various construction stages and under load-testing prior to opening the bridge to the service (Fig. 7). Additionally, monitoring the environmental parameters such as air temperature, wind speed and direction was anticipated.

The system consists of 92 strain-gauges, 40 temperature sensors and 21 corrosion sensors (anode-ladder) mounted at carefully chosen spots on the arch and girders of the superstructure. These documented the initial condition of the structure needed as a reference for future measurements. Unfortunately, the monitoring project was stopped soon afterwards.

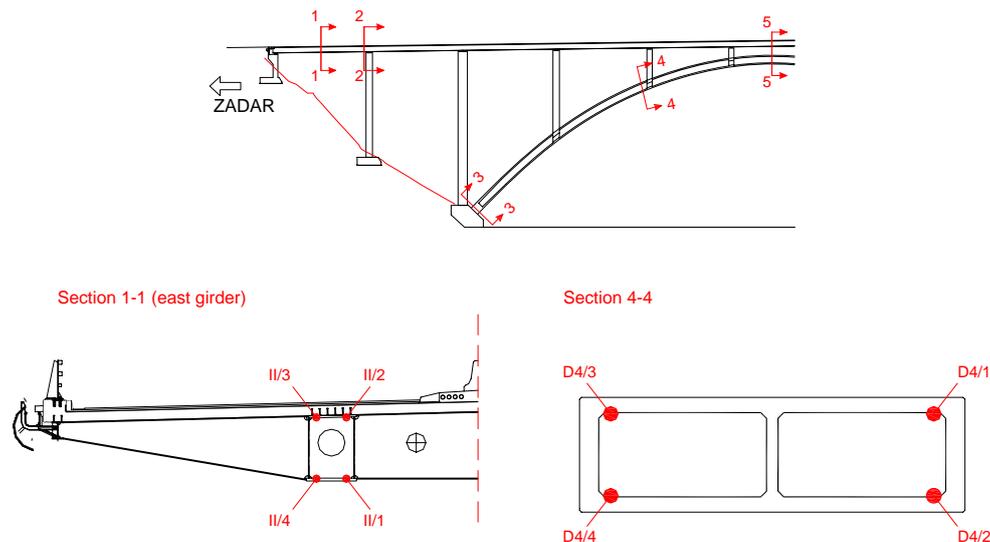
Figure 8 : Location of strain gauges and temperature sensors

Figure 9 : Location of corrosion sensors installed on Skradin Bridge

The monitoring system includes continuous monitoring of strain, temperature and humidity on the structure, periodic displacement measurements, and periodic measurements to evaluate the corrosion progress (Fig. 8 and 9) (Rak et al., 2006).

The superstructure is instrumented with 16 strain gauges, 12 temperature sensors, and 1 humidity sensor.

The arch is instrumented with 6 corrosion sensors (anode-ladder), 12 strain gauges, 9 temperature sensors, and 1 humidity sensor.

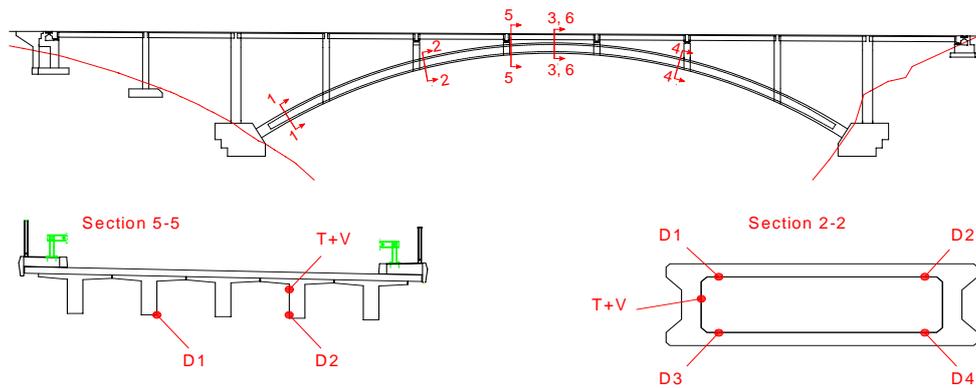
Figure 10 : Location of strain gauges and temperature sensors

The monitoring system includes continuous monitoring of strain, temperature and humidity on the structure, periodic displacement measurements, and periodic measurements to evaluate the corrosion progress (Fig.10 and 11) (Rak et al., 2005).

The superstructure is instrumented with 16 strain gauges (D), 2 temperature sensors (T), and 1 combined humidity + temperature sensor (T+V).

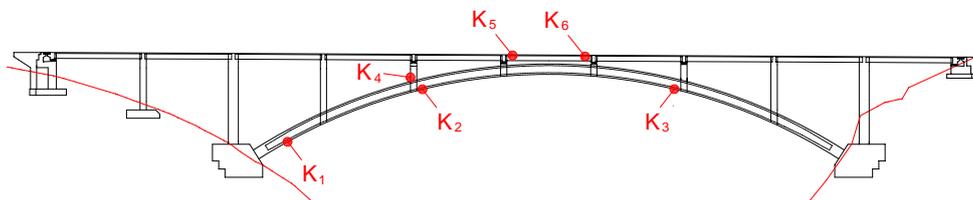
Figure 11 : Location of corrosion sensors installed on Cetina Bridge

The arch is instrumented with 6 corrosion sensors (anode-ladder) (K1 – K6), 12 strain gauges (D), 4 temperature sensors (T), and 1 combined humidity + temperature sensor (T+V). The expected frequency of the corrosion sensors reading is 2 to 4 times a year.
