## DYNAMIC EFFECTS IN ARCH BRIDGES – A FIELD STUDY

Bill Harvey\* and Warren Houghton†

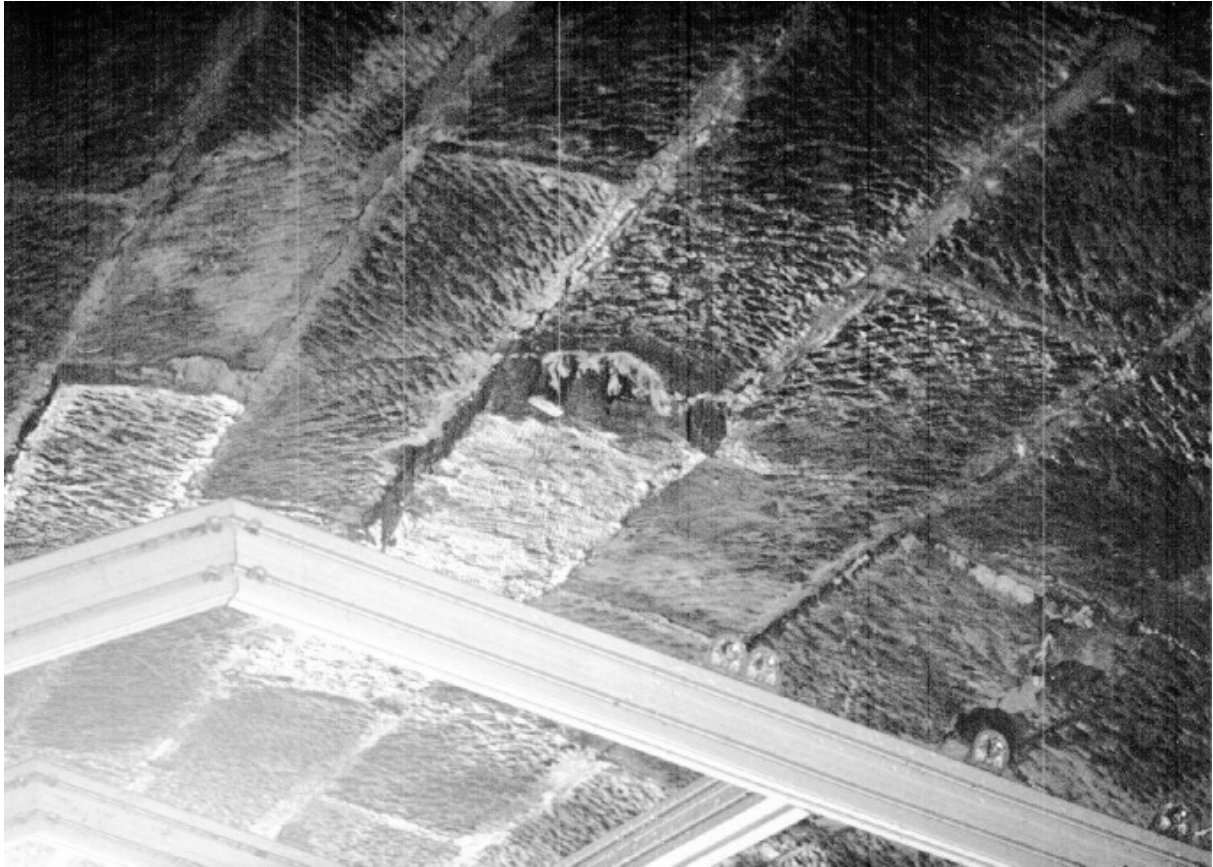
**Figure 2 Dropped stones near the inner face of the spandrel**

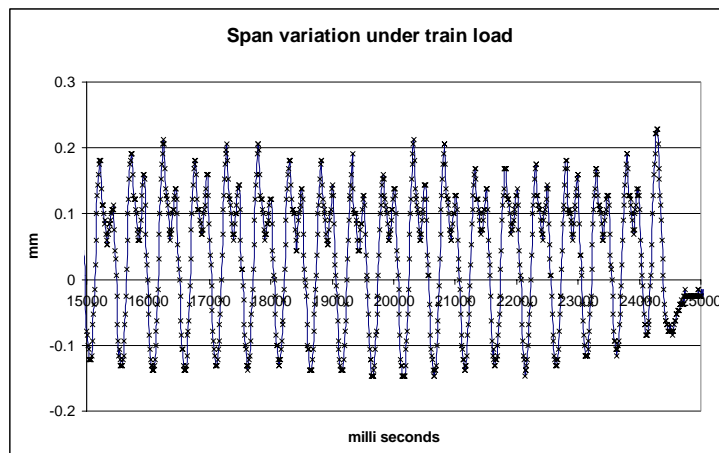
Figure 6 Change in span with load showing rear of train only

A simple deflection pole was constructed using aluminium tent poles and a potentiometer with a parallel port “oscilloscope”. This was used to measure crown deflection and span change under a train with the results shown in Figure 6 and Figure 7.

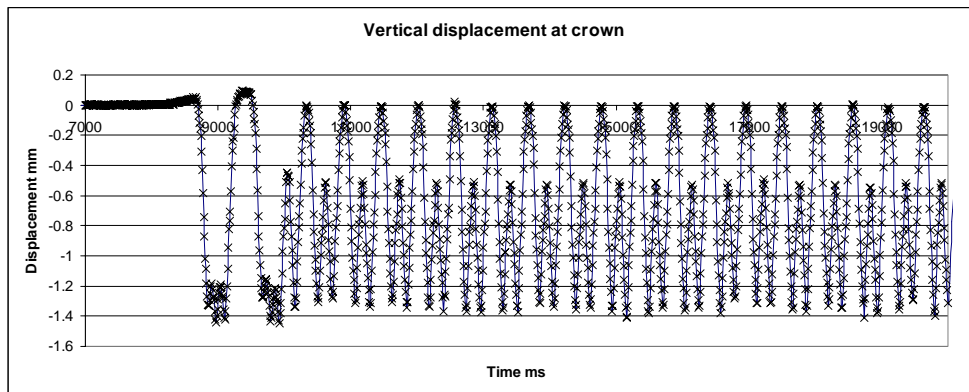
Figure 7 Vertical displacement

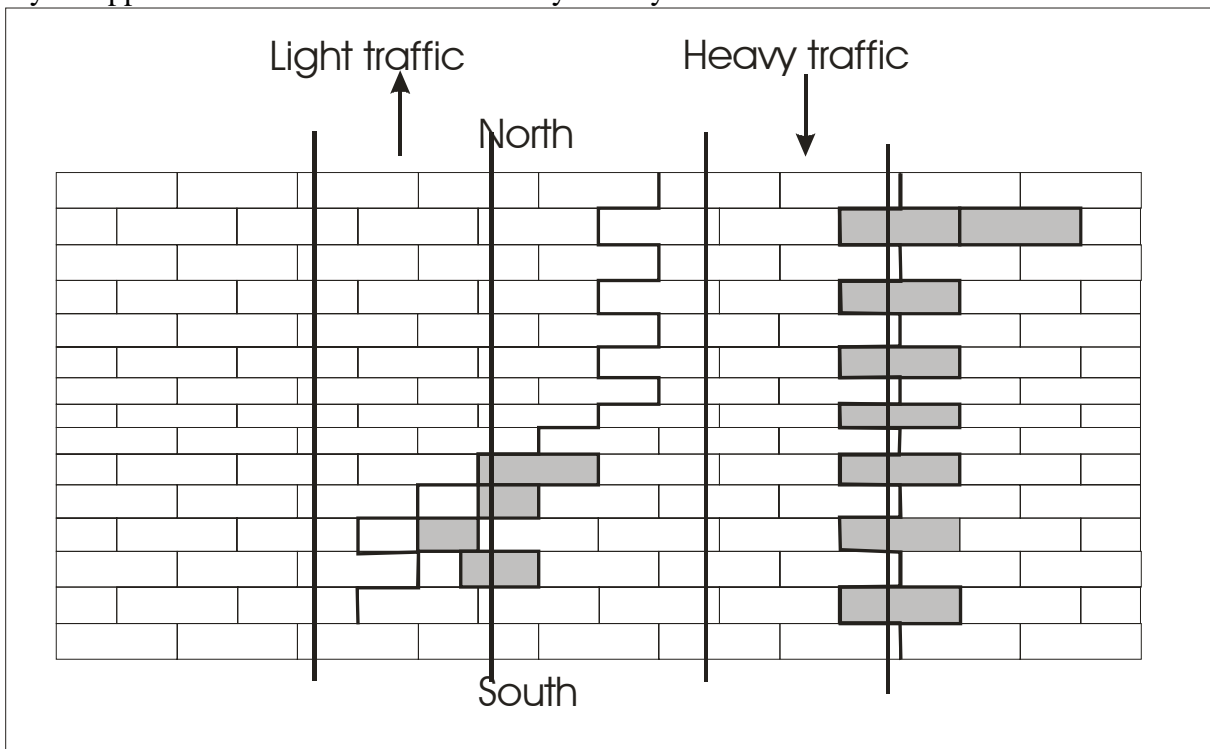
Figure 10 Plan showing voussoirs, cracks and dropped stones

On further inspection of the bridge, the reason for the distribution of open joints and dropped stones became clearer. The arch wants to sway away from the load as it enters. To do this, it has to break the connection to the spandrel wall and to the remaining stable section of the arch. At the spandrel, this is achieved by destroying the mortar and rattling a row of stones to allow movement. On the centre line, the same action works on the approach half, but beyond the crown, the weakest line is on a diagonal through consecutive perpend and bed joints. These open, allowing at least one stone behind the open joint to drop. This detail is set out in Figure 10.
