USE OF INTEGRATED SURVEY TECHNIQUES: MEASURING THE IRON BRIDGE

Bill Blake^{*}, David De Haan[†]

Abstract. *The construction of a high parity 3d CAD model of the historic Ironbridge has demonstrated the value of integrating survey techniques to deliver spatial data of interest to historical analysts, conservators and presentation professionals. The performance of wireframe from photogrammetry as 3DCAD modelling source requires the use of infil techniques such as measured drawing, realtime CAD/REDM and laser scanning. The detailed survey needed to model the structure has added to the understanding of the manufacture and construction sequence.*

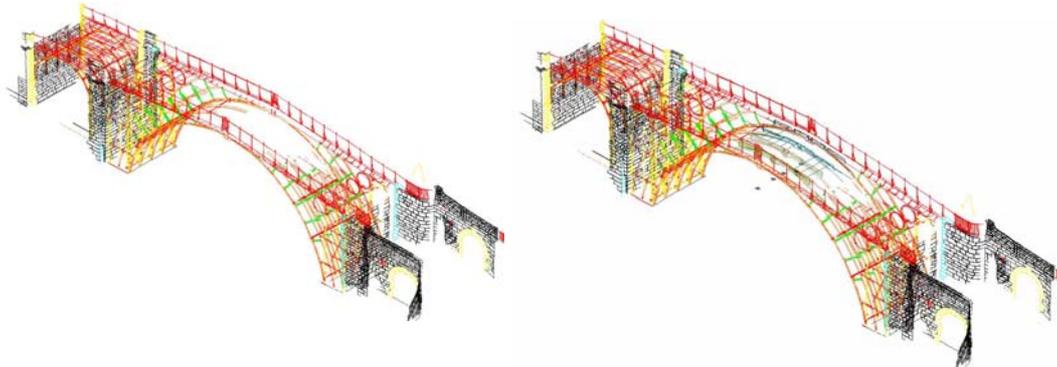
Figure 1: The wire-frame plotted from photogrammetry

The wire-frame is 3d but rarely plots all possible edges of components, this is due to line of sight obstructions, poorly lit imagery or indistinct edges. The consistency of precision in the wire-frame is an inherent property of photogrammetry. Note the soffit of the deck; there is little or no information here due to the deep shadow caused by exposure of photography for the outer frames of the span. (photogrammetric survey by PCA ltd)Right: The photogrammetric wire-frame completed by REDM.

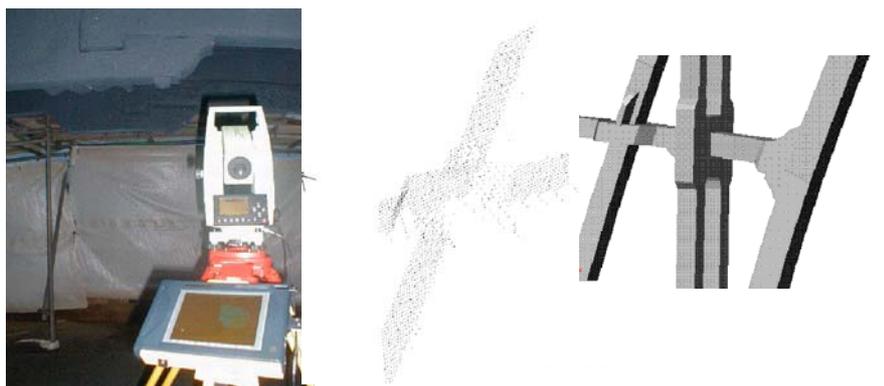
Figure 2: Infill survey techniques

Left: REDM set-up under the bridge deck tracing the crown bearer into AutoCAD using TheoLt on a field computer. Centre: the point cloud data from U K Robotics Z&F scanner: the points have failed to reveal any useful edge detail- some surface information may be useable prepared from point cloud. Right: modelling by primitive fitting to the point cloud. Because the point cloud is edge weak the modelling has failed to re-create the mouldings correctly

When access by scaffold was possible, REDM was used to in-fill gaps in the photogrammetric wire-frame. Stations were set up on the scaffold between each frame, and ties to the photogrammetric wire-frame were made by re-section to detail. By using instrument set-ups under the deck (figure 3) gaps could be in-filled at close range. All the REDM data was recorded in real-time into AutoCAD using TheoLt on a field computer, this process is manually operated 3d digitising. ^[iv]

Laser scans (see figure 2 centre and right) were taken to infill the deck soffit not mapped by REDM or photogrammetry. The data-cloud was modelled and prepared for insertion into CAD by use of automated surface extraction software. The laser scan was unable to supply any edge definition of components generated to the required tolerance due to the complexity of model and this is characteristic of data-cloud derived data. The main value of the data was to add to patches of information on surfaces between the wire-frame edges and to determine surface profiles of the lower parts of the main ribs. The data received from the laser scan was generally of poorer utility than that produced by photogrammetry.

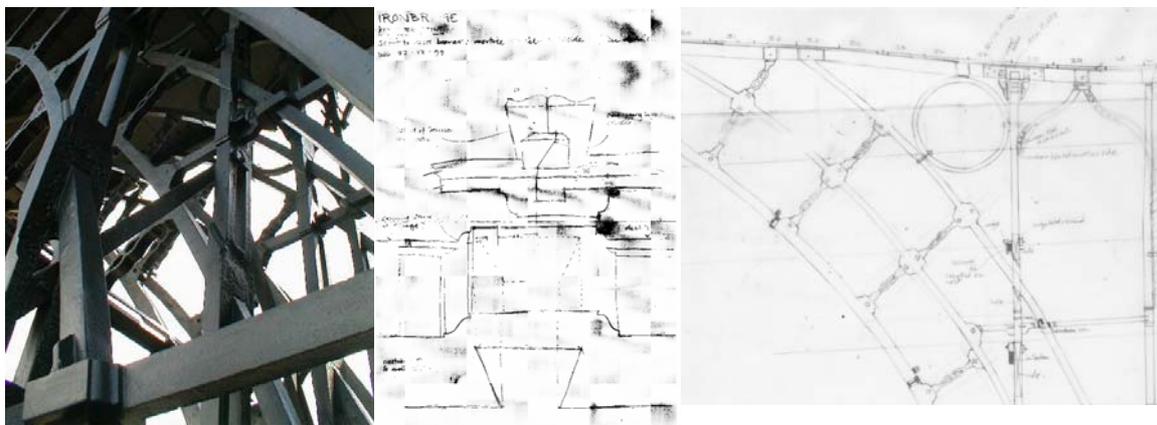
Figure 3:

Sketches and photographs prepared on site during inspection for the completion of the wire frame data. The sketches show the method of inquiry: block diagram, component identification and hidden surface details. Right: Measured drawing prepared by Ironbridge Gorge Museum Trust Archaeology Unit: note the plotting of observations from detailed inspection

2D details of the bridge's joints were recorded by on-site plotting of measured detail directly onto 1:50 scale elevational plots prepared from photogrammetry (see figure 3 right). Where

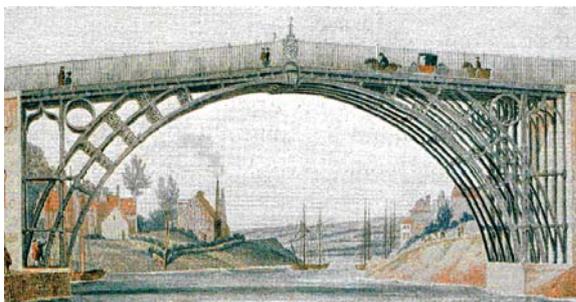
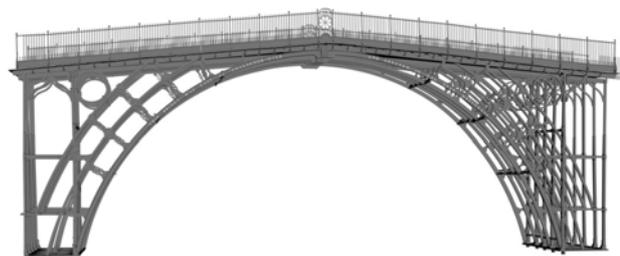
Figure 4

The view of the bridge by M.A.Rooker dated 1780 and the CAD model viewed from the same perspective centre: the “missing ribs” are shown although they were not in place until 1791 and the frame C casting error is absent; this then is a studio prepared view probably prepared from design drawings. The view of the CAD model matched to the view by M.A.Rooker-the view reveals the casting error on frame C.

Inspection of the bridge reveals that frame C [the central frame] differs from the others in 3 ways:

- No shoulder is cast into the outer vertical, the other frames all have this. The upper rib re-uses the 2 sided mortice mouldings from the mid-rib: this is a mistake as the mortices for the upper rib are only one sided. The error is not repeated on the other frames.
- The mid rib rests on a shoe fitted to the sole-plate all the other frames use a surface fixing detail.

Comparison with a matched perspective view by Rooker (c1782) reveals frame C details omitted adding to the evidence for this view being prepared from design drawings rather than from the structure itself
