EVALUATION OF ARCH BRIDGE DEFECTS

A HANDBOOK FOR NETWORK RAIL

Bill Harvey^{*} and Ian Bucknall[†]

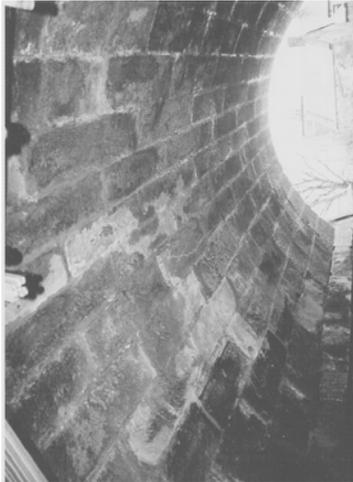
Figure 1: Application of diagnostic methodology to "Dropped stones in small arches"

In this 4m span arch, the dropped stones are associated with the centre line, but deviate from it at one side

Dropped stones are obvious; the reasons are less so. The picture shows a 12ft (3656mm) span, 3ft (914mm) rise bridge with a collection of dropped stones.

The dropped stones are largely in alternate courses. The joints around and between them are all open and largely devoid of mortar. Is there evidence of excessive live load movement? Is this likely to increase rapidly?

"Non-causes": These stones were not pushed down by load from above. If the bridge were otherwise sound (including secure mortar joints) that couldn't happen because the friction would always be too great. Stones drop (and bricks too) because they are freed to do so. In this case, the freedom is a transient event, brought about by movement as loads pass over.

Heavy loads travel down one half of the bridge so it wants to sway and the unloaded half doesn't (see page on live load movement). The stones at the joint are levered apart. Sometimes the action leaves a stone briefly unsupported and it drops a little. The movement of the stones destroys the mortar and makes room for them to drop.

The drops extend from the crown towards the down stream springing on a diagonal working away from the load. This is because the joints open on this diagonal more easily than by levering stones apart locally.

Because these stones are strong and fit well together, there is no immediate danger of failure of the arch. It is clear that wear and tear, if left to continue, would eventually lead to serious damage.

On many railway arches carrying two tracks, a crack is generated down the centre line as a result of the opposing effects of traffic in opposite directions. Occasionally, when the arch is constructed from very strong stone, the forces break up the mortar without cracking the stone as illustrated in the first example.

The sketch in Figure 1 shows stones which have dropped as a result of mortar loss and flexing of the arch. In this case, there is only heavy traffic on one half of the bridge and the damage shows a directional component. The bridge has a 3.6m span, 0.9m rise and is 9m wide. There is a modest covering of fill and ballast at the crown.

Once the dropped stones have progressed so far treatment becomes difficult. Replacing mortar with hard material may give temporary respite but exacerbate problems later. There is often evidence of water penetration where drops are present. The importance of maintaining the waterproofing cannot be over emphasised.

Where access is possible, lifting dropped stones and injecting a lime based mortar to refill the joint is likely to provide medium term respite.

Saddling is a great help, especially if the joints can be restored in the same operation.

Under-lining has been used in bridges where masonry units are moving under load. In this circumstance it is unclear whether the movement is stopped or the underlining is merely containing the loose stones. This process is not reversible or repeatable, since the underlining cannot safely be removed once it has been in place for some time.

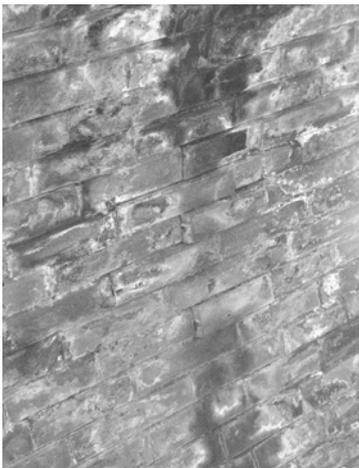
Figure 2: Application of diagnostic methodology to “Dropped stones in a large arch”

In this 11 m span, semi-circular arch the drops are concentrated at the centre

A 35ft (10668mm) span semi-circular arch with a patch stones dropped at the crown. The stones are large, approximately 1500x300mm in plan. The drops are similtaly large, up to 100mm.

The drops are concentrated at mid width and close to the crown. There is a substantial water stain running away from the drops towards each abutment. The dropped stones themselves are largely dry.

Stones can only drop if the wedging action which supports them breaks down. This is nearly always a result of loss of mortar. The cause of the mortar loss is then the difficult question.

Larger viaducts on this line were built with hollow spandrels. These are made by building internal spandrel walls on top of solid haunching. The hollows were capped with large sandstone slabs with their upper surface level with the extrados at the crown.

These slabs presumably create a largely impervious layer which gathers water off the whole span towards the crown where it eventually finds a way through the joints.

Damage of this type is likely to progress unless treated. Access for further investigation and remedial works is a significant consideration for arches of this size.

The second example is on the same line and built from the same stone (Figure 2). When dropped stones are seen on the centre line of this bridge, there is therefore a risk of concluding that the cause is the same as for the bridge described in section 3.1 above. In fact, there are a number of differences.

Here, the dropped stones are in a group close to the crown. Detailed inspection shows that they are associated with two water stains. Water runs in each direction from the end of the damaged area towards the springing. It is clear that the water and the damage are connected. The questions are:

This arch has an 8.6m span and is semicircular. It is part of a viaduct with seven identical spans. There are internal spandrel walls probably capped with slabs and stabilized with cross walls over the pier and at fifth points of the span.

It seems likely that the capping slabs form an effective waterproof barrier. The arch will have dropped when the centres were struck, and may have crept since. The spandrels would follow down and leave the slabs with a slight fall towards mid span. This would concentrate all the water falling over a 12mx8m area of track into the centre of the span.

The first requirement is to create deliberate drainage paths to replace the accidentally created ones. This might require the installation or restoration of a waterproofing layer. It might, though, be sufficient to create a free drain close to the top of the wet patch each side of the crown. Coring a hole through a voussoir would possibly be sufficient, though creating a free draining volume above it would also be useful.

It is desirable that the stones be lifted back into place and the joints repointed. Lifting is possible in such a relatively modest area, using a centre floated underneath and jacked up into position using ties supported from above the bridge.

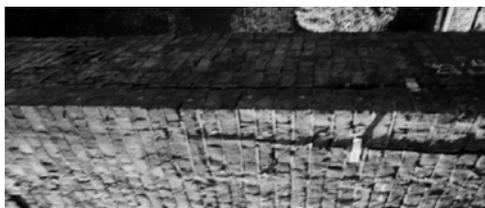
Figure 3: Application of diagnostic methodology to “Bulge in pier face”

Shadow shows panel bulging

Empty perpendiculars in core

Observed defects - Pier
The pier has a bulge in the whole face which has caused the face to break away from the corner restraint.

Further clues to behaviour
Checking the opposite face reveals that the pier as a whole is not bowing. From this superficial view, it seems almost certain that the face of the pier has broken away and is buckling outwards. That, in turn, suggests that the core is not carrying its full share of the load. Other parts of the pier were crushing under the additional stress imposed as this face shed load.

Possible underlying causes
Further investigation revealed that the core was indeed a separate entity and much less well built, with no mortar at all in the perpendicular joints. Perhaps more importantly, there was a string course on the spandrel at road level and this had a dip of nearly 200mm in the span to the left of this photograph and only on the near side. Levelling confirmed that the abutment had tilted. This would have transferred additional load to this leg of the pier.

Significance of defects
With masonry buckling or crushing the life of the structure is difficult to predict. Action is required immediately.

Remedial action to consider
Remove live load immediately, followed by as much dead load as possible. A steel frame clamped round the pier will maintain sufficient strength while the work is done. If the pier is not to be replaced, stitching and grouting is the only workable solution.

Figure 3 shows the pier of a brick built bridge over a railway. There are three semi-circular spans of 9.14m of which the central one crosses the tracks. The two side spans spring from shallow abutments at the top of a cutting. The piers are divided with two legs 1200x1200mm and a central gap of 1200x1200mm. There is an arch above and below the opening to transform the two legs into a solid pier at the main arch springing and at foundation level.

Cracking of the shell of one pier leg triggered a more thorough assessment. Other significant indicators were crushing of brickwork and a dropped string course. The string course (shown in Figure 4) has dropped about 160mm between mid span and the abutment. There is no corresponding settlement on the other face. This large twist has produced no cracks in the arch, but seems likely to have delivered excessive force to the pier leg which then began to fail.

Because each leg of the pier was a sound shell filled with coarse brickwork, the shell carried most of the weight and failed by a combination of buckling and crushing. The buckling of the faces of the leg was only possible once the corners had cracked free. The shadow evident in Figure 3 shows the buckle. (The greyscale illustration limits the clarity of the visual signs of crushing)
