# Structural analysis and strengthening intervention of the multispan stone masonry bridge of Ribellasca, between Italy and Switzerland

**ABSTRACT:** The multispan stone-masonry bridge was built in 1906 in the Ribellasca valley, along the border between Italy and Switzerland. The bridge is 100 m long and its five arches are supported by stone-masonry pillars which reach the maximum height of 25 m.

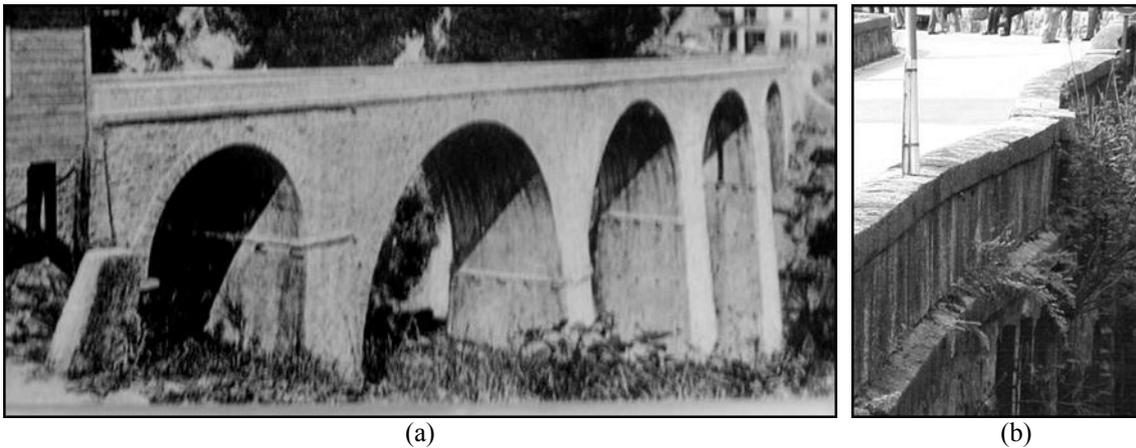
Figure 1 : (a) Photograph taken during the construction of the bridge of Ribellasca in 1906, (b) Particular of the damages observed at present (very large transversal deformation of the lateral walls).

The multispan masonry arch bridge of Ribellasca, between Italy and Switzerland was built in 1906 (Fig.1a shows a photograph taken during the construction phase). After a century, significant damages were observed, mainly due to the water seepage through the waterproofing layer of the bridge (Fig.1b).

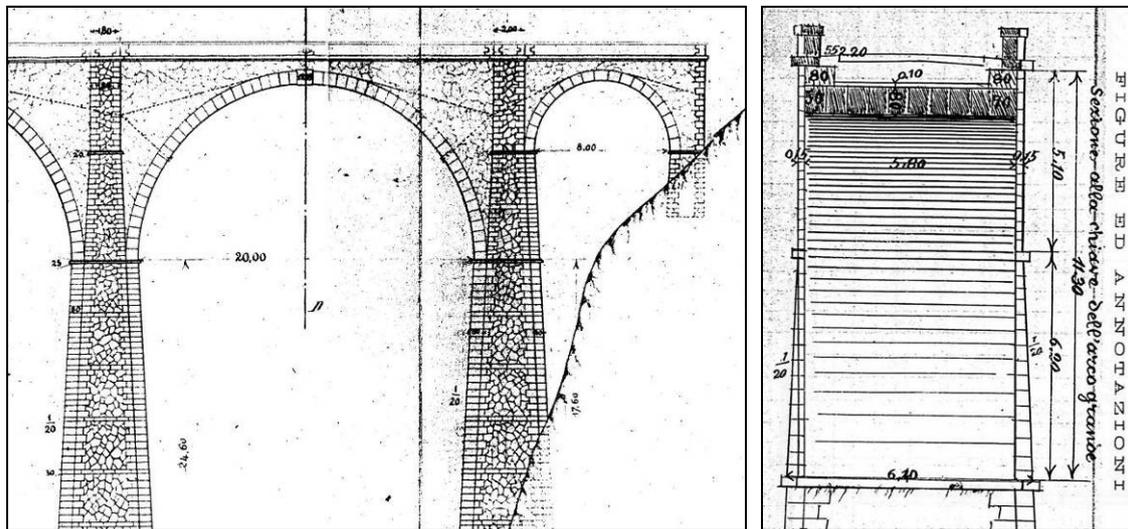
Figure 2 : Two particulars taken from the original design drawings.

After a preliminary historical research and a detailed examination of the original design drawings of the bridge (Fig.2), the damages and the crack pattern observed in the supporting structures (pillars and arches) suggested to carry out a detailed experimental investigations program. All the investigations were carried with the aid of specialized climbers without any scaffolding (Fig.3).

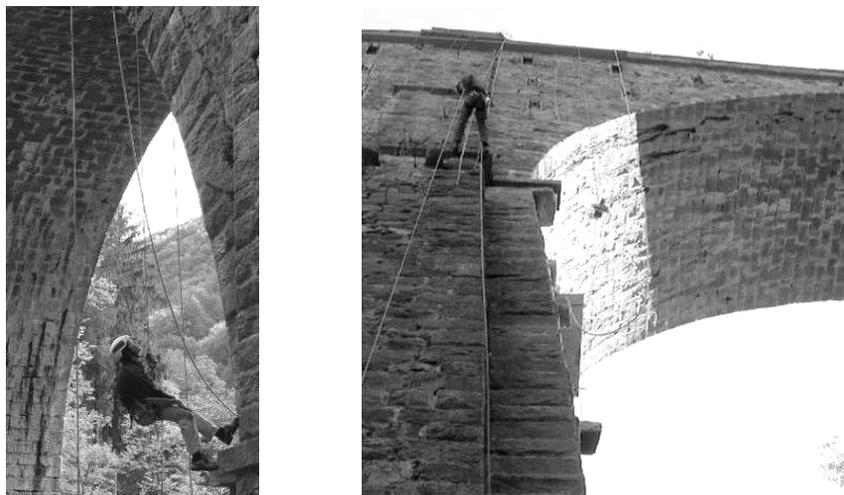
Figure 3 : Crack pattern survey and experimental investigations carried on with the aid of climbers.

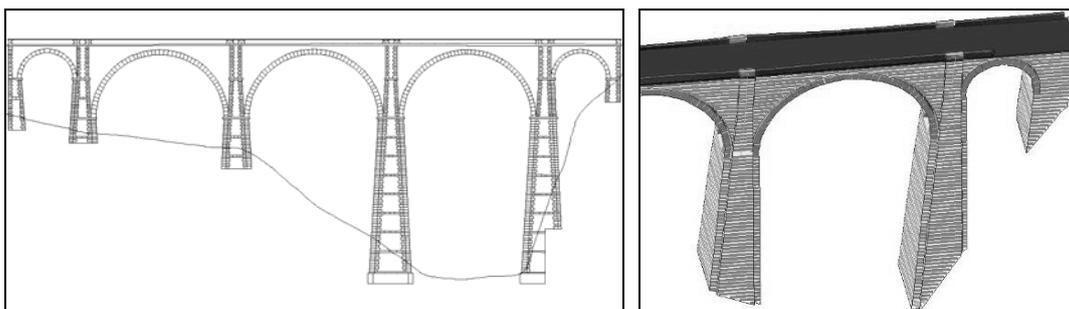
Figure 4 : Geometric survey and three-dimensional model of the bridge.

At first, a detailed geometric survey was carried out in order to obtain a three-dimensional model of the bridge (Fig.4).

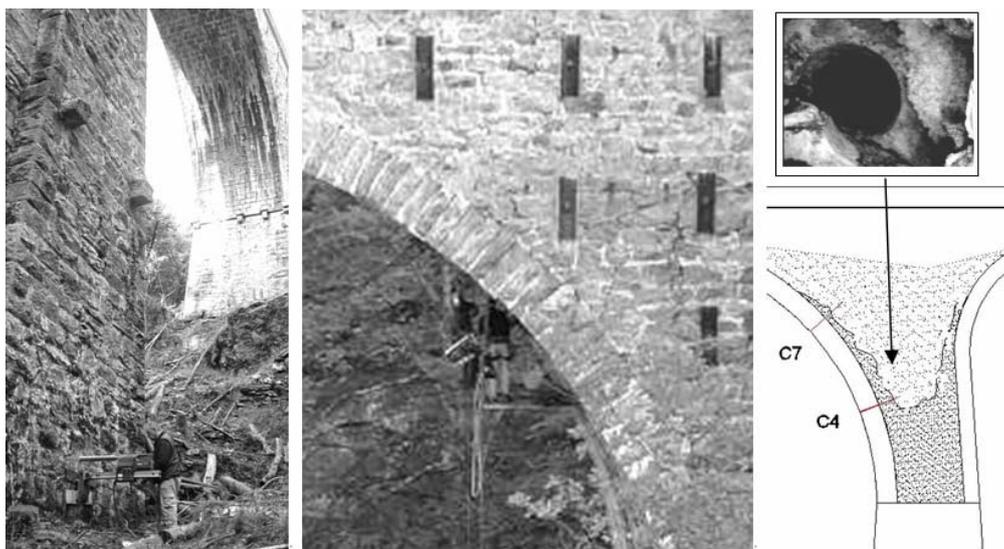
Figure 5 : Coring and video-camera surveys at the base of a pillar and on the intrados of the arches to analyse the composition and the structural characteristics of the masonry and of the filling materials

The composition and the structural characteristics of the masonry were investigated by means of coring and video-camera surveys. Some radial corings starting from the intrados of the arches have revealed the significant degradation of the original masonry and in particular of the mortar which covers the zone of the arches over the pillars (Fig.5). The foundation level of the pillars was determined by means of vertical corings and video-camera survey.

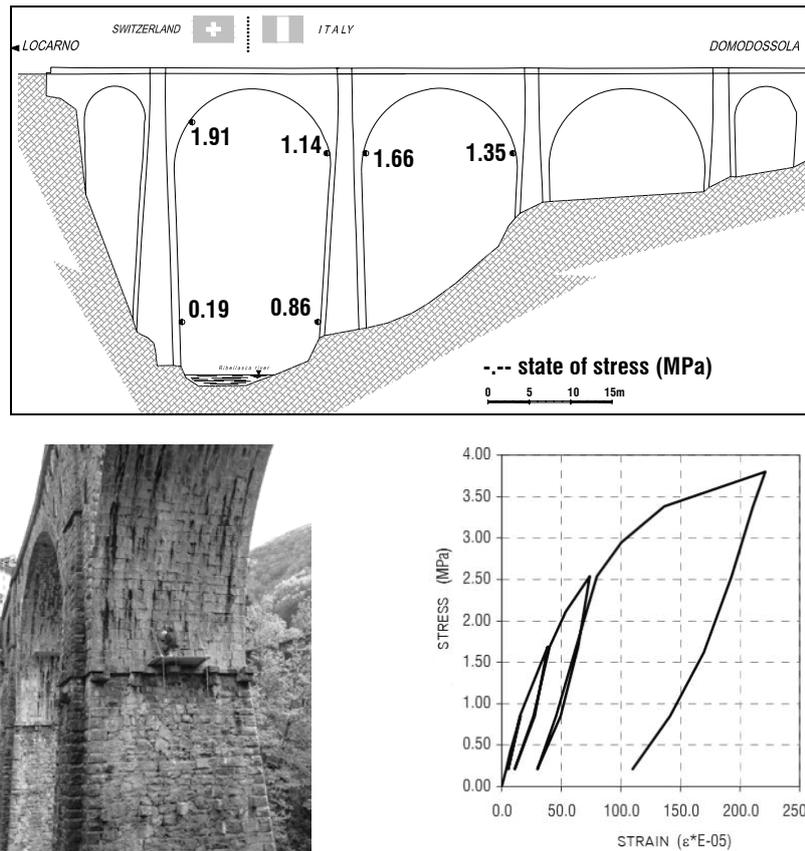
Figure 6 : Measure of the state of stress and of the deformability of the masonry by flat-jack technique: values of the state of stress measured and stress-strain curve of the masonry

The state of stress of the bridge was measured at different heights by using the flat-jack testing technique. The values of the state of stress measured at the base of the pillars and of the main arches are shown in Fig.6. By using two parallel flat-jacks, the deformability characteristics of the masonry were determined (Fig.6).

The mean value of the strength of the masonry, determined by flat-jack tests, is about  $4.0 \text{ N/mm}^2$ . Starting from this mean value it is possible to determine a characteristic value of the strength of  $3.0 \text{ N/mm}^2$  (about 75% of the mean value). Accepting a safety factor variable from 2 to 3, the design strength of the masonry is included in the range between  $1/1.5 \text{ N/mm}^2$ .

The numerical model was validated by the deformability tests carried out with the flat-jack technique, using the value of the deformability modulus  $E = 4000 \text{ N/mm}^2$ , determined by the experimental stress-strain relations.

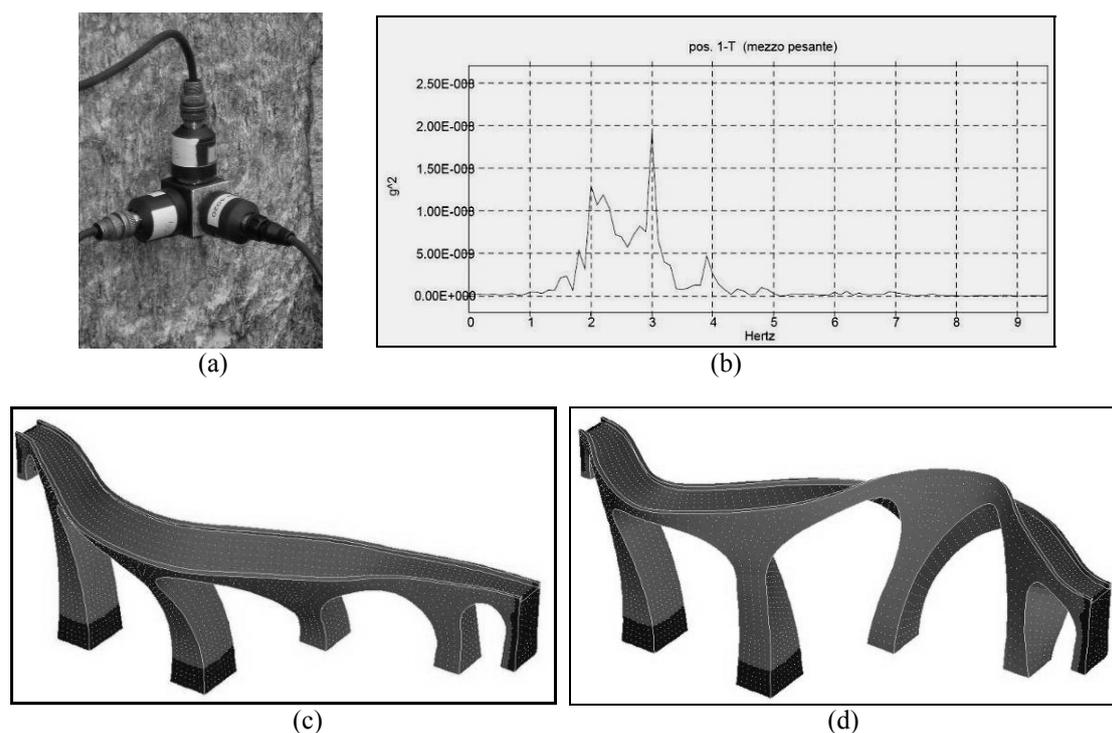
Figure 7 : Dynamic test: (a) three-dimensional accelerometer installed on the masonry of the bridge; (b) natural frequencies of the structure; (c) 1st vibration mode: vertical or global symmetric; (d) 2nd vibration mode: longitudinal or global anti-symmetric.

In order to analyze the dynamic behaviour of the structure, a dynamic test was carried on. Three-dimensional accelerometers (Fig.7a) were installed by the climbers in several points of the masonry structures of the bridge and the test was carried on in three different loading conditions:

The spectral analysis shows that in all the testing conditions, the natural frequencies of the structure are 2.0 and 3.0 Hz (see example of spectrum in Fig.7b).

- (1) 1st vibration mode, vertical (or global symmetric), characterized by in phase transversal vibrations of the keystones of the arches (Fig.7c).
- (2) 2nd vibration mode, vertical (or global antisymmetric), characterized by controphase transversal vibrations of the keystones of the arches (Fig.7d).

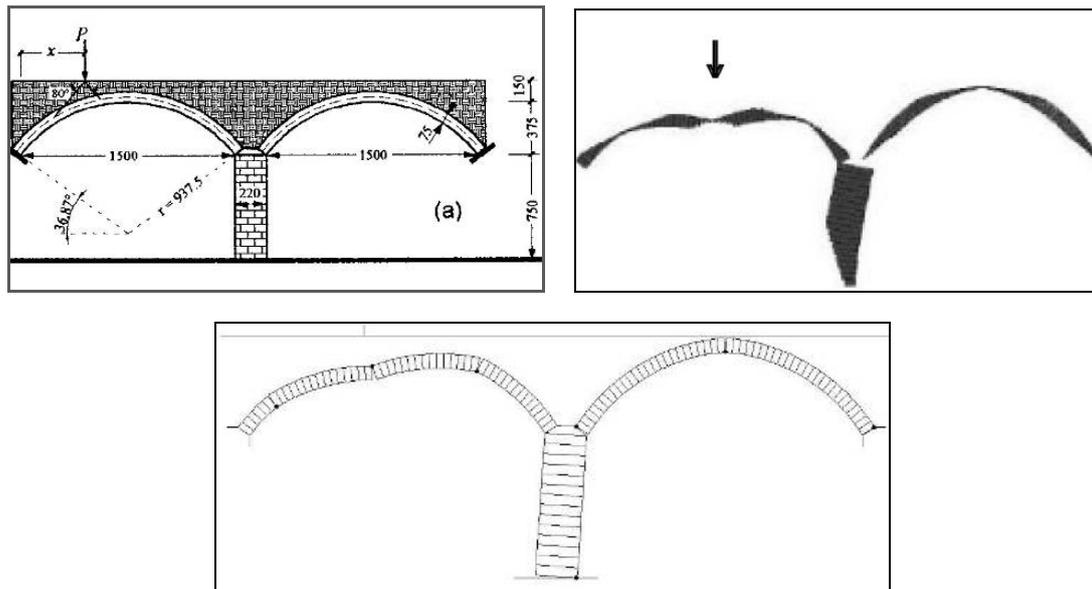
Figure 8 : (Left) Deformation behaviour at collapse determined by the Castigliano's method applied to the elastoplastic case (DISEG method); (Right) collapse behaviour determined by the cinematic method, for a two span arch proposed by Melbourne and Wagstaff (Brencich A. et al. 2004)

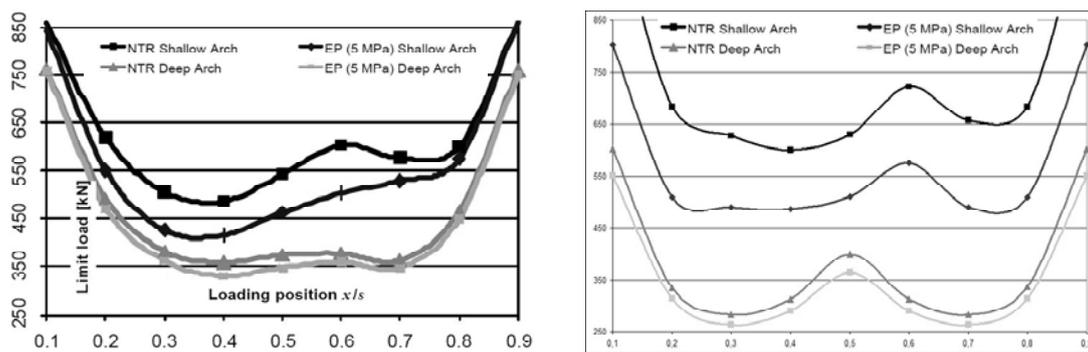
Figure 9 : Comparison of the limit load at failure versus the position of the live load, determined with DISEG's method (Brencich A. et al. 2004) and the cinematic method

The diagram in Fig.9 shows the failure load versus the position of the live load; different type of arches are considered (height of 3.75 m and 5.00 m) and different strength conditions (infinite strength and strength equal to 5 MPa).

The values are coincident with the two methods in the case of less abated arches (like in the case of Ribellasca Bridge).

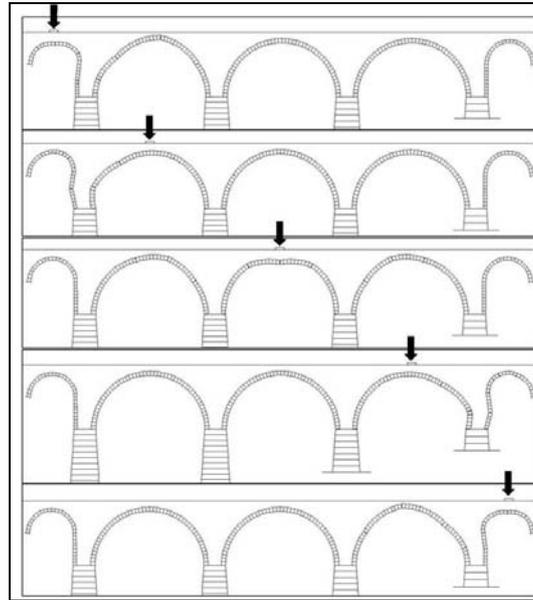
Figure 10 : Collapse cinematism when the live load is applied on the keystones. The minimum collapse load is on the 4th arch near the boundary.

Fig.10 shows the collapse cinematism when the live load is applied on the keystones. The minimum collapse load is on the 4<sup>th</sup> arch near the boundary.

For strength of 2 N/mm<sup>2</sup> the collapse load is equal to about 350 kN, close to the design value without any amplification.

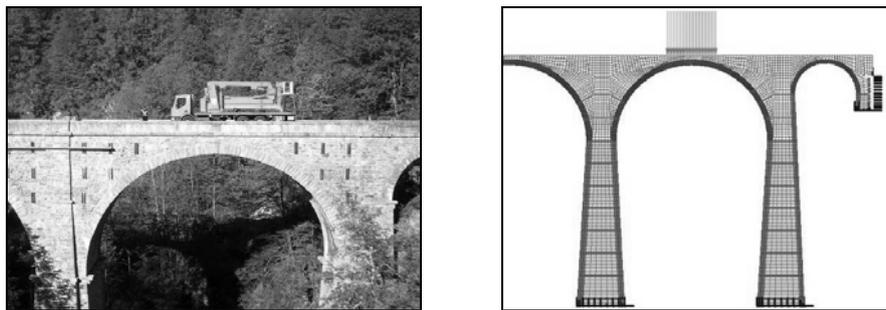
Figure 11 : Validation of the finite elements model by comparing the calculated and experimental (measured with the flat-jack technique) variation of vertical stress due to a live load applied on the top of the main arch.

A finite elements model was then executed. The mechanical parameters of the masonry determined by the flat-jack tests were applied to the model. The validation of the model was carried out by comparing the states of stress calculated on the model and those obtained by flat-jack tests, and by comparing the numerical and experimental variation of the state of stress induced by a live load applied on the top of the main arch (Fig.11).

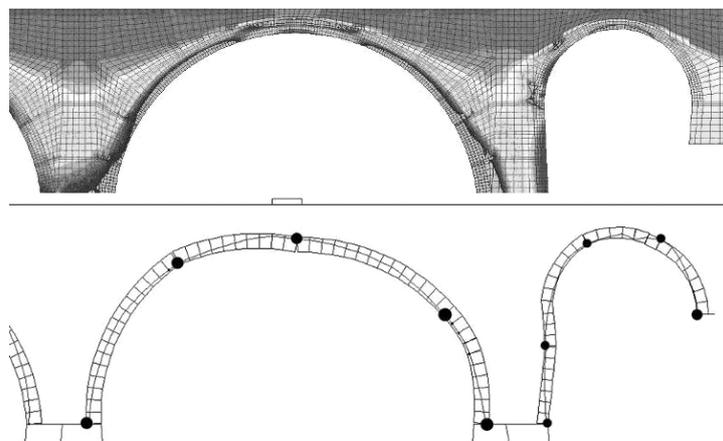
Figure 12 : Comparison between the results of the finite elements analysis and the cinematicanalysis

A non linear analysis was also carried out with the same finite elements model, using the stress-strain curve and the strength determined by the flat-jack tests. In Fig.12 the results of the finite elements analysis and the cinematic analysis are compared. The position of the plastic hinges and the values of the collapse load are similar.

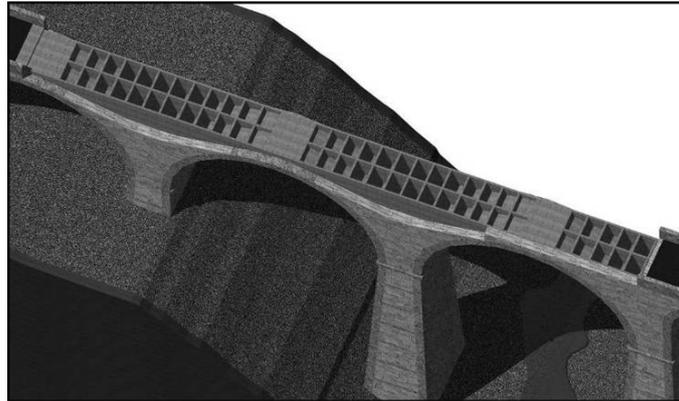
Figure 13 : Scheme of the strengthening intervention

The experimental investigations and the numerical analysis allowed to design the strengthening works which at present have not been finished. The main intervention is the substitution of the filling material which covers the arches with a light boxed structure (Fig.13) made with thin concrete plates which will be able to avoid the transversal deformation of the lateral walls of the bridge. In the meantime, the extrados surfaces of the arches will be consolidated by means of a concrete layer with steel mesh connected to the masonry of the

arches by means of steel anchors fixed with epoxy. The structural conditions of the pillars are considered satisfactory; only local strengthening interventions with steel bars glued with epoxy into small diameter boreholes are foreseen.
