7th International Conference on Arch Bridges

INSPECTION AND MAINTENANCE MEASURES FOR LONG-SPAN REINFORCED CONCRETE BOX ARCH BRIDGES IN MOUNTAIN HIGHWAY

Tong-geng Ji^{*,#}

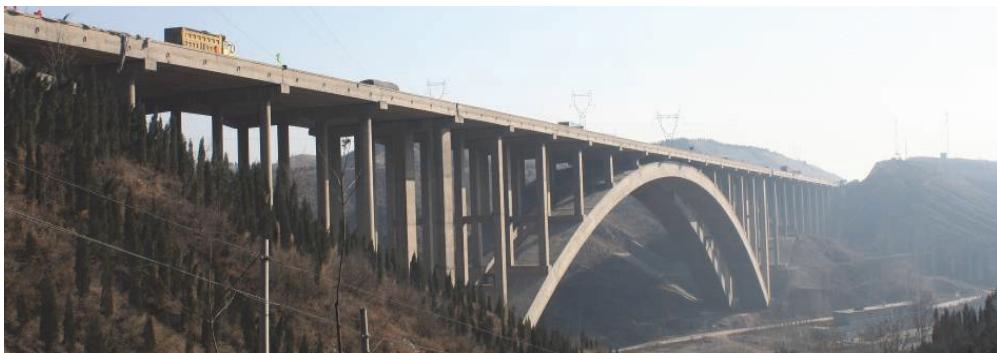
Figure 1: Xugou Bridge

Xugou bridge, located in Lianhuo Expressway (G30) in Yima City of Henan Province, is a continuous uphill section with a total length of 493.14m. The span layout is $9 \times 20\text{m} + 220\text{m} + 4 \times 20\text{m}$ from east to west and the deck has a slope of 2% in the longitudinal direction, as shown in Figure 1. The approach is a prestressed concrete hollow core plank structure. The main bridge is a uniform cross section catenary reinforced concrete box hingeless arch with the arch axis coefficient of 1.543, the clear span is 220m, the net rise is 40m and the ratio of rise to span is 1/5.5. The main arch section is a three-grid box section which is 3.4m high and 9m wide. The 13-17.5m construction on the arch is prestressed concrete hollow core plank and double column frame with horizontal linkages between columns. The six horizontal linkages are arranged between the two pieces of the main box arch to enhance the lateral stability. The abutment is a gravity foundation seated on the intact sandstone. The design loads are QC-20 and G-120. The bridge design was based on the seismic intensity of seven degree while the real site seismic intensity is six degree. The bridge had been constructed in August 2001. The tubular scaffold, layered and segmented pouring, piecewise closure were used during the construction of the main arch.

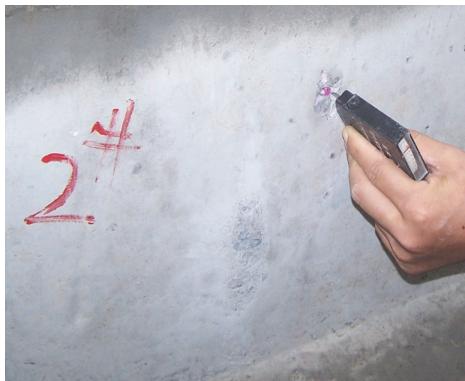
Main Arch: No disease. The average depth of carbonation of the main arch was 15.58mm as shown in Figure 2.

Figure 2: Concrete Carbonation Test (2006) Figure 3: Bridge Deck System Disease (2007)

(6) It was found that the depth of the concrete carbonization was increasing year by year by using phenolphthalein reagent to detect the depth of the concrete carbonization of the main arch. The average annual increment of the depth of the concrete carbonization was 0.83 mm for the bridge operation from 5 to 10 years. While the average annual increment of the depth of the concrete carbonization was increased to 1.04 mm for the bridge operation after 10 years, which indicated that environment of the bridge seriously affected on concrete aging.

(6) Even if there was no disease found for the main arch during detection, the concrete carbonation increased year by year. In order to ensure the operation safety in its design life the special maintenance measures, such as epoxy mortar resin coating to prevent the concrete from erosion, should be adopted to improve the durability of the bridge.

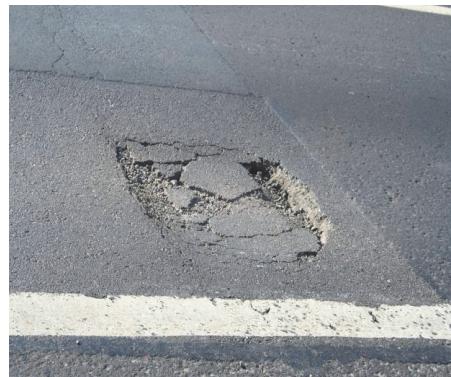
Bridge Deck System: There were 3 pits in L22 lane on the left bridge with the area of $0.3m \times 0.5m$, $0.1m \times 0.2m$, $0.5m \times 1m$ respectively. The typical disease is shown in Figure 3. The drainage holes of deck drainage system were all blocked on the left bridge. There was 1 pits in R15 lane on the right bridge with the area of $0.2m \times 0.3m$. The drainage holes of deck drainage system were all blocked on right bridge also.

(2) In 2007 the second detection was performed 6 years after the bridge in operation. The bridge was in good condition with minor damage such as pits on the bridge deck system and drainage system blocked. Deck system diseases mainly due to high traffic flow, high proportion of overloaded vehicles and bridge deck asphalt concrete aging etc. unfavorable factors cause partial damage. The left bridge due to the continuous downhill bring about adversely accelerating effect, therefore the diseases are more serious.

- (1) The maintenance stair and platform should be added onto the main arch for convenience.
- (2) For the diseases of rut, settlement and net cracking on the asphalt pavement the repair should be started after the pavement around the diseases has been chipped out.
- (3) The deck waterproof of the bridge should be repaired when the leakage at the hinge joint is serious.
- (4) The rubber bearing should be resetted when the rubber bearing cavity happened; The rubber bearing should be timely replaced for the damage of shear deformation, aging and cracking.
- (5) The cracks found in the structural member during the inspection should be timely enclosed with epoxy resin or polyurethane under the dry or wet condition respectively.

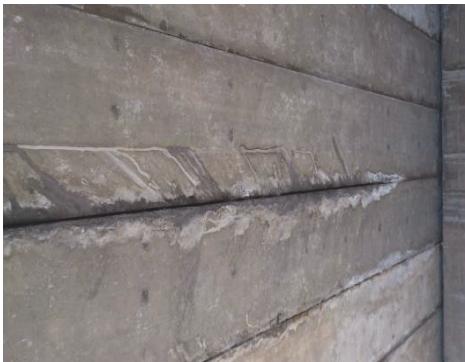
Construction on the Arch: There were 4 places of bearing shear deformation on the left bridge. The longitudinal crack with the length of 1.5m and width of 0.15mm was found on the web of L10-12 beam. There were 7 places of bearing cavity and 39 places of bearing shear deformation on the right bridge. There were 8 places of water penetration at the hinge joint between the slabs on the left and right of bridge with the longest length of 16m as shown in Figure 4.

Figure 4: Water Penetration Between Slabs (2011)

micro cracks were observed on the individual beam and shear deformation was observed on parts of the rubber bearing. Several rubber bearing appeared cavity. The disease of the construction on the arch structure is mainly caused by the reduction of the overall strength and stiffness of bridge deck system and the damage of the longitudinal joint between the hollow core planks. The serious diseases are some hollow core planks working separately and rubber bearing cavity, which resulted in cracks on hollow core planks and beams due to the bearing of unfavorable loads.

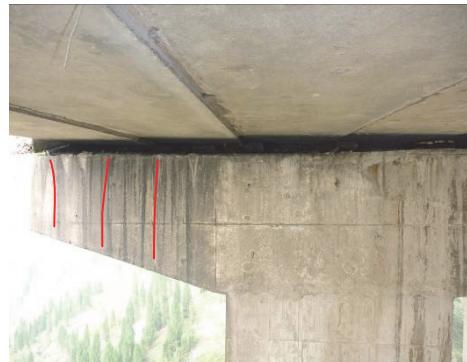
Construction on the Arch: There were 11 places of bearing shear deformation on the left bridge. Three vertical cracks with the length of 0.4m and width of 0.2mm existed on L-22 bent-cap, see Figure 5. There were 26 places of bearing shear deformation on the right bridge. There was one place of concrete damage and rebar exposure on the cantilever beam.

Figure 5: Vertical Cracks on the Bent- cap (2009)

(4) In 2011 the fourth detection was performed 10 years after the bridge in operation. The diseases, such as pits on the bridge deck system, micro cracks on beams, rubber bearing shear deformation and rubber bearing cavity, were found out. When compared with cracks observed in 2009 it indicated that special maintenance on the bridge deck system implemented in 2009 worked well. However, due to the large traffic flow the one way closed maintenance cannot be performed. And thus the reduction of the bridge deck integrity has not been improved.

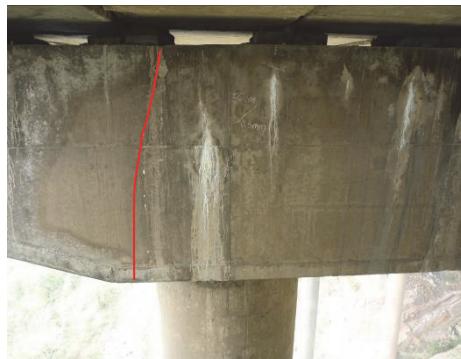
Construction on the Arch: There were 15 places of bearing shear deformation on the left bridge. Three vertical cracks with the length of 0.4m and width of 0.2mm existed on L-22 bent-cap. The vertical crack with the length of 0.5m and width of 0.15mm existed on the east side of L-13 bent-cap, see Figure 6. There were 28 places of bearing shear deformation and one place of water penetration with the length of 4.0m at the hinge joint between slabs. There was one place of concrete damage and rebar exposure on the cantilever end of the bent-cap.

Figure 6: Vertical Crack on the Bent-cap(2012)

(5) Because of the maintenance for the right bridge deck system in 2011 only slight damage was found during the detection performed in 2012. The cracks on beams were located mainly in the left bridge. And there was no disease found in the right bridge. No structural disease was found in arch support. But sediment pollution was observed on the top of the arch support.
