## VACUUM-AIDED CONCRETE CASTING TECHNIQUE FOR CFST ARCH BRIDGES: EXPERIMENTAL INVESTIGATION AND PRACTICAL APPLICATIONS

To address the interfacial concrete separation problem of concrete-filled steel tube (CFST) arch bridges, 2 50m-long steel tube models were designed and fabricated for comparative tests, where the vacuum-aided grouting technique and the normal-pressure grouting procedure were employed respectively to cast the concrete in tubes. The ultrasonic detection method and the cutting inspection method were applied to the experimental concrete-filled tubes to verify the effectiveness of the vacuum-aided grouting technique, of which the working mechanism was also clarified. In turn the defects and the corresponding improving measures of the original vacuum-aided grouting technique were discussed. Finally the improved technique was applied in the construction of real bridge engineering, to actually realize full-process vacuum-aided grouting. The developed technique greatly reduces the interfacial concrete separation areas as well as the long-term separation distances, and effectively insures the compactness of the cast concrete in the steel tubes. This technique has been pat

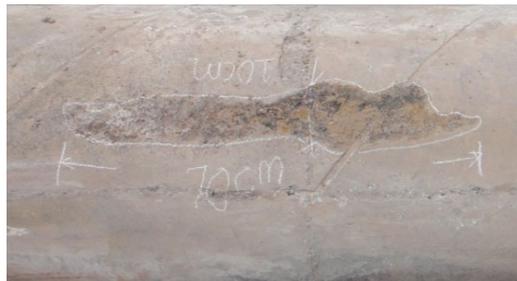
After cutting open of the steel tube, the exposed concrete body was fractured into 39 segments due to transport, then the segments was numbered for convenience. Visual inspection was made on the following typical segments: segment 1-9 at the 9 m (the horizontal distance from the lowest point of the tube, the same below) point of the tube, with local small voids; segment 1-20 at the 21 m point, with pits and local water/air passages; segment 1-36 at the 38m point, without defects; segment 1-37 at the 38.5 m point, with local concrete loosening; segment 1-38 at the 42.5 m point, with local interfacial separation of 70 cm × 10 cm sizes, shown in Fig. 7; segment 1-39 at the 44.7 m point, the last one, with local concrete loosening.

*Fig. 7. The local interfacial separation on segment 1-3.*

- 1) Overall, the comparison of the cutting inspection results between the 1# and 2# tubes shows, within the 0 m ~ 38 m range (corresponding to segments 1-1 to 1-36 of the 1# tube or segments 2-1 to 2-33 of the 2#) of the 50 m tube length, the appearance of the concrete segments from the 2# tube is far better than that from the 1#; within the 38m ~ 50m range, the results from the 2 tubes respectively have some defects: for the 1# tube 1 interfacial separation exists on segment 1-38 and 2 concrete loosening areas occur on segments 1-37 and 1-39, while for the 2# tube wider and deeper water/air passages occur.

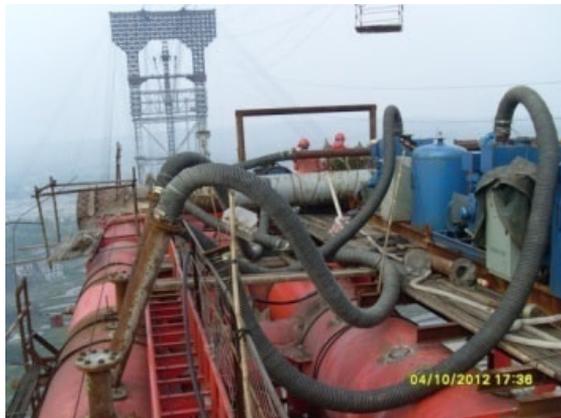
Since in the above tests not a full-process vacuum-aided grouting procedure was realized and excessively wide water/air passages occurred as a non-negligible deficiency, an improving countermeasure was proposed and implemented in the construction of the real bridge: a hollow steel tube with a volume of 4m<sup>3</sup> was used as a slurry tub placed on the crown of the arch rib, to connect the highest-point slurry pipe with the vacuum pump. The addition of this slurry tub allows for discharge of waste grout or concrete into the tub but avoids opening of the slurry pipe and letting outside air in, and effectively keeps the expected vacuum degree in the tube. Thus the realization of a full-process vacuum-aided grouting procedure was insured in the real bridge construction with a vacuum-pumping system shown in Fig. 11 (there the grey horizontal tube was the slurry tub).

*Fig. 11. The vacuum-pumping system on the arch crown of the real bridge.*

The slurry tub came into use for the concrete casting in the 3<sup>rd</sup> main tube of the real bridge and its good effects were proved in practice, which maybe meant the first-time realized full-process vacuum-aided grouting procedure for concrete casting in arch rib steel tubes in the world.
