## DYNAMICAL INVESTIGATION OF A FOOTBRIDGE IN WRONKI NEAR POZNAŃ

The objective of this paper is to present results of dynamical tests of a footbridge in Wronki near Poznań in Poland and clearly summarize them. The investigated footbridge, with asymmetrical arch and the main span 90.0 m long, is an example of original architecture and interesting structural solutions.

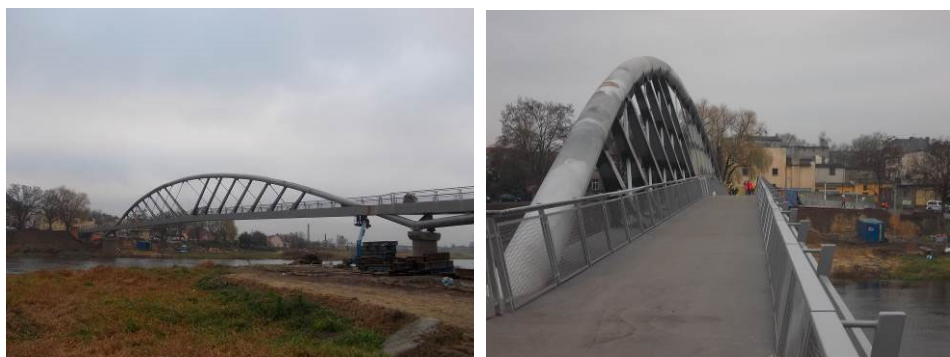
The footbridge was designed as consisted of two structural parts. The first one, located over the main current of the Warta River, is the arch structure (Fig. 1). The deck is made of an orthotropic plate with steel cantilevers and a box main girder, which is a tie-beam of the arch. The deck is connected to the asymmetrically inclined arch with plate girder hangers and steel rods. In side spans of this part of the structure, the deck is a reinforced concrete slab supported on steel cantilevers.

**Fig. 1.** View of the structure over the main current of the Warta River.

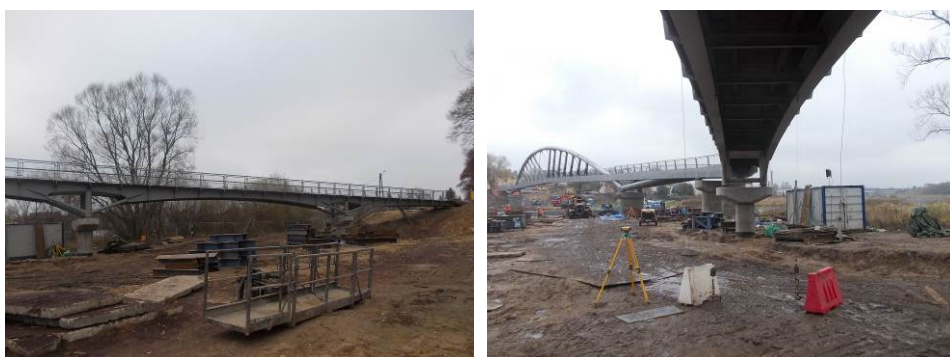
The second part of the footbridge (Fig. 2) is situated over inundation area of the river and is constructed as a beam structure, made of steel I-bar beams, braced by cross-beams. In a connection place of both parts of the footbridge the deck is widened. The idea of this solution was to create an observation deck.

**Fig. 2.** View of the structure over the inundation area of the Warta River.

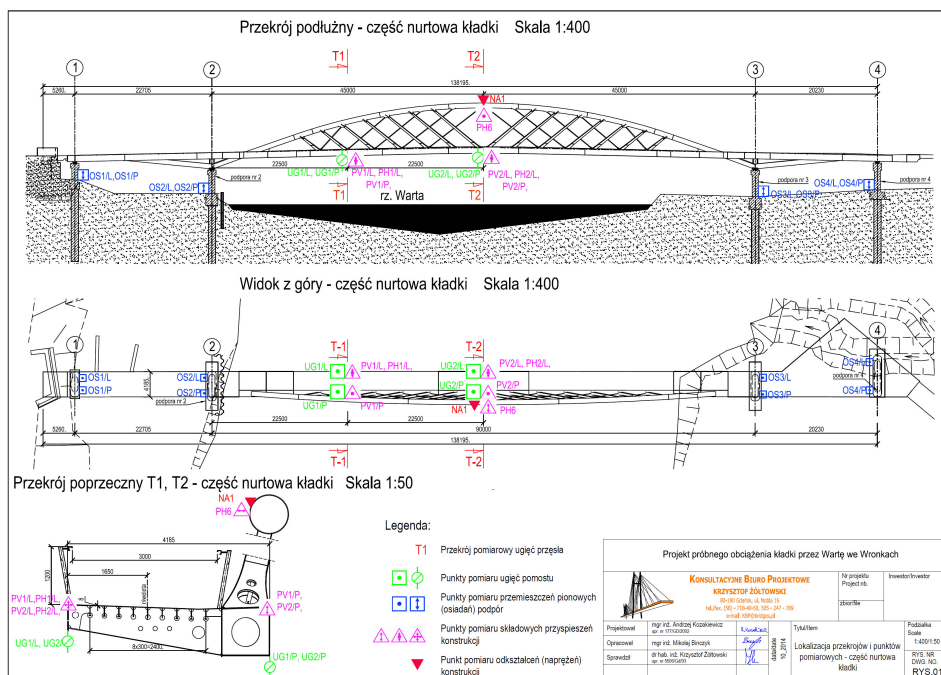
Accelerations of vibrations were measured in points PV1, PV2, PH1, PH2 and PH6, whereas in a point NA1w1 strain was measured (measurements points are presented in Fig. 3).

**Fig. 3.** Scheme of location of measurements devices (arch part of the structure) [3] – side view, top view and cross-section of the footbridge (PV – measurement of vertical vibrations, PH – measurement of horizontal vibrations, NA – measurement of strains).

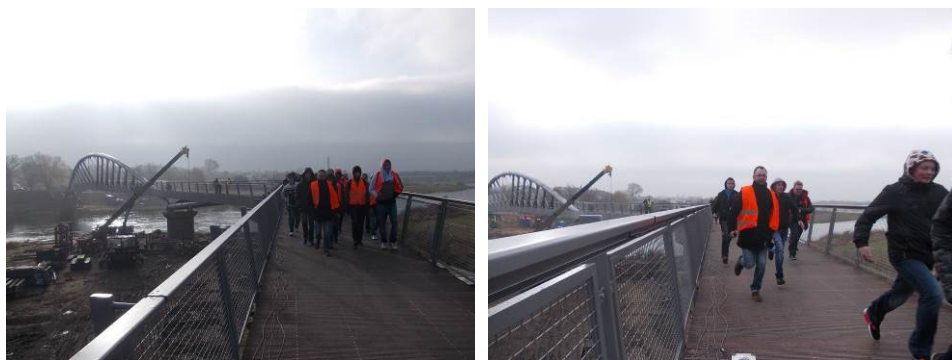
Walking and running schemes were carried out in groups of 10, 20, 30 and 40 pedestrians, according to investigation procedures [4]. Examples of schemes are presented in Fig. 4.

**Fig. 4.** Walking and running of a group of pedestrians with a free path rate.

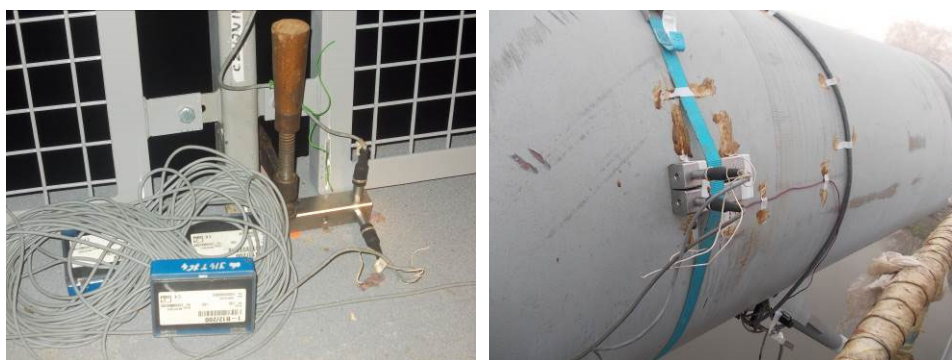
Accelerometers by HBM Hottinger Baldwin Messtechnik GmbH (type B12/200), with SPIDER8 amplifier and CATMAN program (version Express 4.5), as well as electric resistance wire strain gauges were used for the tests of the footbridge (Fig. 5).

**Fig. 5.** Accelerometer B12/200 – measurement of vertical and horizontal accelerations of the deck (on the left) and measurement of horizontal accelerations of the arch (on the right).

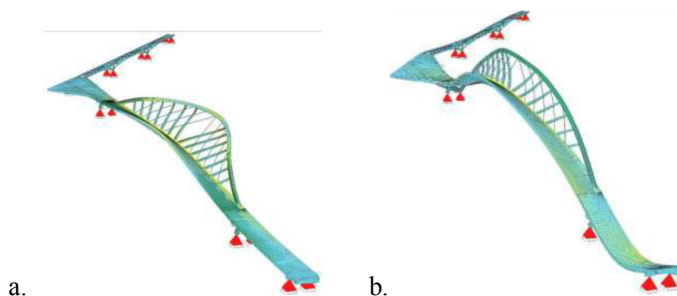
The first two determined in the proof load test project [3] modal shapes with calculated corresponding frequencies are presented in Fig. 6.

**Fig. 6.** Modal shapes of the deck in the arch part: a. the first modal shape ( $f = 1.57$  Hz), b. the second modal shape ( $f = 2.13$  Hz) [3].

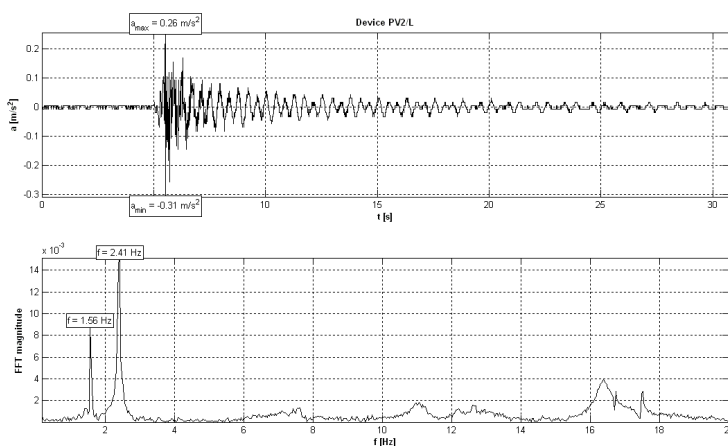
Experimentally identified frequencies are presented in Tab. 1. These frequencies were determined by analyzing vibrations signals registered in a scheme D1. The example of registered signal is presented in Fig. 7 in a time and frequency domain.

**Fig. 7.** Identification of the 1<sup>st</sup> and the 2<sup>nd</sup> frequency of the footbridge (scheme D1).

The investigation of considered footbridge shows that very good compatibility between the results obtained using the computational model and results of experimental tests of the structure is achieved. Calculated natural frequency of flexural vibrations of the bridge is 1.57 Hz, while the value obtained experimentally is 1.56 Hz. This proves that the model of the structure was correct.

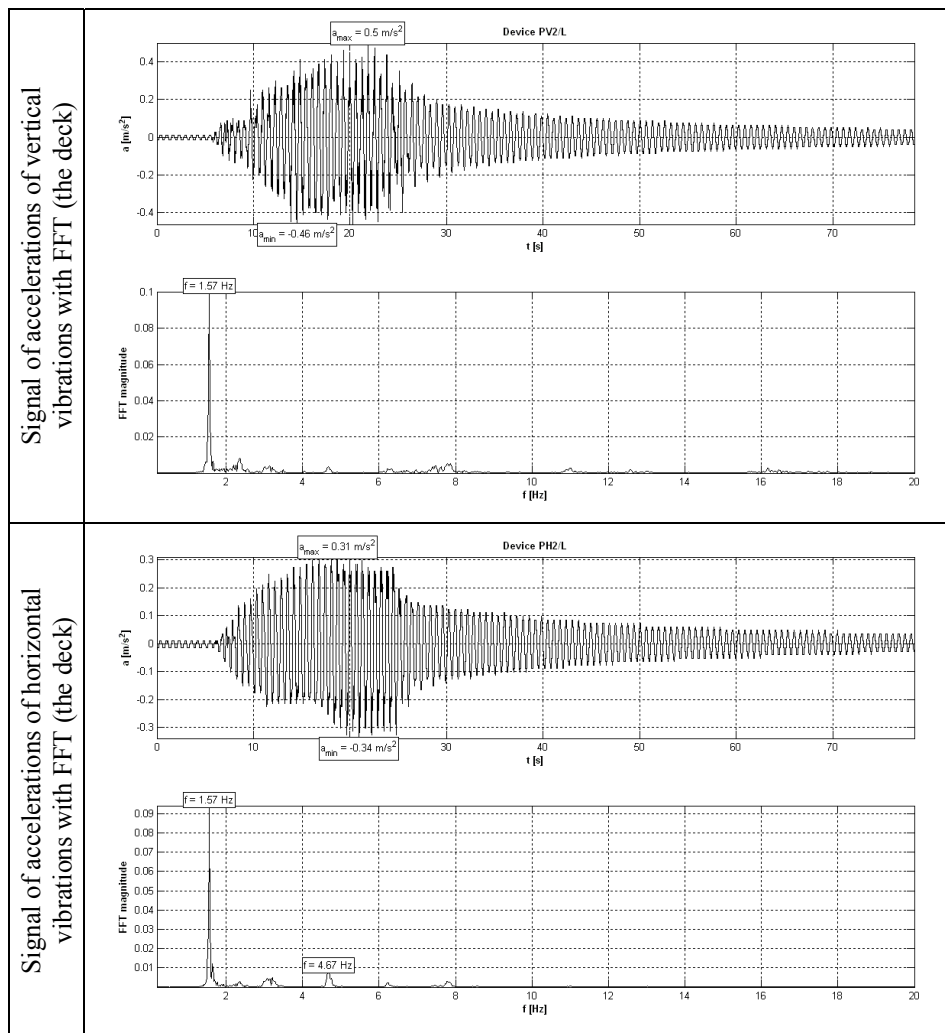
**Fig. 8.** Inducing of vibrations by half-crouching with frequency  $f_1$  (the deck).

Examples of registered signals of the deck vibrations in vertical and horizontal directions in scheme D6 are presented in Fig. 8. Signal of the arch vibrations in a horizontal direction and signal of strain registered in the same scheme by strain gauge sensor (NA1w1) is presented in Fig. 9. Signals are presented in time and frequency domain.

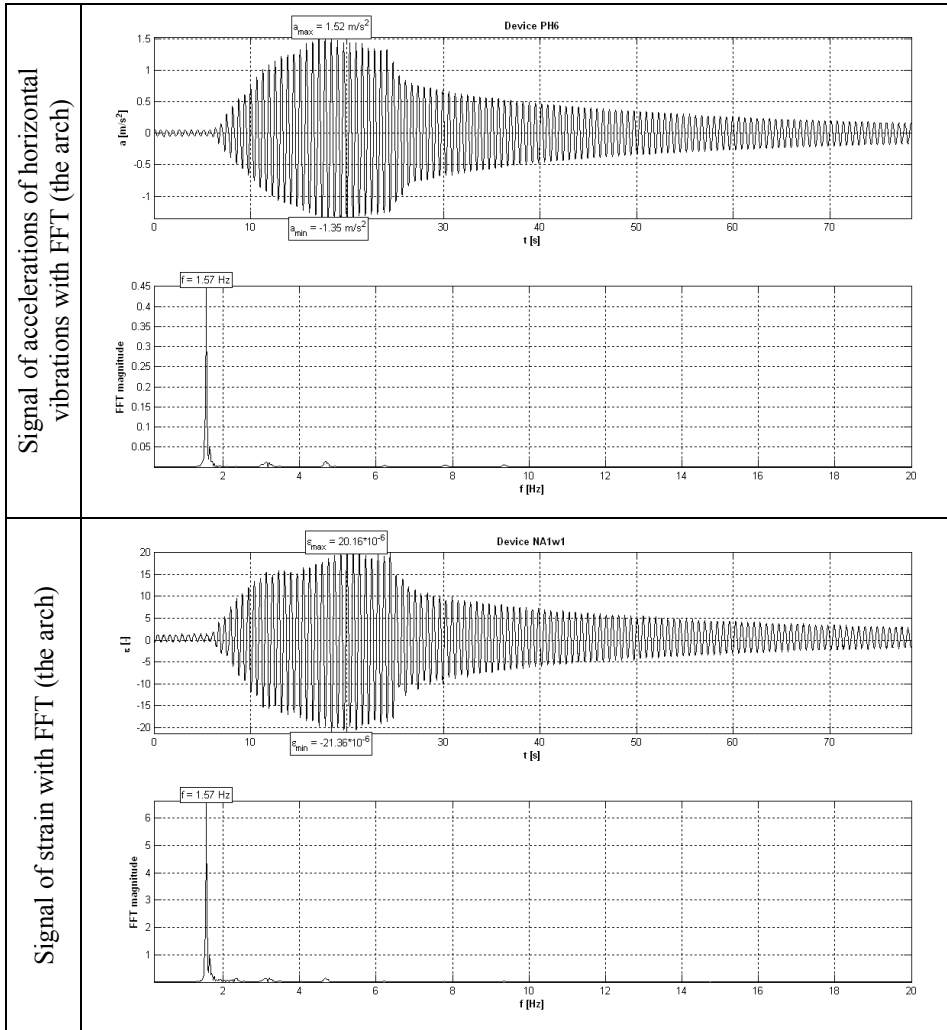
**Fig. 9.** Inducing of vibrations by half-crouching with frequency  $f_1$  (the arch).

The criterion of the footbridge load capacity in dynamical conditions were checked by comparing values of stresses and displacements measured in the dynamic tests with design values. In relation to the arch part of the structure the criterion taken into account was not exceeding values of the design stresses in the arch. The maximum value of strains is  $24.48 \cdot 10^{-6}$ , that corresponds to 5.0 MPa. This result is much lower than the calculated value of the stresses due to statical proof load tests (in scheme U2, in a measurement point NA1w1 calculated value of stresses is 32.7 MPa). These strains results lead to the statement that the safety of the structure in conditions of dynamic influences is fulfilled (including vandal actions on the structure).
