## THE ARCH BRIDGES OF DURHAM CITY, ENGLAND

A.G. Mordey

Atkins Limited, Birmingham, ENGLAND.

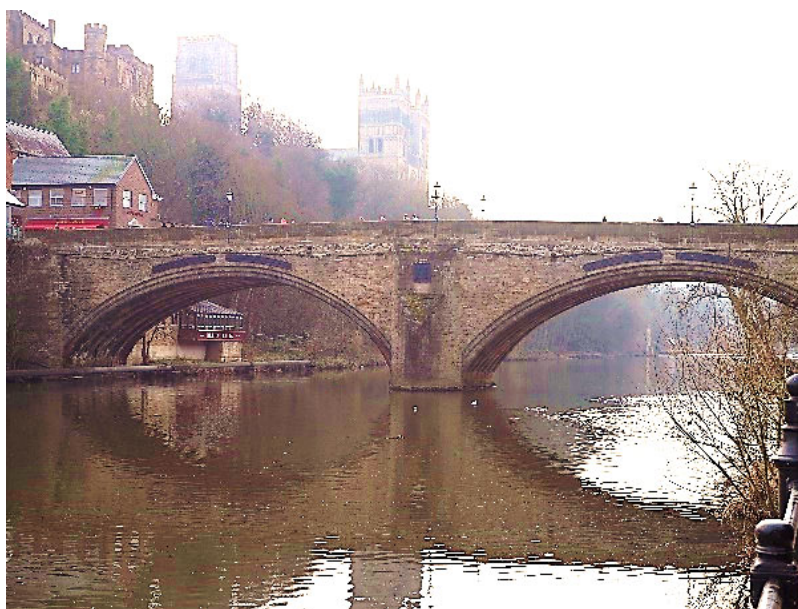
The construction of the original bridge is normally ascribed to Bishop Flambard, who was also responsible for part of Durham Cathedral. However, it was washed away in a flood of 1400, and replaced by the present bridge under the direction of Bishop Langley later in the 15<sup>th</sup> Century. This has two river spans of 90ft (27 m) each, with a low rise; this is a much bolder span than those of Elvet Bridge, which has a number of smaller spans with a greater rise, indicating the improved understanding of design and construction techniques which occurred between the 12<sup>th</sup> and the 15<sup>th</sup> Centuries (Fig. 3).

*Fig. 3. Framwellgate Bridge – 15<sup>th</sup> Century Reconstruction.*

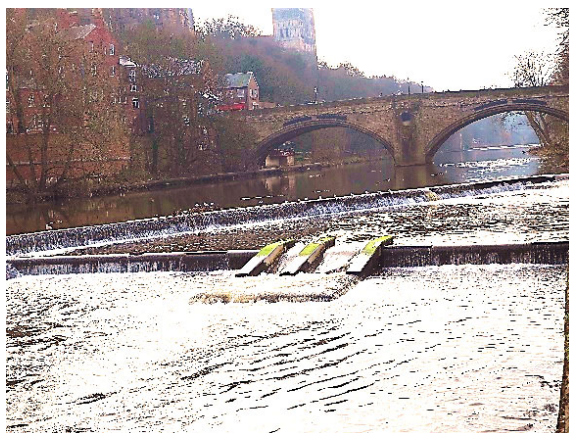
A concrete weir can be seen when looking downstream from the bridge; this is at the site of an earlier weir which raised the water level to power the Bishop's Mill, and would have set the level of the river from which the pier and arch springing levels would have been set out (Fig. 4). Some of the original stones can still be seen within the concrete weir. It is recorded that the previous weir fell out of use due to the action of the river in 1543, which suggests that it would have been in use in the previous century when the replacement bridge was constructed, hence the bridge being constructed at the present level.

*Fig. 4. Weir fixing the springing level of the bridge.*

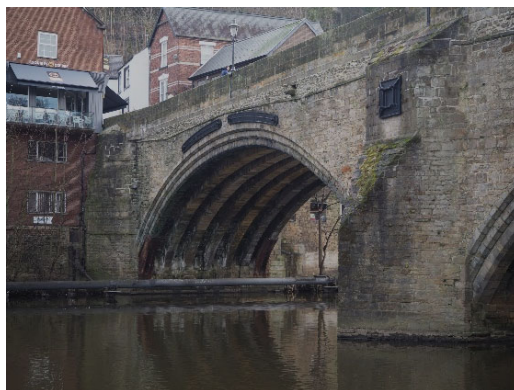
The width of the bridge was increased in 1859; seven arch ribs are visible from beneath, five of them being original, two being added in 1859. The whole bridge is tied together using tie rods and cast iron plates which can be seen on the spandrels (Fig. 5).

*Fig. 5. Ribbed arches and through-ties of Framwellgate Bridge.*

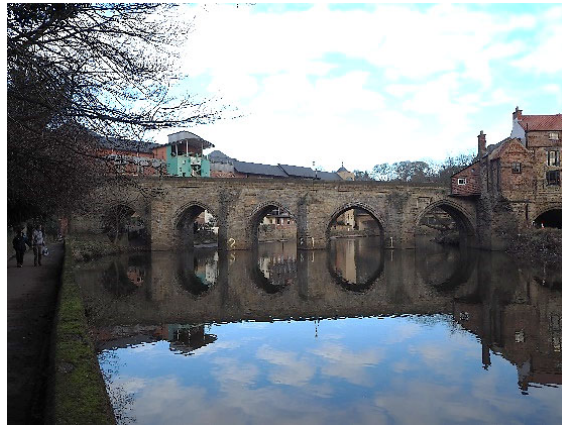
Elvet Bridge was built between 1170 and 1195, and is Grade 1 listed. It consists of three river spans, early English in form, plus two flood spans (Fig. 6). One of these spans includes a riverside walk. There is a further span at the higher end, closed by a metal barred gate. This is believed to have once provided access to overflow prison cells within the arch of the bridge which took prisoners that the nearby House of Correction could not accommodate. It was originally constructed under the direction of Bishop Hugh Le Puiset, who had also been responsible for the construction of the Galilee Chapel within the Cathedral, and had buildings on it. However, the two central spans were replaced in the 13<sup>th</sup> Century after damage by floods. The bridge is on a comparatively steep gradient, and once had a chapel at each end. It also included a guard post to control entry and exit to the city, but this was removed in 1760.

*Fig. 6. Elvet Bridge – early English arch form.*

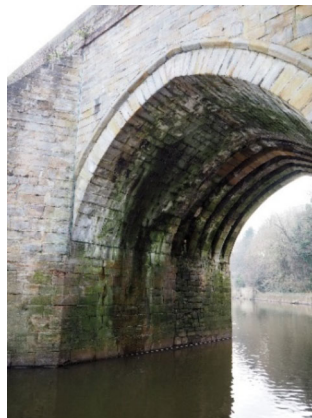
*Fig. 7. Widened Elvet Bridge – photograph shows additional ribs.*

It was doubled in width in the 19<sup>th</sup> Century as the city developed commercially. This can be seen in the different forms of construction of the arch barrel. The original arches barrels are in one plane between the north elevation and the centreline, but the bridge from the centreline to the south elevation is of much more modern ribbed construction (Fig. 7).

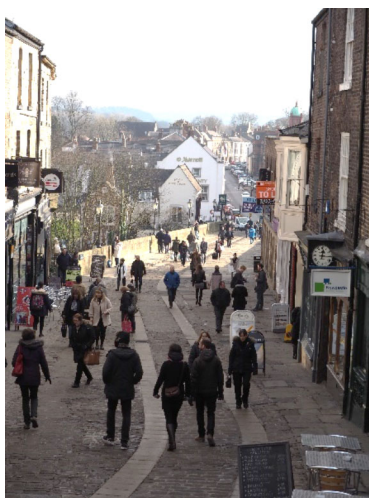
As with Framwellgate Bridge, the most recent change to the bridge occurred when the major traffic through the city was transferred on to the new Inner Relief Road, in the 1960s, and the walking surface was changed from the previous flexible surfacing with paved footways to stone setts with larger flagstones set at a track width to suit service vehicles, tying in the bridge with the rest of the city centre, which is largely pedestrianised, while reducing the impact from modern traffic, with a view to preserving the life of the bridge (Fig. 8).

*Fig. 8. The pedestrianised Elvet Bridge.*

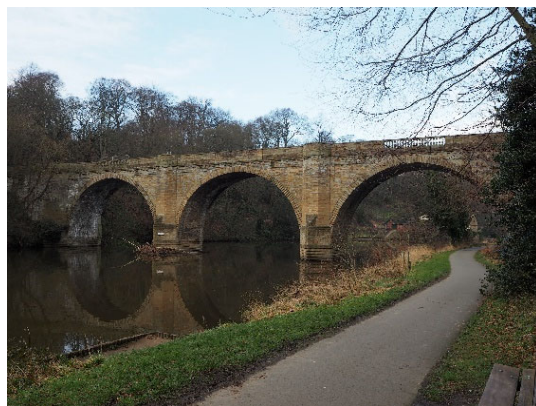
*Fig. 9. Prebend's Bridge from the south.*

It has three spans of 20.4m each, semi-circular in form, with cutwaters on the leading and trailing sides of the river piers. These extend upwards to form refuges or viewing points. The parapets on the two side spans are Palladian balustrades in stone (Fig. 9).

The overall height is 12.2m above water level. The river level at the point of the bridge crossing is fixed by a weir just downstream of the bridge; this can be dated to the construction of a fulling mill which is recorded as operating in the 17<sup>th</sup> and 18<sup>th</sup> Centuries, for which power was provided by the river.

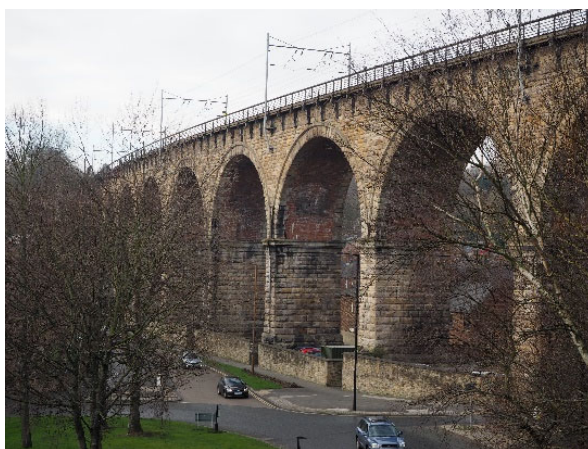
*Fig. 11. Durham Viaduct in 2016.*

The viaduct is built on stone piers, with stone voussoirs and spandrels, and brick arch barrels. There are 11 spans of circular arch form, the viaduct being approximately 500m long (Fig. 11). The designer was Thomas Elliot Harrison, and it was built by the Tyneside contractor Richard Cail as part of a contract which included Brasside Viaduct just north of Durham, and Newton Cap Viaduct on the same line to the south near Bishop Auckland. It is built on both a radius and an up-gradient to the south, and is founded on boggy land. The engineers at the time were praised for their success in constructing the bridge on such poor ground; it is reputed to be built on a mixture of ‘withy mats and sheep’s wool’, and it was predicted that the bridge would not last long, but it is still there, 159 years later, taking modern railway loading, firstly following the adoption of diesel traction in the 1960’s, then following the electrification of the line in the late 1980’s. However, the appearance of the overhead line electrification supports which can now be seen was subject to aesthetic scrutiny and had to be submitted to the Royal Fine Art Commission for approval before they could be put up, which is a measure of the importance of the appearance of the bridge in a city such as Durham (Fig. 12).

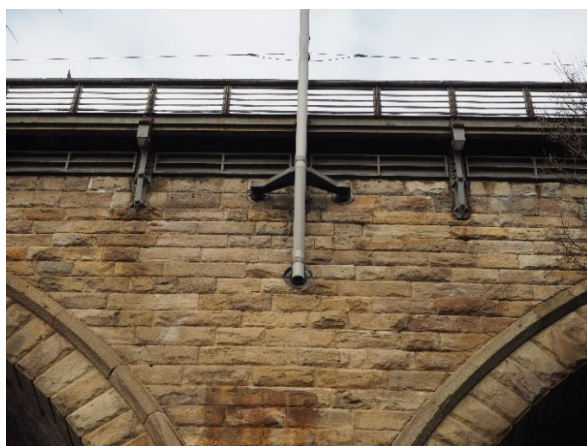
*Fig. 12. Fixing of the Overhead Line Equipment to the Viaduct.*
