RECONSTRUCTION OF THE OLD SOUTH JAGIELLONIAN ARCH BRIDGE OVER CHANNEL OF THE Odra RIVER

In the paper authors presented general overview on the reconstructed road bridge over the flood canal of the Odra river in Wrocław. Overall parameters of the bridge are indicated and interesting details of the bridge are shown. Authors described also assumptions for finite elements calculations, which were carried out in accordance to PN-S standards. The large scope of reconstruction was the reason of the lack of maintenance works throughout last 30 years combined with non-durable solutions of previous designs, especially using a concrete deck on Zores sections. Performed works should guarantee safe exploitation of the bridge in the next decades.

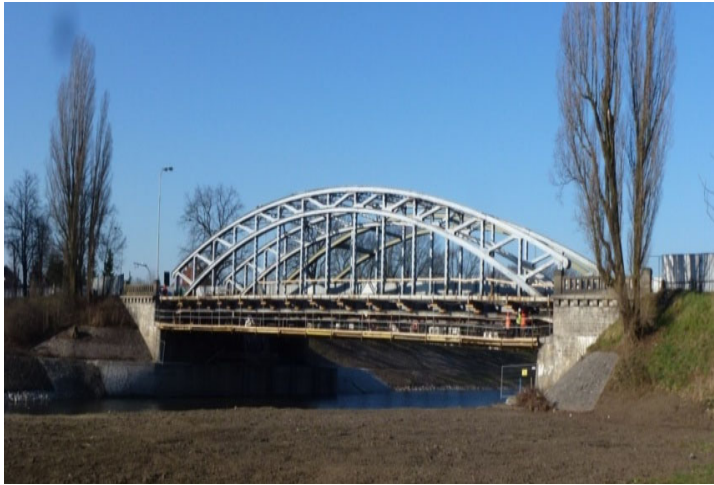
Fig. 3. A general view of the bridge during repair.

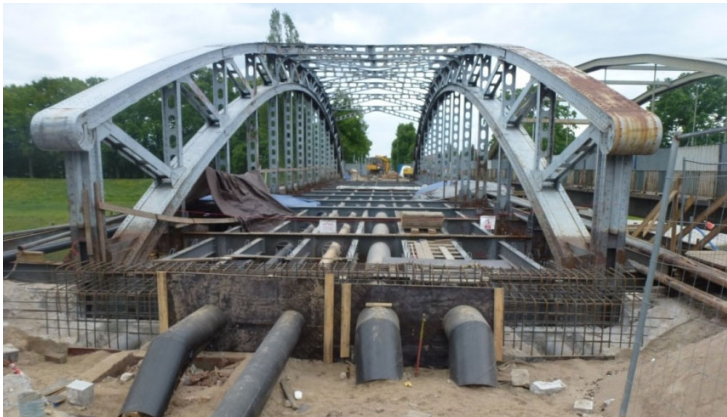
Fig 4. The reinforcement of the wall of the abutment.

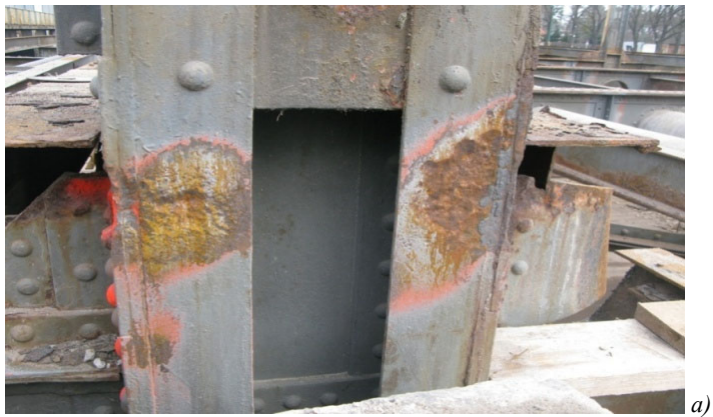
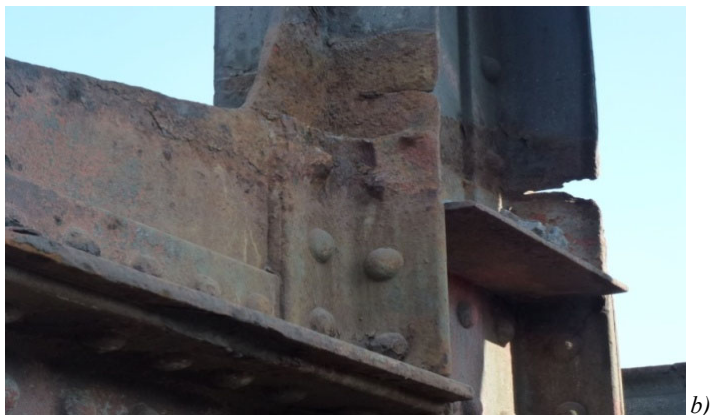
Repair work on the bridge lasting from late autumn 2014, completed recently (01.10.2015). Facility under its former name Nakonz-Brucke built the company Beuchelt of the Green Mountains, under the regulation of Wrocław Floodway after the floods of July 1903. During the post-war use of object several times repaired, performing, among others: a new reinforced concrete slabs on the sidewalk, a new bituminous surface on the roadway, installation of new expansion joints and performing extreme cross-support.. Superstructure is composed of two truss arches with a brace made entirely as riveted. Main girders are arranged at a spacing 9.50 m. The deck is suspended on the arches by means of rigid hangers. Quite interesting solution is the node connecting the hanger, the crossbeam and tie, in which the tie is suspended the way enabling longitudinal displacement. Crossbeams are spaced 4.225 m, longitudinal beams IN 380 are spaced 1.250 m. In the lower level of crossbeams X-shaped wind brackets made of L80x120x12 mm are placed. The greatest structural damage is extensive corrosion of deck, wind brackets hangers with local cracks at the joints of hangers to crossbeams.

Fig. 6. a) Corrosion of supporting column and b) crack of hanger next to the crossbeam.

- Strengthening hanger-crossbeam connections,
- Renewal of the paint,
- Renew the insulation of the gas pipe and water pipe,
- Installing new lighting of the bridge,
- The execution of a new drainage system of the bridge,
- The thorough renovation of access roads and the environment next to the bridge.

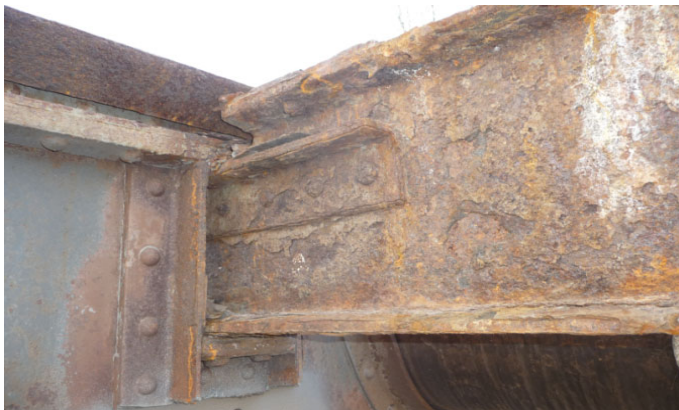
Fig. 7. Corrosion of longitudinal beam next to first crossbeam.

- Replacement of all longitudinal beams for new IN 380 mm beams,
- Replacement of wind brackets,
- Replacement of defective rivets on new or screws,
- The strengthening crossbeams,

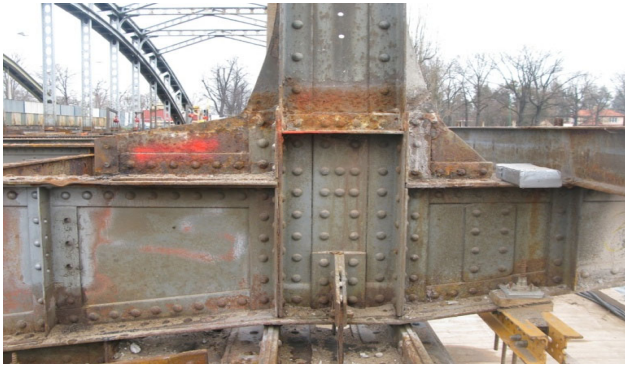
Fig. 8. Corrosion of crossbeam and hanger at midspan.

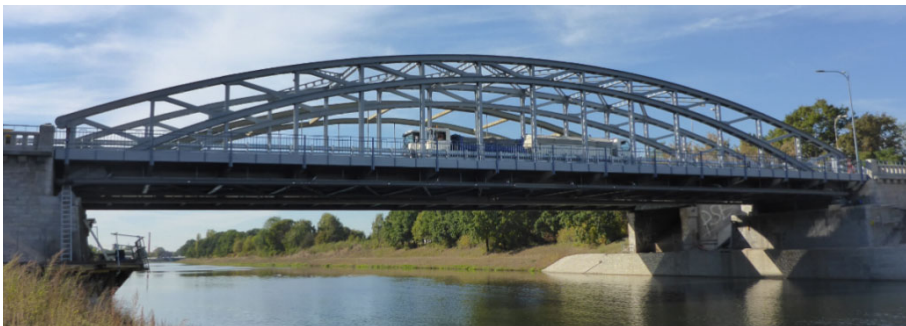
Fig. 11. Jagiellonian Old South bridge during the load test (10/01/2015).

The correctness of the assumptions made at the stage of the calculation, and the effectiveness of completed repair work was confirmed by the results of the test load of the bridge (Fig. 11).
