CAST IRON ARCH BRIDGES – PART OF THE WORLD HERITAGE

R. Helmerich^{1,2}, A. Zunkel¹, R. Häcker¹

¹Bundesanstalt für Materialforschung und –prüfung, BAM, Berlin, GERMANY.

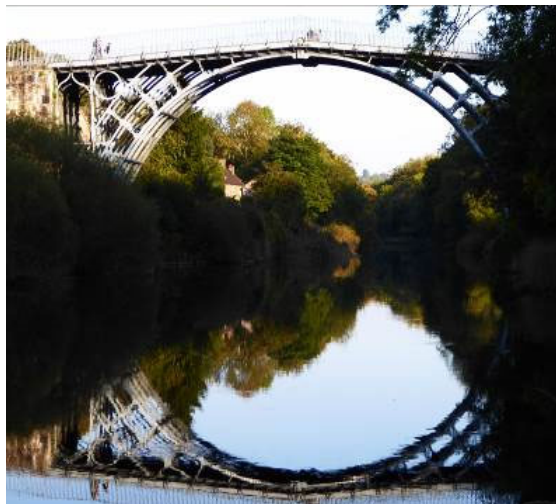
Fig. 1. Iron bridge in the iron gorge.

The first cast Iron bridge (Fig. 1) in the world ever, personally visited in 2015 [1], was designed by Thomas Pritchard in 1775 built by Abraham Darby III in 1777-1779. The construction of the bridge was result of the industrial development in the iron gorge in the 18th century. Growing industrialisation requires more transport of raw material and goods. The bridge spans 30.62 m (100 ft) over the river Severn. The height is 45 feet from the support, i.e. 55 feet from the water level. The roadway is 7.31 m (10 yards). Five parallel cast iron arches have a weight of almost 380 t. The connections of this early cast iron construction remind us timber connections as faucet joints and some bolted connections with square-head bolts (Fig. 2). The original roadway consisted of cast iron plates, now covered with an asphalt layer.

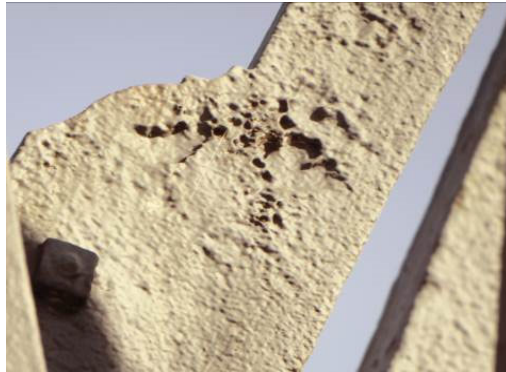
Fig. 2. Raw upper surface of the arches cast in open sand moulds.

The upper surface of the arches is characterised by evaporating gases from the cast iron during the cooling process and shows still unevenness (Fig. 2). A table next to the bridge explains: The bridge was intended to be an advertisement for the skills of the Coalbrookdale ironmasters [1].

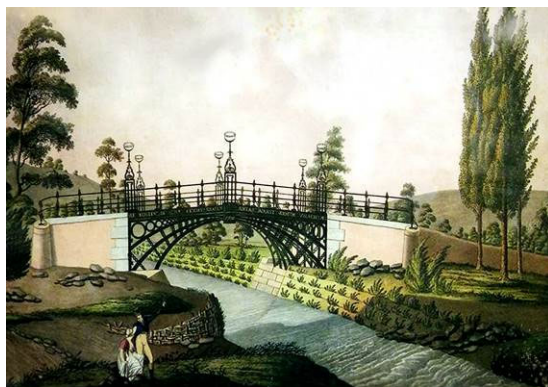
Fig. 3. First cast iron bridge on the European mainland in Laasan, 1796 (today Łaźany)[2].

The first cast iron arch bridge on the European mainland was built in Laasan, now Łaźany, Poland. The bridge was cast by the engineer John Baildon in Malapane foundry (now Ozimek, Poland) in 1794. In 1796 the bridge was taken into service (see Fig. 3, [2]). The bridge was not destroyed because of insufficient materials properties, ageing or corrosion, but collapsed in the end of World War II by overload.

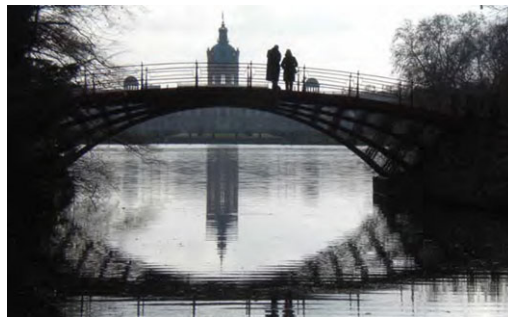
Fig. 5. Castle bridge in the castle garden in Berlin-Charlottenburg.

The Hohe Brücke (High bridge, Fig. 5) in red colour is bridging a 11.4 m wide canal in the Charlottenburg castle park. The bridge consists of four arches located on a masonry abutment. The bridge in Coalbrookdale was not decorated with elements that are not necessary for the load carrying capacity.

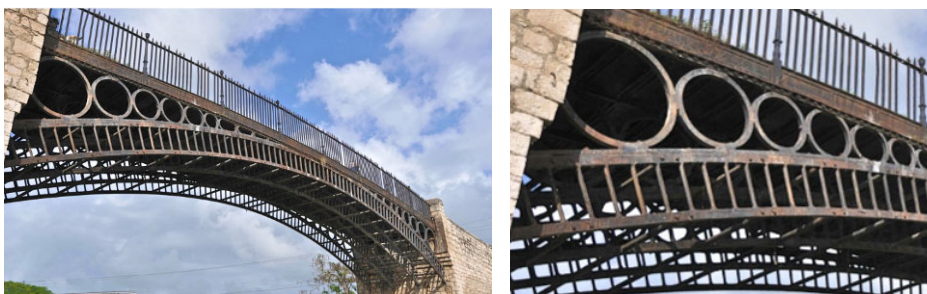
Fig. 8. Earliest cast iron arch bridge (left) in the Western Hemisphere in Spanish town, Jamaica, with corroded surface (right), [6], Photo (2010): by courtesy J. Pheasant.

The bridge was shipped from West Yorkshire to Jamaica in parts. There, the four arches of the bridge were assembled and fitted with cast iron frames for completing in 1801. The bridge spans 25 m over the Rio Cobre. The weight of the cast iron structure is 87 ton. Jamaican authorities, supported by the Friends of the Gregorian Society in Jamaica (FGSJ) contributed to rescuing the bridge from badly damaged abutment walls after heavy tornado. The bridge abutments have been repaired[6]. None the less, the cast iron arch on a photo [6] taken in 2010 (see Fig. 8) is heavily corroded.

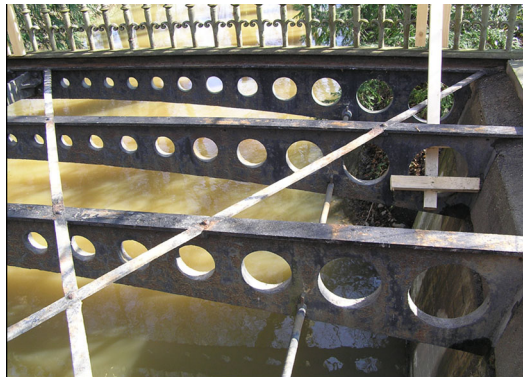
Fig. 9. Bridge structure during rehabilitation works in 2014.

The bridge in the Bad Muskau castle park (Fig. 9) was probably built in 1820. It is not reported, precise when and where the bridge was cast. Some decades ago, the bridge abutments, made of stone, were replaced by concrete abutments with a masonry surface cover. Fortunately, no deterioration is visible in the concrete structure. As the six arches are clamped in the concrete abutment, there is only one transverse stiffener in the vertex of the arches and relatively thin wind bracings in the level of the upper chords riveted to the upper chords of the cast iron arches.

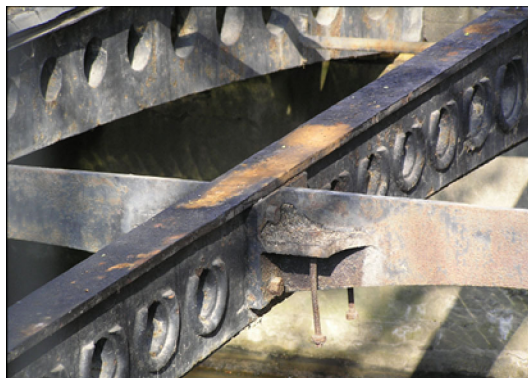
Fig. 10. Transverse stabilization in the vertex of the arch.

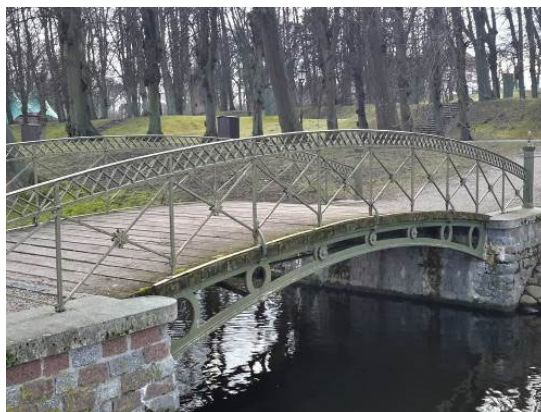
In the 18th century a garden around the Schwerin castle; Germany, was designed in baroque style. Later, in the 19th century, the garden was rearranged in a Landscape garden. Five historic The Schwerin castle garden bridges were probably built between 1850 and 1860. The last rehabilitation was carried out in 2001 by Binder [8]. The bridges were rehabilitated by substituting damaged cast iron arches by new cast arches cast in Poland. About 80 % of the arches were reused, cracks were partly repaired by hammer peeing. None the less, the rehabilitation was a good reason for the investigation of old cast iron material with lamellar graphite.

Fig. 11. Schwerin castle garden bridge.

J. Alex [9] analysed the old grey cast iron material of the bridges and proposed a material model for plane stress (2D). Regarding mechanic parameters he reports a ratio between tensile and compression strength of lamellar cast iron between 24 and 33 %, both with non-linear materials behaviour. Besides iron (2-5%) and oxygen, silicium, mangan, phosphor and sulfur form metal alloy. Silicium enhances the graphite precipitation of and contributes to the solidification in a stable system. Mangan is responsible for the creation of cementite, reducing the graphite formation. Phosphor reduces the ductility and sulphur weakens the grain boundaries due to deposite of iron sulfites along the boundaries [9].

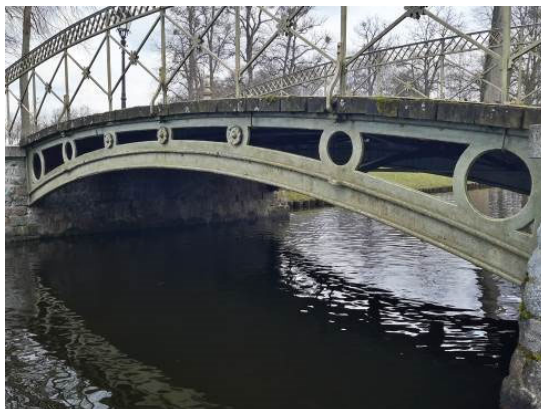
Fig. 12. Schwerin castle garden bridge.

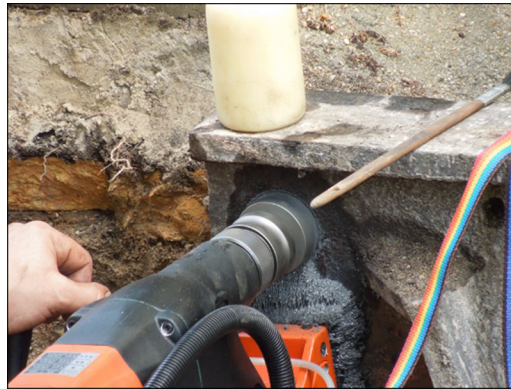
Fig. 13. Core drilling at Bad Muskau cast iron arch [7].

The cast iron bridge and the landscape in the German Fürst-Pückler Park in Bad Muskau are listed as national heritage. For rehabilitation it was necessary to know more details about the mechanic-technological parameters of the old material. The mechanic parameters will be the basis for static calculation and the rehabilitation concept. Cores were taken of statically low loaded cross sections, see Fig. 13 and tensile test specimens were produced acc. to the sketch in Fig. 14.

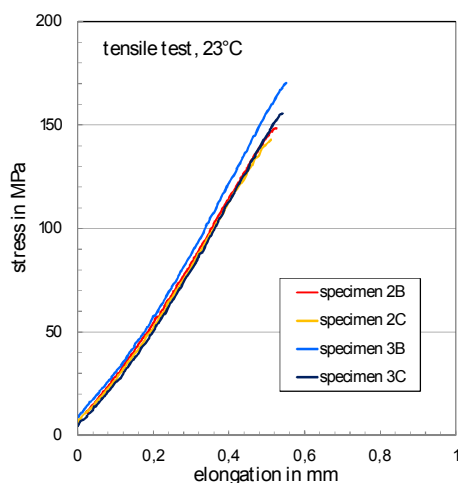
Fig. 15. Tensile test without necking and local strains.

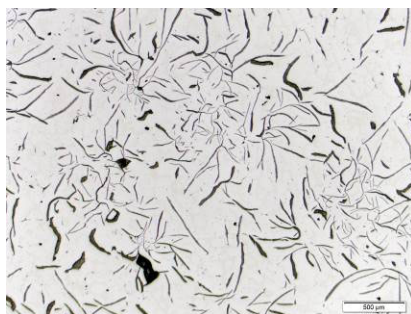
Fig. 16. Metallography of the cast iron material after embedding and polishing the surface.

The historic grey cast iron has a lamellar microstructure. A carbon content between 2.9 % and 5 % is regularly distributed flake-like in the material microstructure. The test report about the material of a cast iron arch, BAM-9.1/918 (2014) presents the microstructure of the old cast iron. Fig. 16 [7] shows the regular distributed lamellar graphite. In [9], Alex explains the rule of the lamellar graphite being responsible for the notch effect during tensile test. A second factor increasing the severity of the notch effect

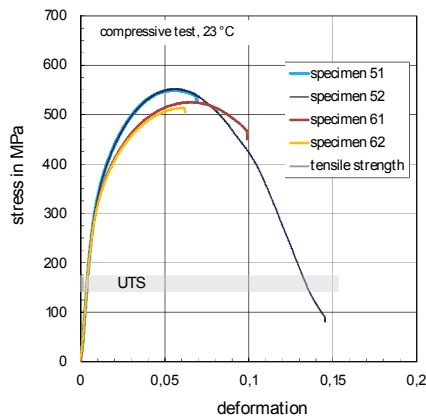
Fig. 17. Technical stress-deformation curves with the tensile strength R_m for comparison.

The results are presented in Tab. 2. Figure 17 and 18 show the stress – deformation (shortening) curves. The compression strength (the compression curve) maxima are between 513 and 552 MPa. Figure 18 shows the flow curves until the load maximum.

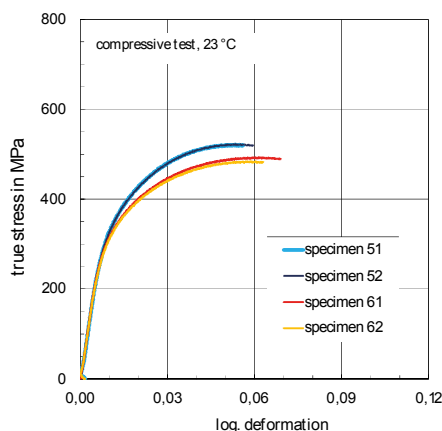
Fig. 18. Flow curves determined until load maximum of technical stress-deformation curves Fig. 17.

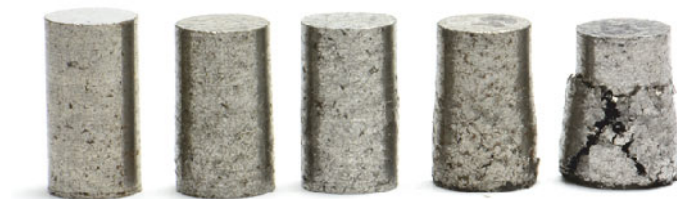
Fig. 19. Compression test cylinders before (left), during (middle) and after the test (right).

The compression test specimens were taken from the areas in the drilled cores from arch 2 and 3 that were remaining besides the tensile test specimens. From each specimen, we produced four small compression test cylinders. The compression test specimens were oriented perpendicular to the beam direction. We assume an arch production in a horizontal direction and intended to get an integral value between the lower and upper surface of the cast iron. The height of the cylinders was 16 mm; the mean diameter was 8.49 mm. The test was carried out with a strain rate of 310^{-4} 1/s (velocity 0.005 mm/s). The tests were stopped at different compression conditions due to observation of the deformations in each state. The calculation of the flow curves based on the one-dimensional stress conditions was performed according to [11] until load maximum.

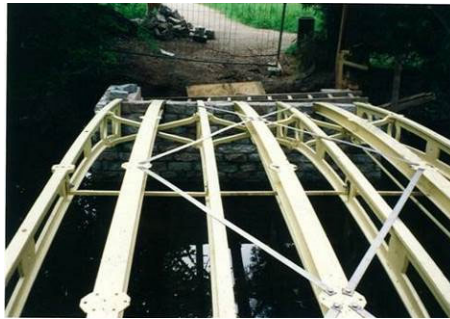
Fig. 20. Four original cast iron arches and three later added arched beams [8].

On possibility for strengthening old cast iron bridges is adding new arches between the old cast iron arches. Photos 20 and 21 show three additional arches located between the old cast iron arches to strengthen the bridge e.g. for fire brigades or vehicles for gardening.

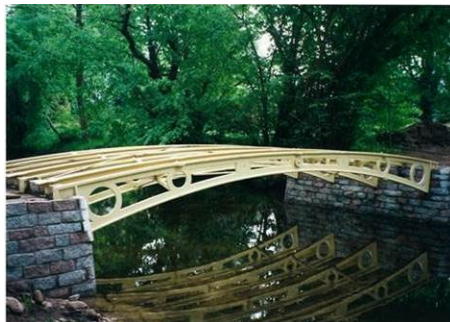
Fig. 21. Schwerin castle garden bridge during rehabilitation [8].
