# An overview of Krk Bridge repairs

Jovo Beslac, Jelena Bleiziffer and Jure Radic

*Institute IGH, Faculty of Civil Engineering, Croatia University of Zagreb, Zagreb, Croatia*

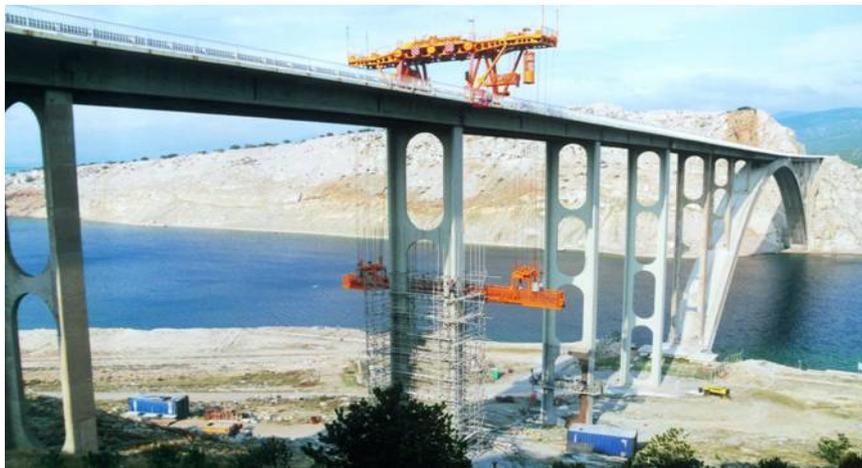
The problem of the monitoring and repair and protection of non accessible parts of the bridge structure was solved in the year 1990 by the very complex multipurpose moveable scaffolding (Fig.6) constructed for this purpose and paid about 45000 USD.

Figure 6 : Multipurpose moveable scaffolding for the maintenance of Krk Bridge.

From that time monitoring, repair and protection of the whole concrete bridge structure started, firstly the mostly attached columns and lower parts of the arches and later on the rest of the concrete structure. As it was the time of improved technology of the protection of reinforced concrete by the pure polymer coats impermeable for chloride ingress it was designed as it follows:
