## REFURBISHMENT OF CONCRETE ARCH BRIDGE IN NE ITALY

P. Franchetti, M. Frizzarin

Studio Franchetti, Arzignano, ITALY.

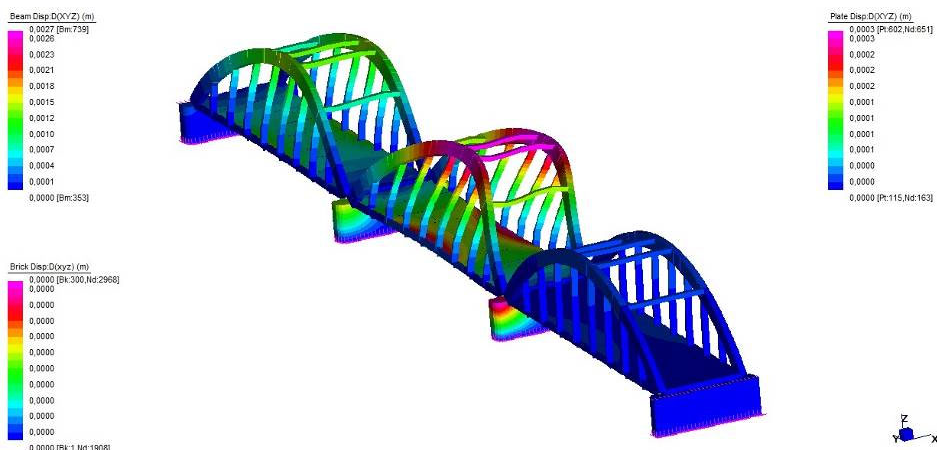
*Fig. 10. FE model of the bridge.*

For the global analysis, the verifications were carried out by calculating the solicitation parameters from a finite element model. The model consists of 3230 nodes, 1608 beams, 1701 plates and 394 bricks. The constraints of the bridge are modeled in order to schematize an isostatic system, except for the damaged bearings where sliding was contrasted by the corrosion of the parts.

The results of the global analysis, showed, as expected, that the capacity of the structural elements is not suitable to resist to the action determined by the recent Italian Code, that involves also a seismic action not considered in the original project of the bridges.

The resistance of the elements is generally exceeded by the solicitations with a factor around 1.5 for the slab and until 10 for the damaged transversal beams.
