TEN YEARS AFTER THE RECONSTRUCTION OF PLEČNIK'S FOOTBRIDGE AT PRAGUE CASTLE

V. Vacek, J. Kolísko, P. Tej, L. Kudrnáčová

An example of a successful reconstruction of the small but important and culturally significant structures Plečnik's footbridge located on the premises of Prague Castle is discussed in this paper. The building was severely disrupted for 10 years after a previous reconstruction. This damage and degradation was caused mainly as a result of faults incorrectly designed new waterproofing and water freezing in the new drainage pipe bridge. Technically properly designed and in 2006, well made reparations, resulting problems removed and for 10 years after completion fulfils its function perfectly and reliably protects valuable object.

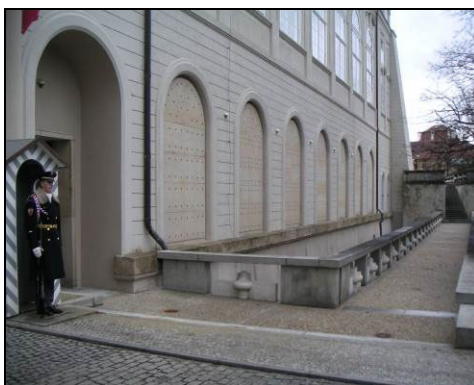
Fig. 1. This is a Plečník's footbridge viewed from the Paccassi gate, front of the Spanish Hall at Prague Castle.

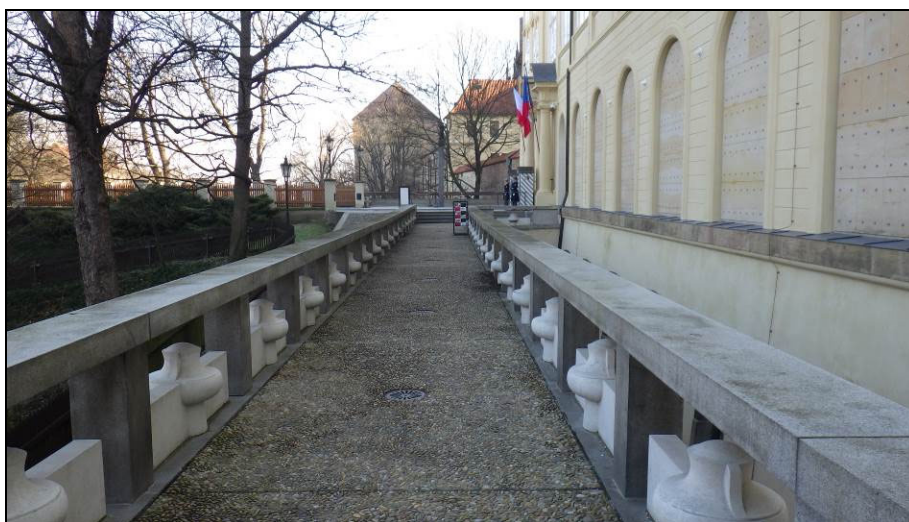
Fig. 17. This is a Plečnik's footbridge viewed to the Paccassi gate, front of the Spanish Hall at Prague Castle in February 2016.

Functionality of the drainage system, its heating and very high quality double water insulation of the bridge deck had been tested during several frost waves in the winter 2007. Reliability of the new solution was confirmed, the system is fully protecting the footbridge structure against adverse impacts of rainwater which is led from the structure even during winter operation under action of the frost and layers of snow with ice melting on the bridge deck. We are pleased to state that the repair carried out in 2006 is unlike previous attempts reliable and fully functional even after ten years of operation of the reconstructed Plečnik's footbridge and is in compliance with all demands of the national heritage authority related to this unique works.
