# Investigation of the historical Osobowicki Bridge in Wroclaw

Tomasz Kamiński, Jan Bień, Mieszko Kużawa and Józef Rabiega Institute of Civil Engineering, Wrocław University of Technology, Wrocław, Poland

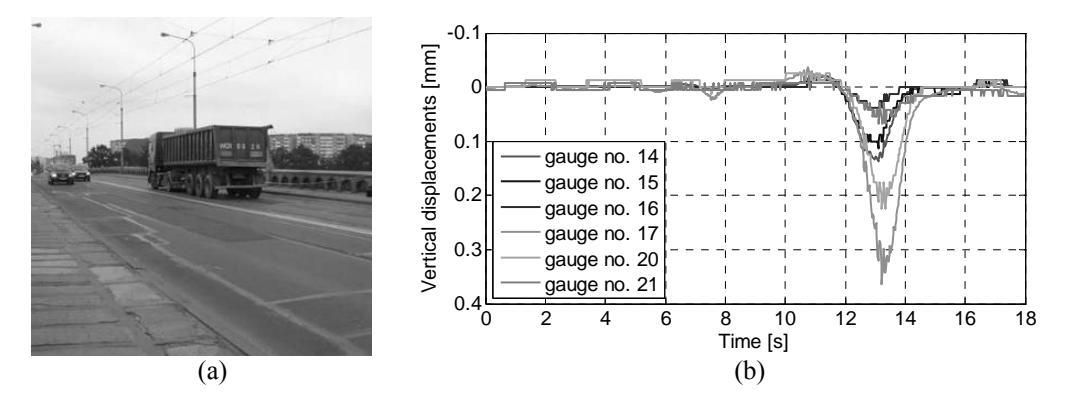
During the tests several tens of random traffic runs were controlled among which some representative loading schemes were selected. One of the typical loading schemes giving the highest values of the span deformation is presented in Fig. 8a. It is represented by a single truck with 3-axle rear bogie with about 100 kN per axle crossing the bridge along the right lane. The biggest displacement caused by such loading was measured in the middle of the span at the edge and reached 0.35 mm. Results of displacements' change in time during passing of the representative truck for all six monitored points of span no. 2-3 are presented in Fig.8b.

Figure 8 : Representative traffic loading: (a) photographic view, (b) results of displacements.

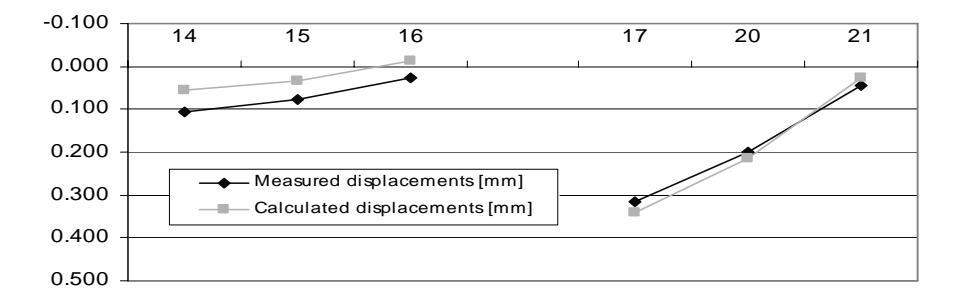
Results of calculations by means of the 3D model utilizing the parameters given in Table 1 are shown and compared with measured quantities in Fig.10. Finally, the convergence reached between the calculated and the measured vertical displacements of selected points of span no. 2-3 (see Fig.3) were considered as satisfactory.

Figure 10 : Calculated and measured vertical displacements of selected points of span no. 2-3.
