## WIDENING AND STRENGTHENING OF A TWO-SPAN ARCH BRIDGE

**Janusz Holowaty**

West Pomeranian University in Szczecin, Poland  
Janusz.Holowaty@zut.edu.pl

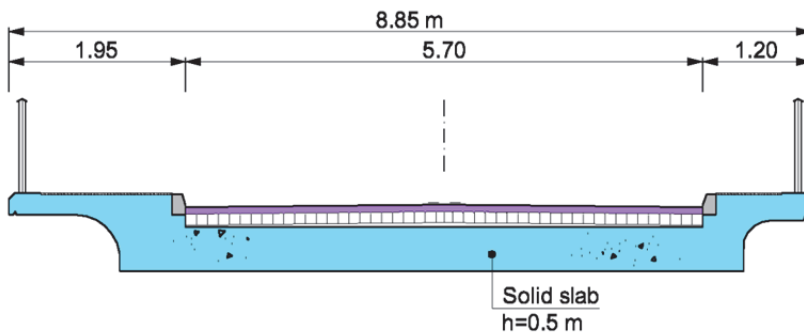
It is estimated that the bridge was constructed in around 1920 as two-span arch with a 5.7 m carriageway and sidewalks of narrow widths. The total width of the bridge was 8.85 m (Figure 1). The overall length was 39.3 m. The bridge is located over the Rega River along a busy street in the old town. The street also serves as a county road of regional importance. At the time of construction, the width of the deck and sidewalks were quite sufficient for demand. The superstructure was a two-span arch cast “in-situ” with clear spans  $2 \times 16.10$  m at the springing line.

Figure 1: Cross section at the crown (as built)
