ST. PATRICK'S PEDESTRIAN BRIDGE DESIGN AND CONSTRUCTION

The St. Patrick's Bridge, recently re-named the George C. King Bridge, is a 182 metre, three-span, continuous network tied-arch structure that spans over the Bow River at St. Patrick's Island on the east side of downtown Calgary. The inherently efficient structural scheme, with generous span to depth ratios, was optimized parametrically with respect to member geometry and sizes. Construction of the footbridge began in April 2012, but was delayed by nearly a year due to extreme flooding of the Bow River in June of 2013 that inundated the island, and damaged and washed out critical temporary falsework supporting the post-tensioned concrete bridge deck and steel arch sections. Replacement of the entire deck was required, altering the erection sequencing and forcing winter construction methods not initially envisioned.

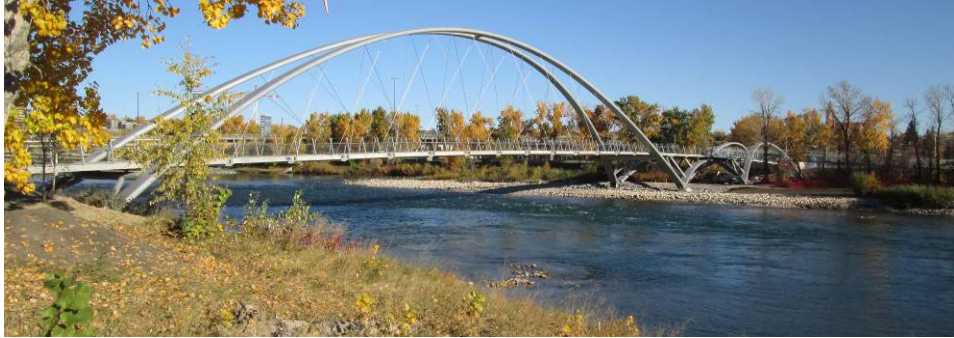
Fig. 1. Completed bridge.

The arches are arranged in spans of 52 m, 31m, and 99 m for the north, centre and south arches, respectively, running continuously between sliding bearings on the two abutments, with each arch rib composed of twin steel pipes joined by welded top and bottom plates forming oblong cross-sections. The long arches over the north and south river channels are bowstring arches with the post-tensioned concrete deck acting as the tension tie.

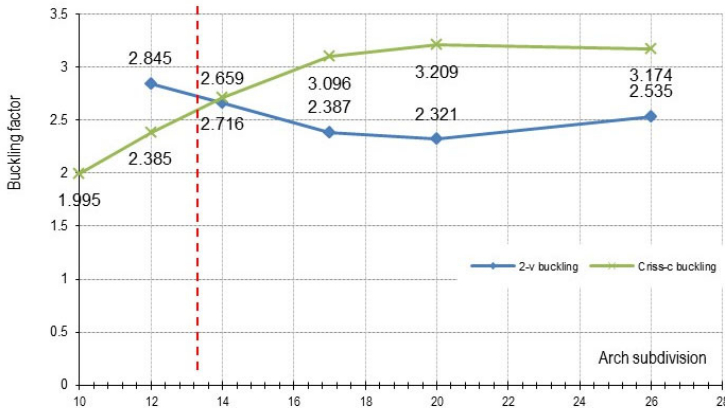
Fig. 3. Optimization evaluation for number of south span hangers vs. arch buckling.

The designers undertook a series of parametric studies of the arch geometry to optimize the efficiency and economy of the slender structure using advanced software interfaces. Rhino was used for the geometric modelling of the bridge structure. Grasshopper was used as a plug-in to allow parametric modelling while updating the Rhino model in real time. Numerous geometries and layouts were studied including the arch rise to span ratios of each arch, arch inclination, and hanger cable layouts.

Oasys GSA software was used for structural modelling. Geometry Gym's Smart Structural Interpreter (SSI) as used to important the parametric geometric model from Rhino by the touch of a button. This allowed for a quasi-instantaneous evaluation and optimization of the geometric parameters with respect to structural design.

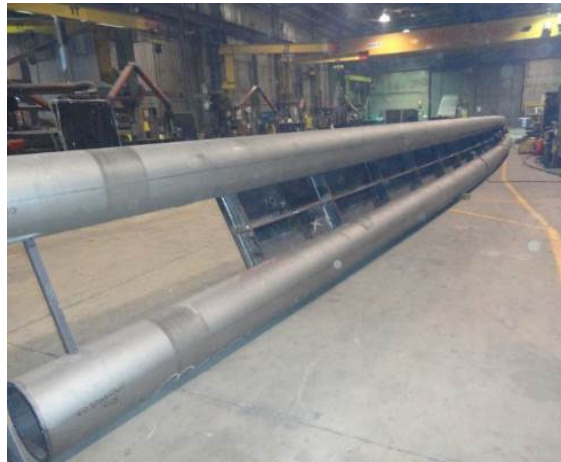
Fig. 4. Arch rib fabrication.

More than 300 tonnes of structural steel for the bridge was fabricated by ADF Group in their shop in Terrebonne, Quebec, from Canadian Standards Association (CSA) G40.21 350 WT steel, a weldable notch-tough steel with a yield stress of 350 MPa and a tensile strength ranging between 450 MPa and 620 MPa. The oblong arch section was fabricated from two steel tubes welded together via transverse stiffeners and a heavy top and bottom cover plate, as shown in Fig. 4 and Fig. 5.

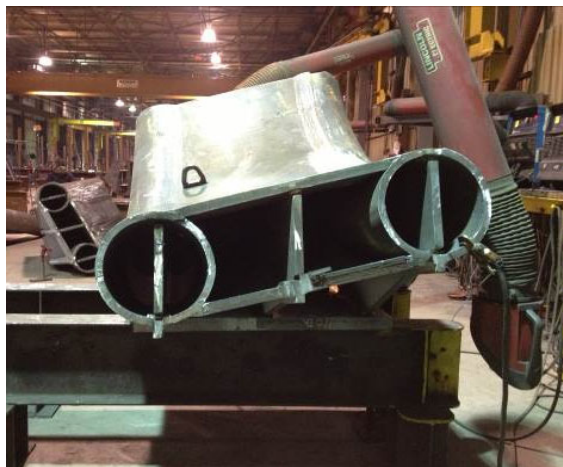
Fig. 5. Centre arch knuckle fabrication.

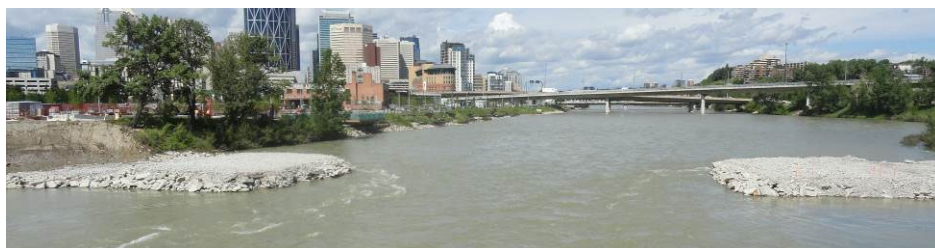
Fig. 6. Temporary berms.

Prior to fabrication of the deck and erection of the steel arches, large temporary beams were lifted over both the north and south channels of the river to support the construction works on temporary berms imported into the river. These temporary beams were intended to support both the deck formwork over the rivers and the scaffolding supports for erecting the main arch. Driven H-piles and steel frames were welded together as temporary abutments to support the large beams over the river channels.

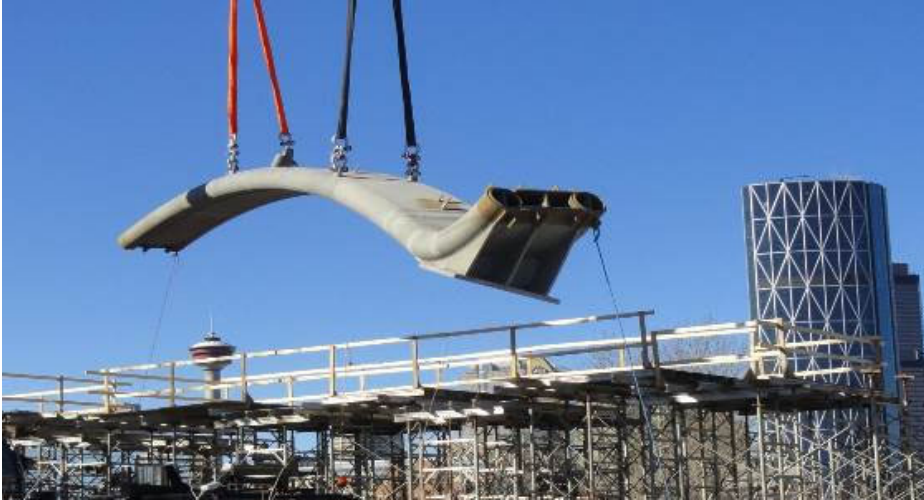
Fig. 7. Erection of centre arch segment.

Erection of the steel arches began with the centre arch sections on the island, with a single splice near the apex. Two days were required to lift the four pieces. Installation and complete splice welding was required before placement of the deck formwork could begin above centre span arches. The stainless steel rocker bearings were attached to the base of each arch section prior to placement in order to bear on the piers.

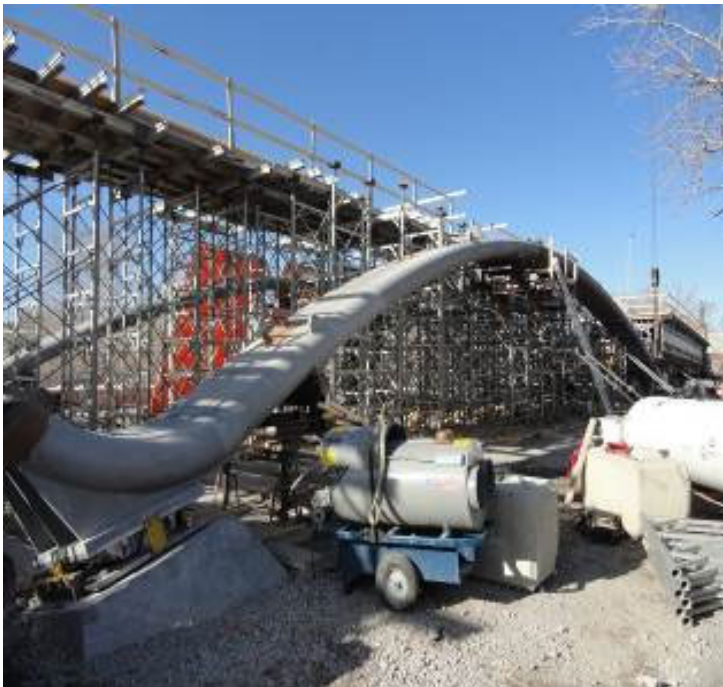
Fig. 8. Completed centre arches.

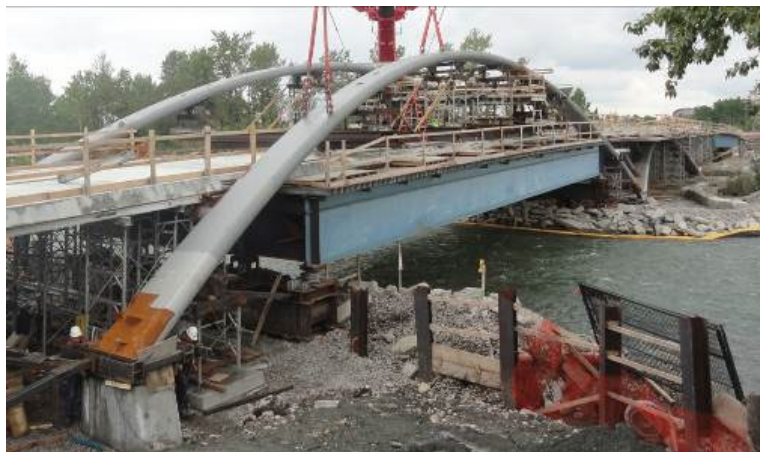
Fig. 9. North arches erected.

The north arch sections, again with a single splice near the apex, were erected second, after the deck below was cast and post-tensioned. In addition to the mid-span splice, another splice was required at the island piers to connect the arches to the centre arches.

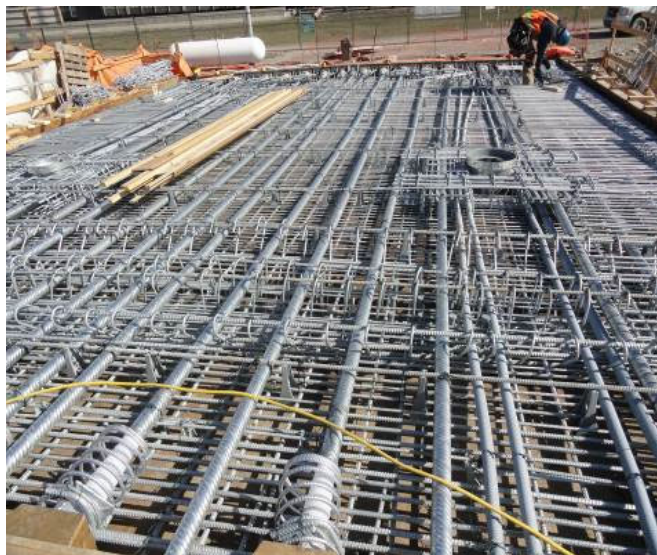
Fig. 10. Deck reinforcing bars and PT ducts.

The deck reinforcement consists entirely of galvanized bars, varying from 10M to 30M bars. Outside of the hold-down areas at either abutment, the reinforcement layout is relatively typical, with special configuration details at the arch to deck connection locations.

The deck is constructed from 45 MPa high performance concrete, with 15mm diameter low-relaxation post-tensioning (PT) strands. The deck pours are arranged around the multiple post-tensioning sections. There are three individual PT sections, one near each abutment and one over the centre arch, resulting in two infill pours between these three sections. The end section pours are approximately 35 cubic metres in volume, with the centre section pour being approximately 200 cubic metres.

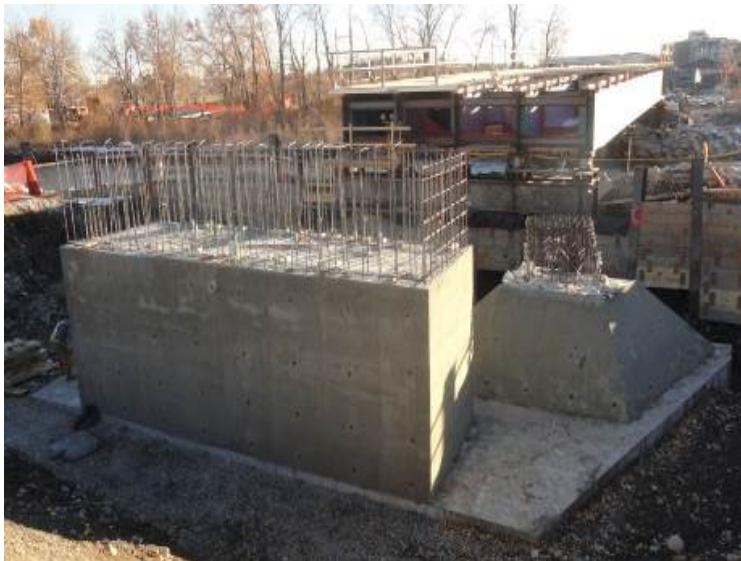
Fig. 13. Abutment pier foundation.

The abutments are supported on 12 drilled concrete piles, with a 1.25m thick pile cap supporting the arch bearing plinths and tie-down mass structure to resist uplift forces at each abutment. The north and south abutment pile layouts and pile cap configurations have identical dimensions, although the depths of pile tips vary based on geotechnical data.

Because the pile caps are located below grade, the abutment bearing plinths are extended to the surface via truncated pyramid-shaped extensions. Heights of the extensions vary for each arch bearing location due to the design termination elevations. Each abutment is reinforced with uncoated steel bars and constructed with 35 MPa design strength concrete.

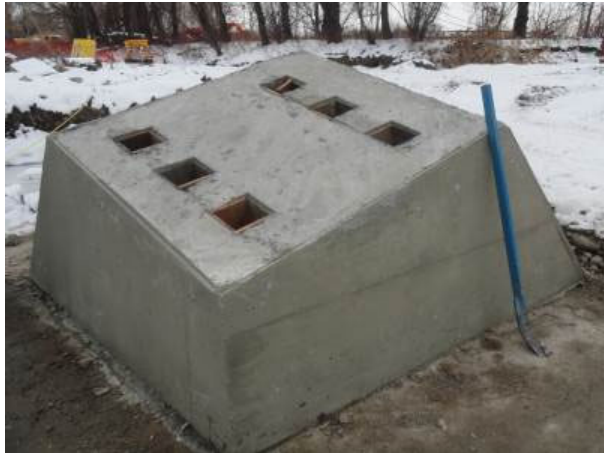
Fig. 14. Intermediate pier foundation.

Four intermediate piers support the north and south channel arches on St. Patrick's island. All of the piers have identical dimensions, with five drilled concrete piles and a pile cap.

To support the arch bearings on the intermediate piers, inclined bearing surfaces were detailed on truncate pyramid-shaped extensions atop the pile caps. The tops of the bearing surfaces are inclined in order to be normal to the support reaction. Since the north and south channel arch sections are continuously welded to the centre arch section over the island piers, the intermediate piers resist all directions of translation.

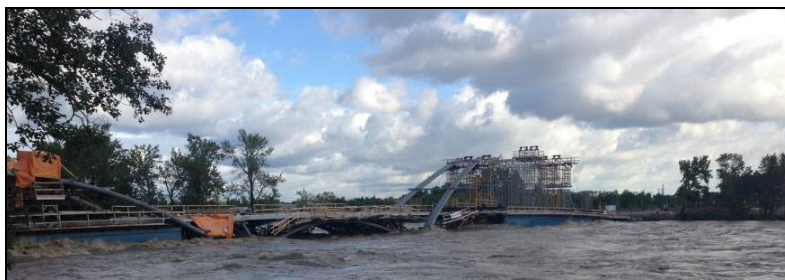
Fig. 15. Upstream side during flood event.

On June 19, swift river currents carrying debris steadily increased, as the worst flood in Alberta history began. The flooding impacted the bridge foundations and the scaffolding supporting the deck. Initial failures of scaffolding began on the island near the south intermediate pier, resulting in deflection of the deck. Subsequent flood flows dislodged scaffolding from beneath the deck in front of the southern abutment, which also resulted in significant deflections.

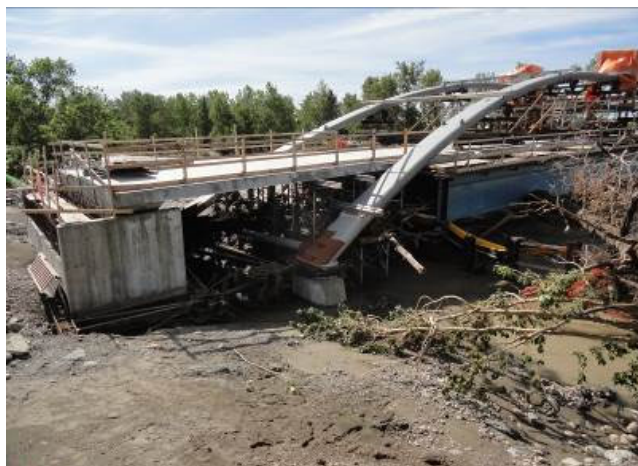
Fig. 16. Flood debris under north end.

Before deck removal and recovery could begin, a substantial amount of debris and damaged scaffolding needed to be removed from under the deck, and temporary support of deck sections needed to be re-installed. The clean-up required safe working practices and a large effort from the contractor to restore the site back to normal working conditions.

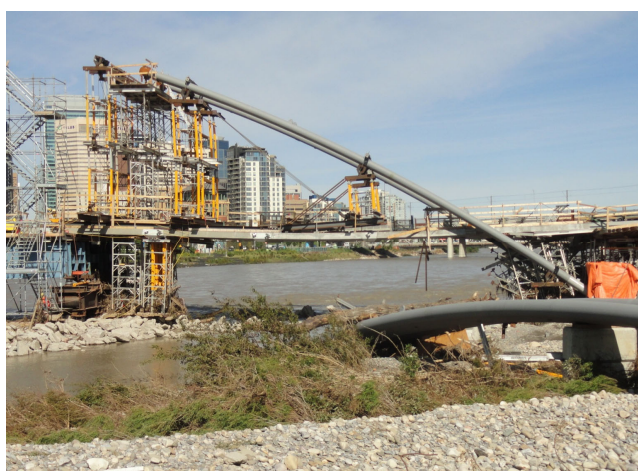
Fig. 17. Deck deflection after flooding.

Inspections and analysis following the flood damage concluded that the deck deflections resulting from loss of scaffolding support caused the reinforcing bars and PT strands to yield, therefore requiring replacement of the deck. Due to the full length post-tensioning ducts having been previously grouted, the two deck sections that experienced significant deflection could not be independently removed and replaced. Consequently, it was necessary to remove and replace the entire concrete deck.

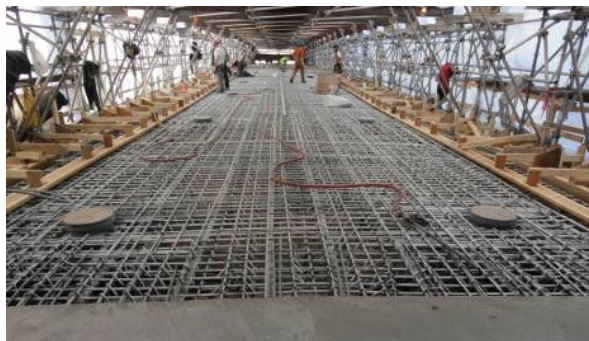
Fig. 18. Reinforcing within hoarding.

After removal of the deck, the erection sequencing was adjusted, such that all arch sections were erected first and followed by full deck replacement. Due to the delay, pouring of the deck occurred during the winter months in order to ensure the new deck was complete and supported by the arches before the following June when the potential for more flooding is the highest. This required full enclosures to hoard and heat the deck. The south arch sections were lifted in three sections, and spliced to each other and to the centre arch prior to removal of the temporary scaffolding. Two temporary support frames were left in place to support the as-built geometry until the hanger cables were installed and tensioned.

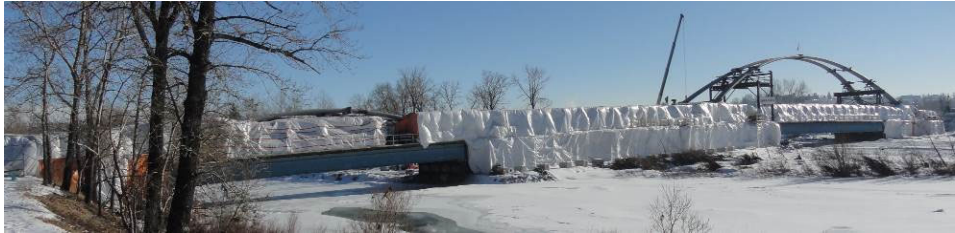
Fig. 19. Hoarding and heating of entire bridge deck during winter construction.

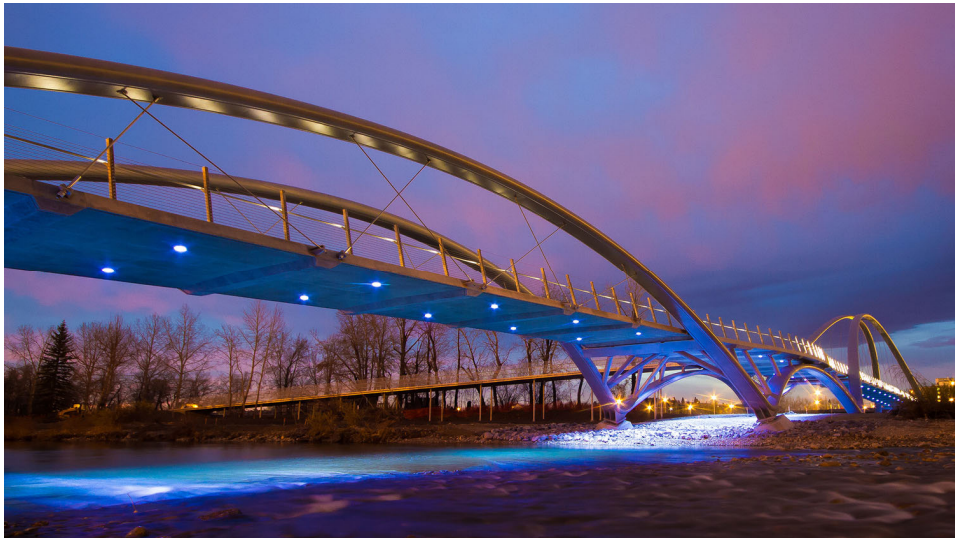
Fig. 20. Completed bridge and island access ramp with lighting.
