# Structural design, modelling, material testing and construction of a new stone masonry arch bridge in Vila Fria, Portugal

**ABSTRACT:** This paper presents the main activities involved in the construction of a new stone masonry arch bridge, the Vila Fria Bridge located in the north of Portugal, as part of a wider multidisciplinary project. The paper briefly describes the main aspects related to the design, construction, the characterization of the adopted materials and the numerical simulations to support the undertaken choices from the construction to the beginning of the bridge service conditions.

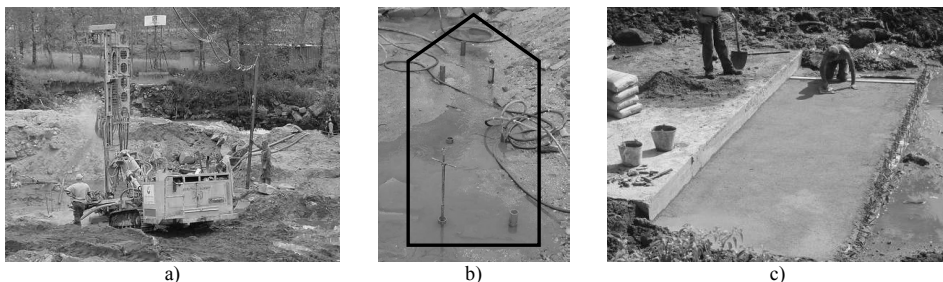
Due to extremely bad soil conditions, the new Vila Fria Bridge was built on deep foundations made by groups of micro-piles (Figs.2a,b) with reinforced concrete top caps (Fig.2c) on which the bridge stone piers were mounted.

Figure 2 : Bridge foundations – (a) Micropile instalation, (b) micropiles and (c) top RC cap.

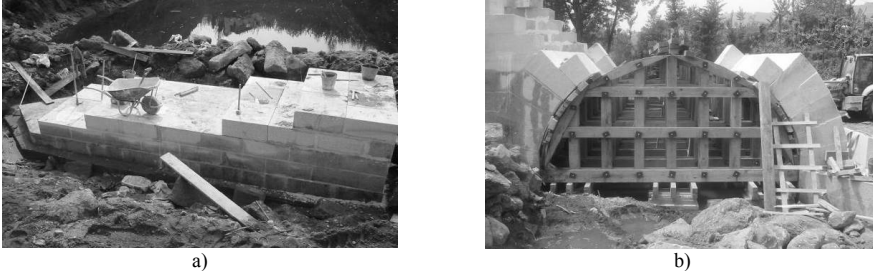
Supported by the micro-pile RC caps, the solid piers were built in massive stone layers separated by beds and vertical joints comprising a thin layer of weak mortar (see Fig. 3a). This mortar is especially produced for this type of applications and consists on a mixture of lime based mortar with a small percentage of Portland cement.

In the subsequent phase, the temporary wood centering for each arch was placed directly supported in the ground after having deviated the river towards other lateral flow zones. In order to resist the arch weight before its final closed configuration, the centering was made of several strong wood frames giving support to thick wood boards on which the arch stones were laid (Fig. 3b).

Figure 3 : Vila Fria bridge structure – (a) piers and (b) arches

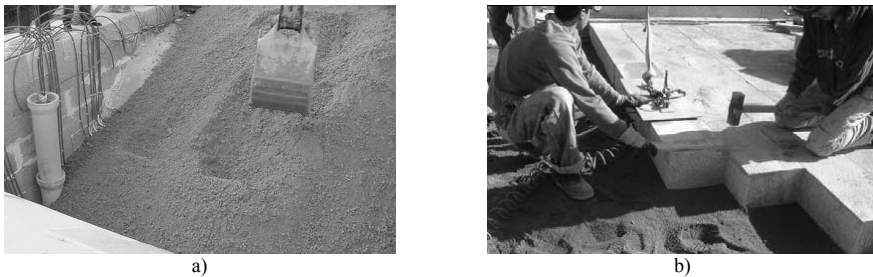
The stone assembly of the main elements (piers, arches and breakwaters) was already specified in the design in terms of their dimensions and construction sequence. The subsequent step consisted on the elevation of spandrel walls and posterior spread of the backfill material (*tout-venant*) along the bridge, as can be seen in Fig. 4a.

Above the backfill material, a layer of *tout-venant* mixed with cement provided a regularized surface covered by a waterproof membrane. A final layer of a dry sand and cement mixture was made in order to lay down the granite stone pavement, as shown in Fig. 4b. Parapets are also made of granite stones fixed to the spandrel walls by means of two stainless steel bars. Fig. 5 shows the final result after three years of bridge construction opened to traffic by May 2005.

Figure 4 : Vila Fria bridge structure – (a) backfill material and (b) granite stone pavement

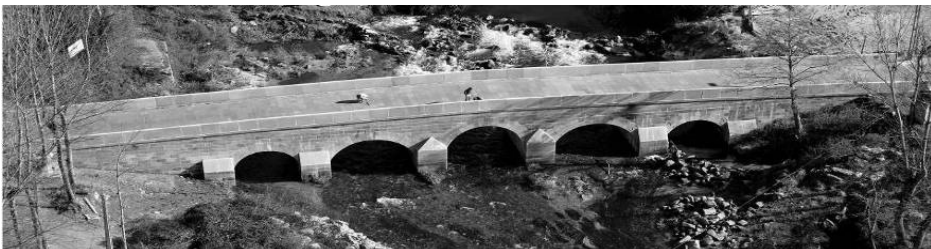
Figure 5: The new Vila Fria Bridge. Aerial view. Courtesy of Prof. F. Piqueiro and Foto Engenho ©.

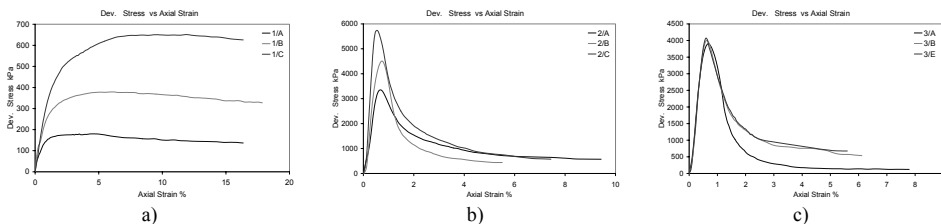
In order to characterize the shear resistance of the backfill material by recourse to the *triaxial* test, nine specimens were tested. Table 1 identifies the specimens and describes the parameters changed between them. Fig. 6a,b,c shows the results from *triaxial* tests in specimens of *tout-venant* and *tout-venant* mixed with cement in two different proportions.

Figure 6 : Stress-strain results from triaxial tests: (a) *tout-venant*, (b) *tout-venant* with 10% cement and (c) *tout-venant* with 7% cement

Concerning the behaviour shown in the three curves of Fig. 6a,b,c (note the different scales!) the results show typical elastic-plastic soil behaviour for the case without any cement. When cement is added, the curve reaches a peak strength typical of cohesive materials, followed by a softening zone towards a residual value. These results will be particular relevance for numerical modelling of the backfill material.

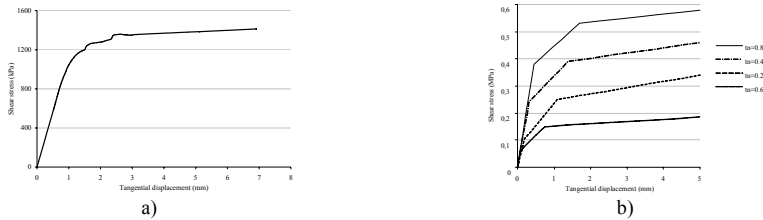
The shear strength of masonry joints is evaluated by monitoring the sliding along their discontinuity plan. Tangential displacements are imposed under a given constant normal force, and both the corresponding tangential forces and the normal displacements are measured. This procedure was iterated for different values of the normal compression stress varying from 0.2 to 2 MPa in several specimens consisting of: *i*) two blocks and a thin layer of mortar in the interface (case 1-mortared interfaces); *ii*) two blocks without any mortar in the interface (case 2-dry interfaces) and *iii*) one stone block and infill material (case 3-block/*tout-venant* interfaces). Fig. 7a shows the result of one shear test in mortared interfaces and Fig. 7b depicts

the theoretical fitted curves as used in the numerical model for monotonic behaviour. Further tests are still under development, for both cyclic shear and normal behaviour characterization.

Figure 7 : Shear behaviour for mortared interfaces. (a) Experimental and (b) theoretical fitted curve.

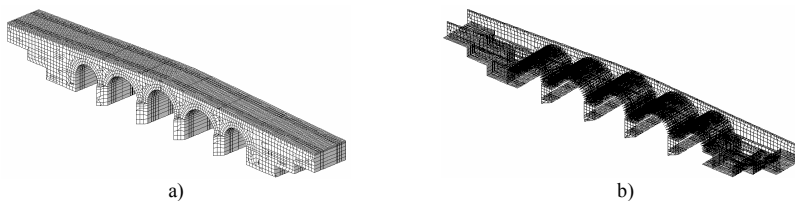
For additional support to design options the structural analysis of the Vila Fria bridge was carried out using a 3D structural numerical model using the finite element method by means of CAST3M software (Pasquet, P. 2003). The stone blocks were simulated by solid elements with linear behaviour duly individualized, in order to consider explicitly the following joints: *i*) in the arches zone; *ii*) between the piers and the remaining structure; *iii*) between the infill and the spandrel walls and arches; *iv*) between the breakwaters and the remaining structure. The deck zone was also discretized with 3D elements. All the interfaces between the distinct components of the structure were simulated using joint elements allowing the nonlinear behaviour to be activated. Fig. 8a,b shows the whole meshes of both solid and joint elements for the Vila Fria bridge finite element model.

Figure 8: Finite element mesh of (a) 3D elements and (b) joint elements used in the numerical analysis.

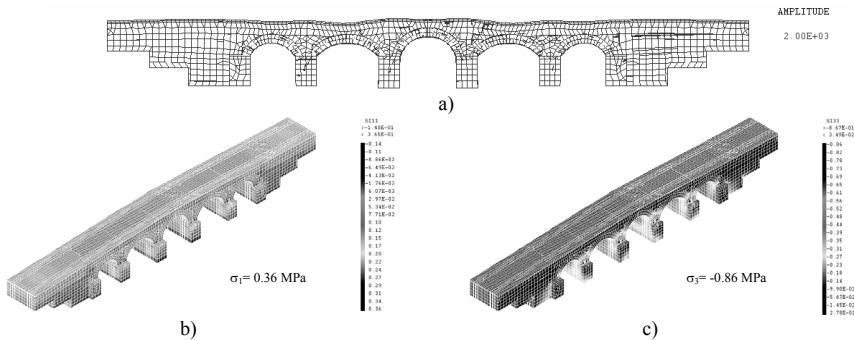
Figs. 9a,b,c shows the results of the bridge linear elastic analysis in terms of deformed shape and the principal stresses due to dead load. Results of the non-linear analysis are not yet fully available since the experimental results were not completely processed by the time this paper was written. In a very near future, however, such results will be the object of a specific publication.

Figure 9 : (a) Deformed shape of the bridge due to dead load. (b) Tensile and (c) compressive principal stresses in solid elements (peak values in brackets).

Concerning these results, it is clear that peak tensions and compressions in the solid elements are compatible with the corresponding strengths as determined in the laboratory tests of stone blocks. Accordingly, the peak compressive stresses in joints between blocks have values which are quite common in this type of stone masonry structures, i.e. around or below 1 MPa and, therefore, far below the corresponding compressive strength.
